Inspection Photos

Operator: H & M PETROLEUM CORPORATION

Location ID: 312312

Logan County, CO

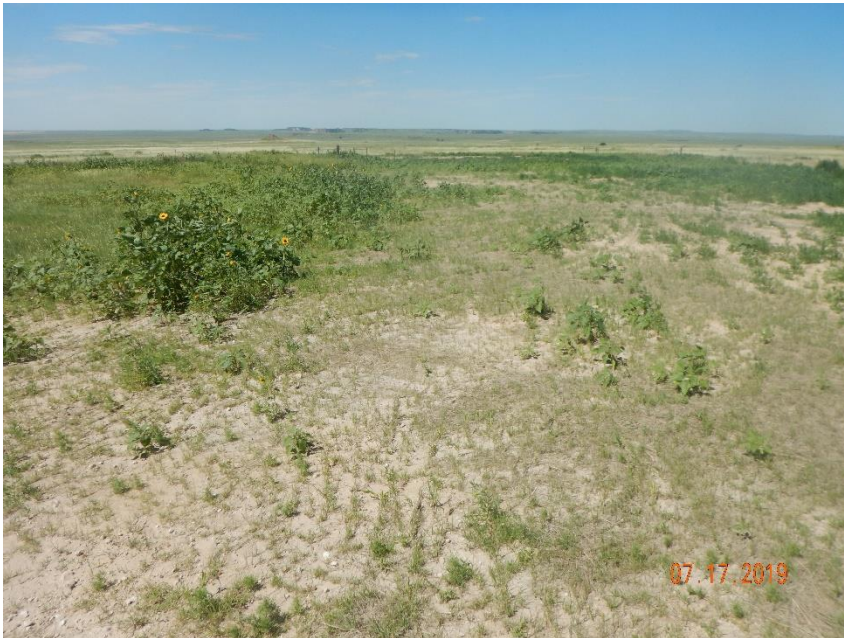
Photo 1: Photo taken from the east end of the location, facing west. Photo shows battery facility and pits have been closed, equipment removed and reclamation conducted. Though germination is evident, location is predominantly undesirable weedy plant species.

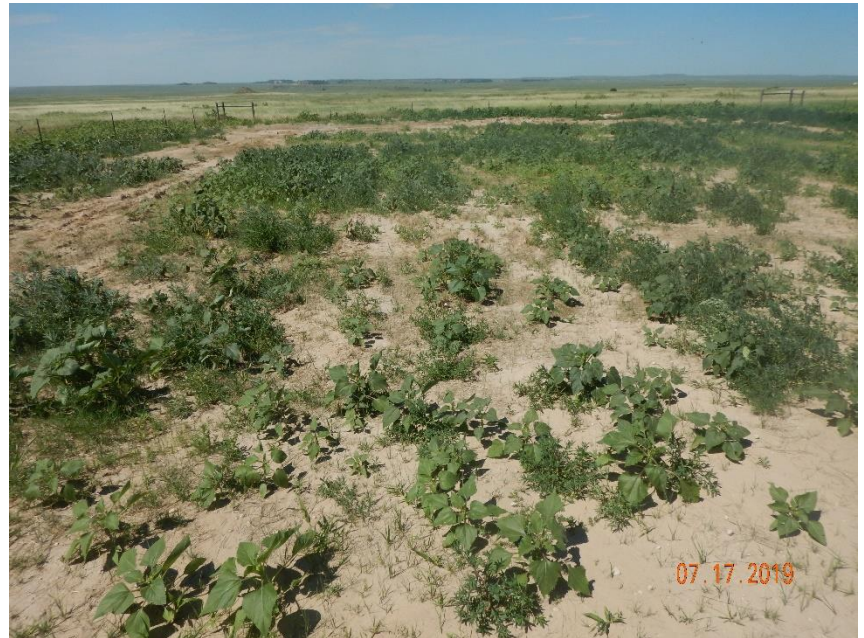
Photo 2: Photo taken from the east end of the pits, facing west. Photo shows pits have been closed. Though germination is evident, location is predominantly undesirable weedy plant species.

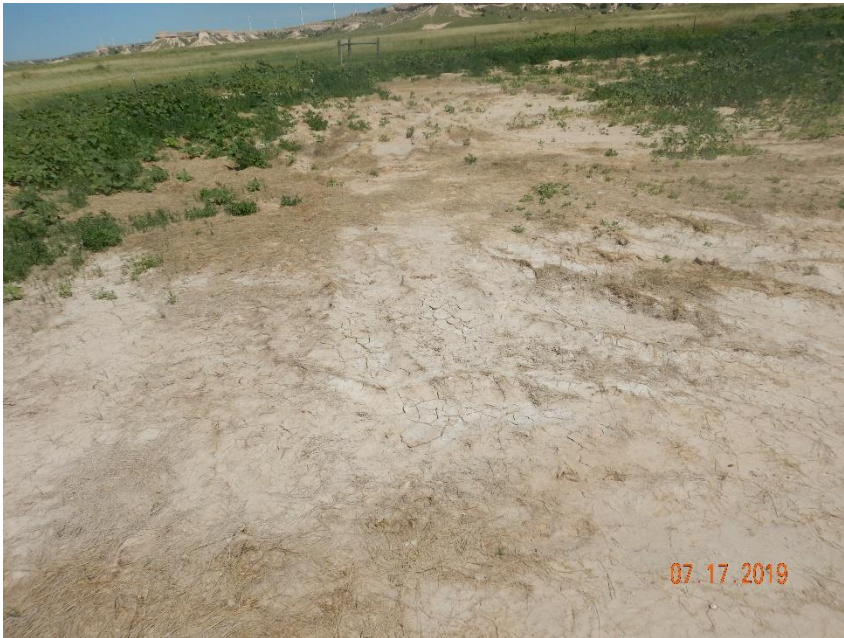
Photo 3: Photo taken from the southwest end of the pits, facing north. Photo shows area of the pits where desirable germination is not evident.

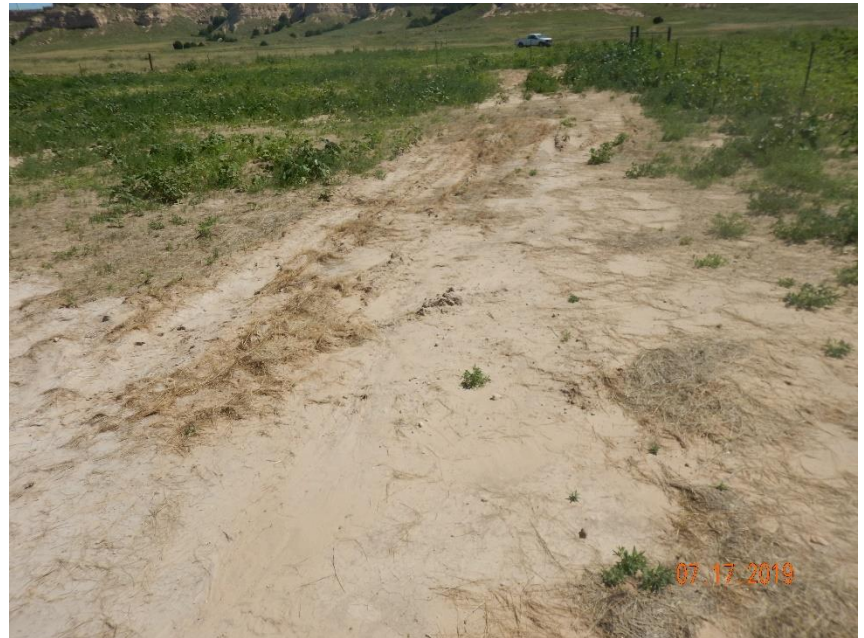
Photo 4: Photo taken from the southwest end of the pits, facing east. Photo shows area of the pits where desirable germination is not evident.

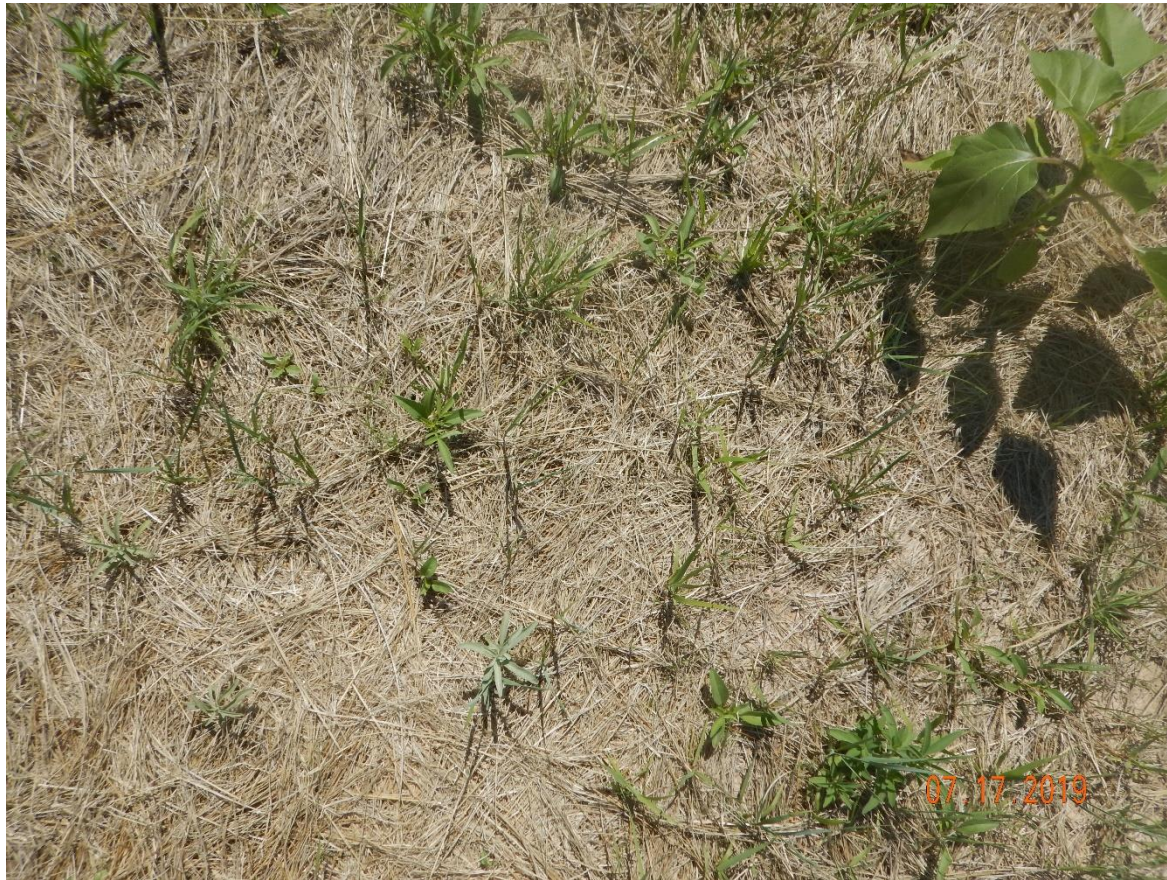
Photo 5: Photo taken from the location. Photo shows grass germination.
