# Inspection Photos

07/17/2019

Operator: BRITISH AMERICAN OIL PROD CO -  
#10558 / Chevron USA INC - Operator  
#16700

Location ID: 389108  
Logan County, CO

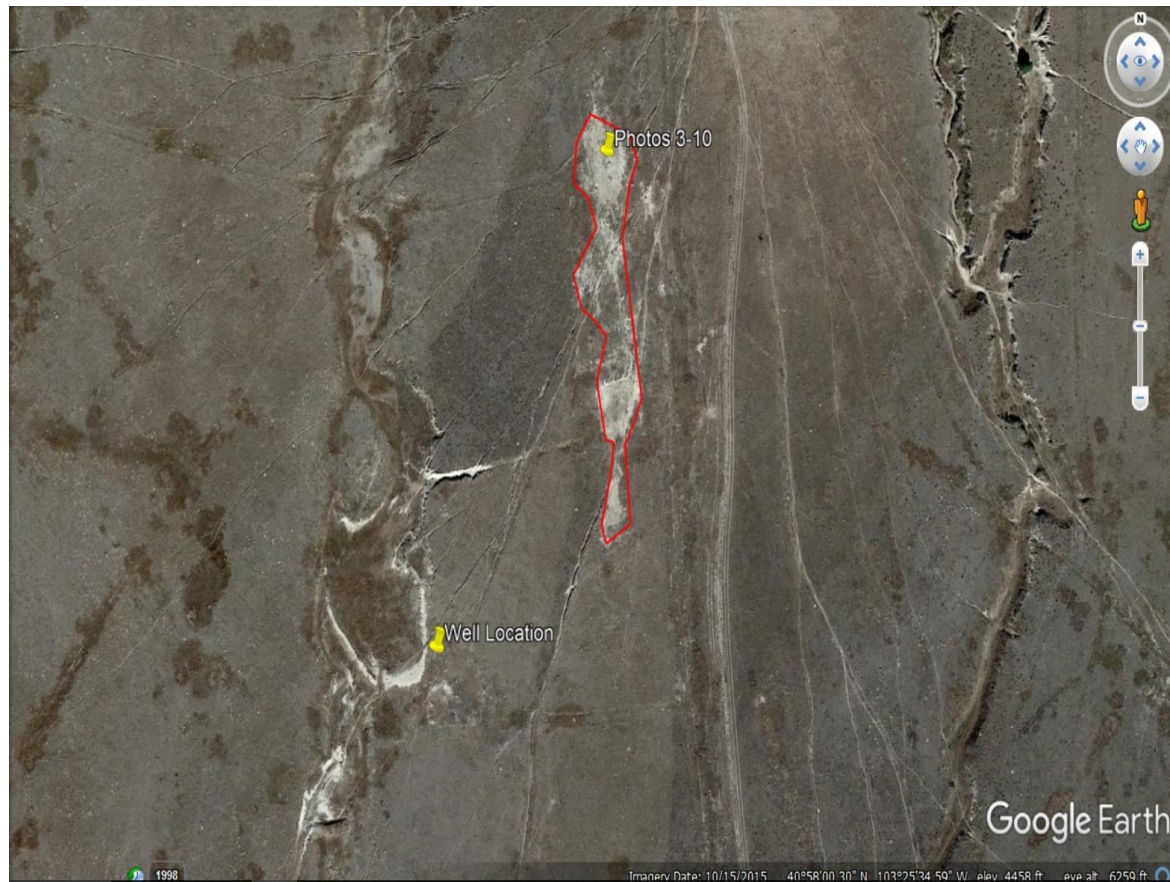
**Photo 1:** Image and comments taken from photo document #682502748: Current aerial imager (2015) showing well location and the former battery location. Red polygon represents area of the former battery and areas where degradation is evident either due to improper reclamation or stormwater runoff onto adjacent lands. Debris was observed scattered throughout this area.

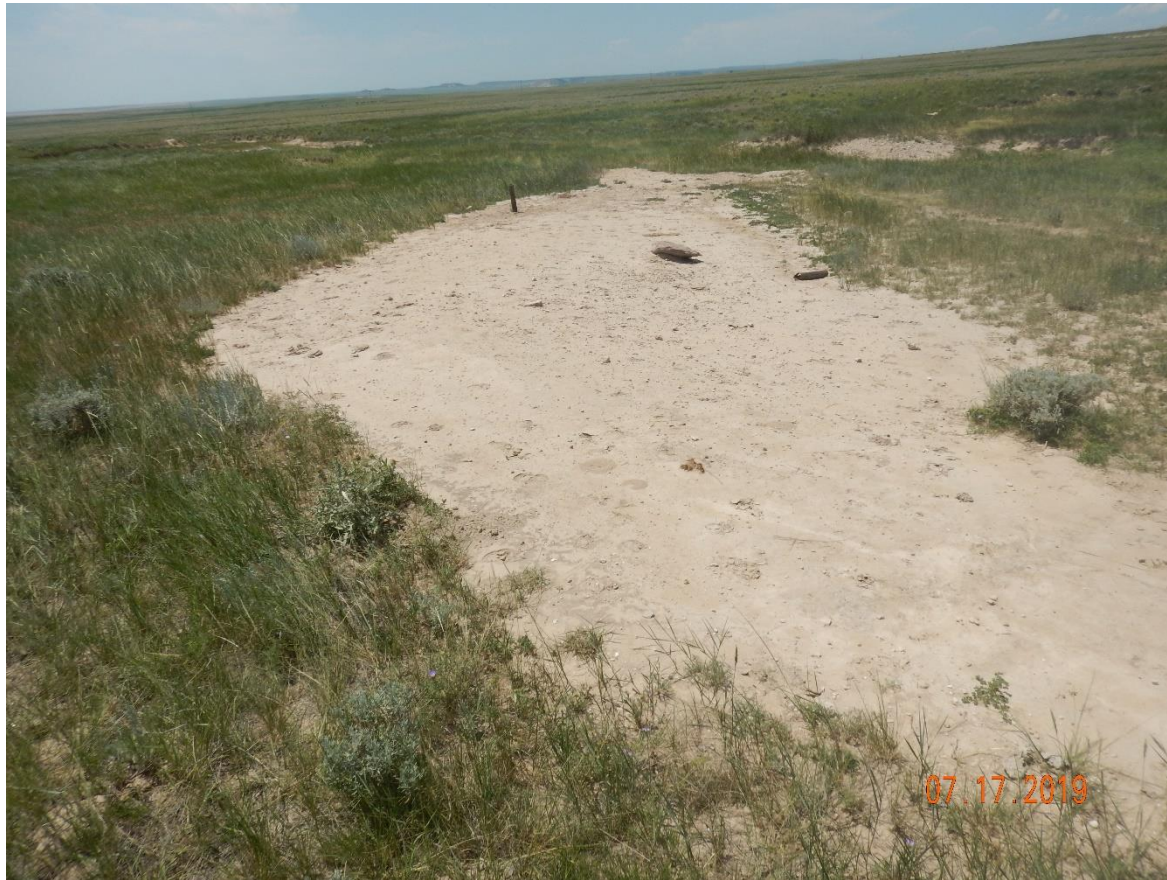
**Photo 2:** Photo taken from the well location, facing west. Photo shows riser remaining at location. Photo also shows location remains bare and exposed soil. Unable to find evidence that reclamation has been conducted per corrective actions.

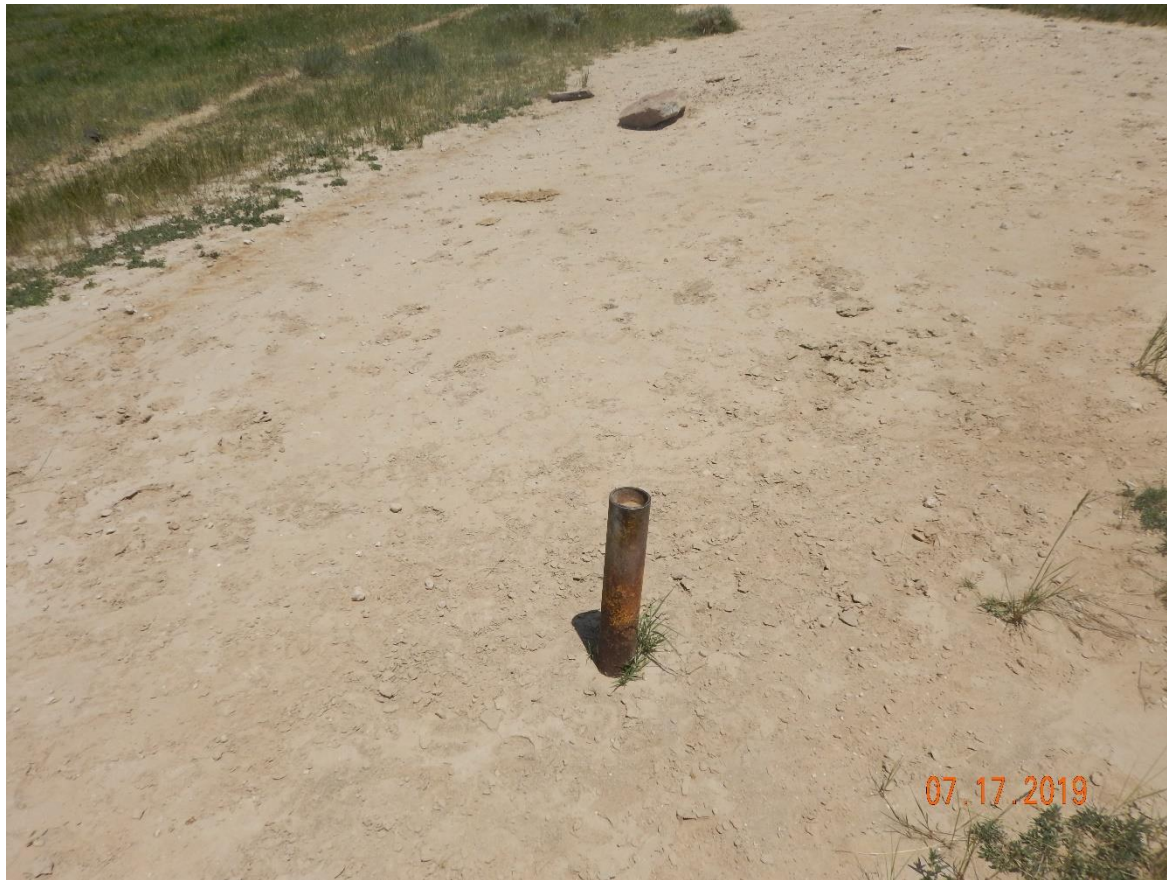
**Photo 3:** Photo shows riser remaining at location. Unable to find evidence that reclamation has been conducted per corrective actions.

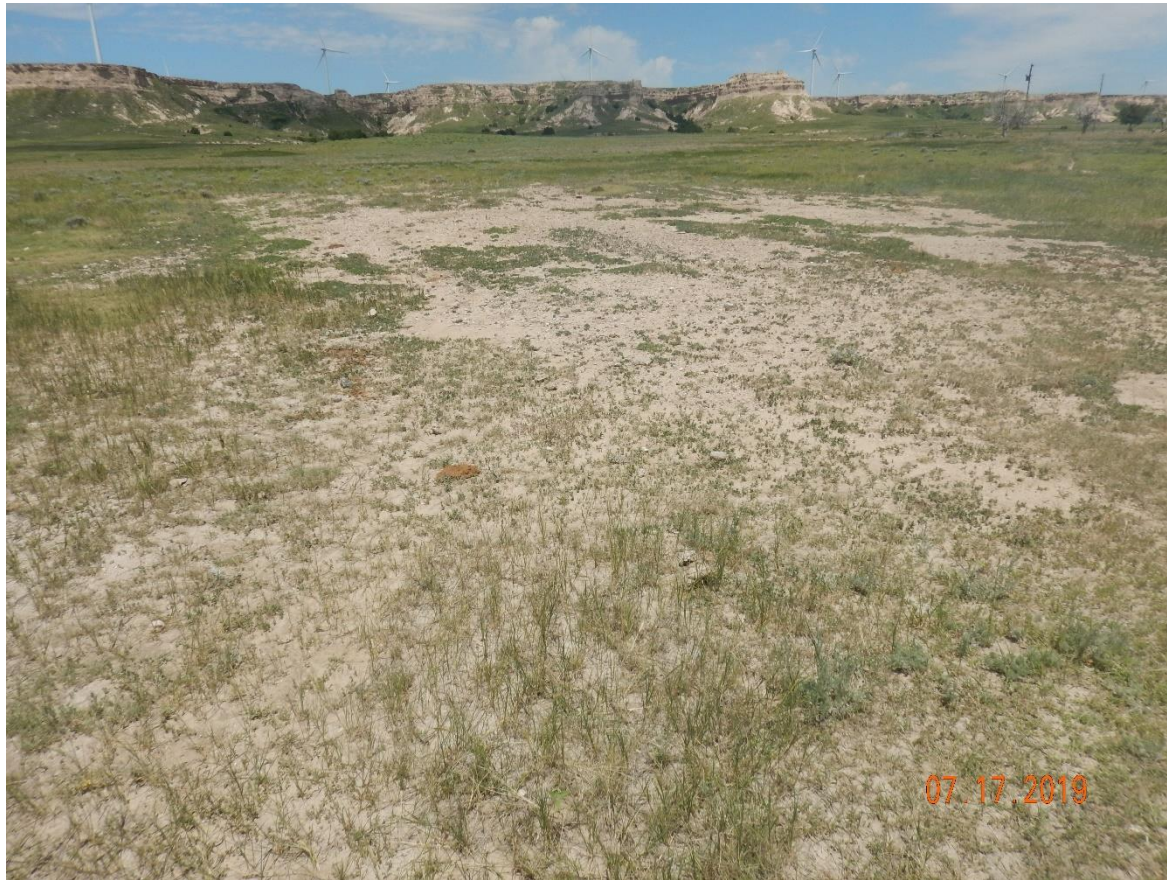
**Photo 4:** Photo taken from the south end of the former battery location. Photo shows trash debris and risers have been removed. Location remains bare and exposed soil. Unable to find evidence that reclamation has been conducted per corrective actions.

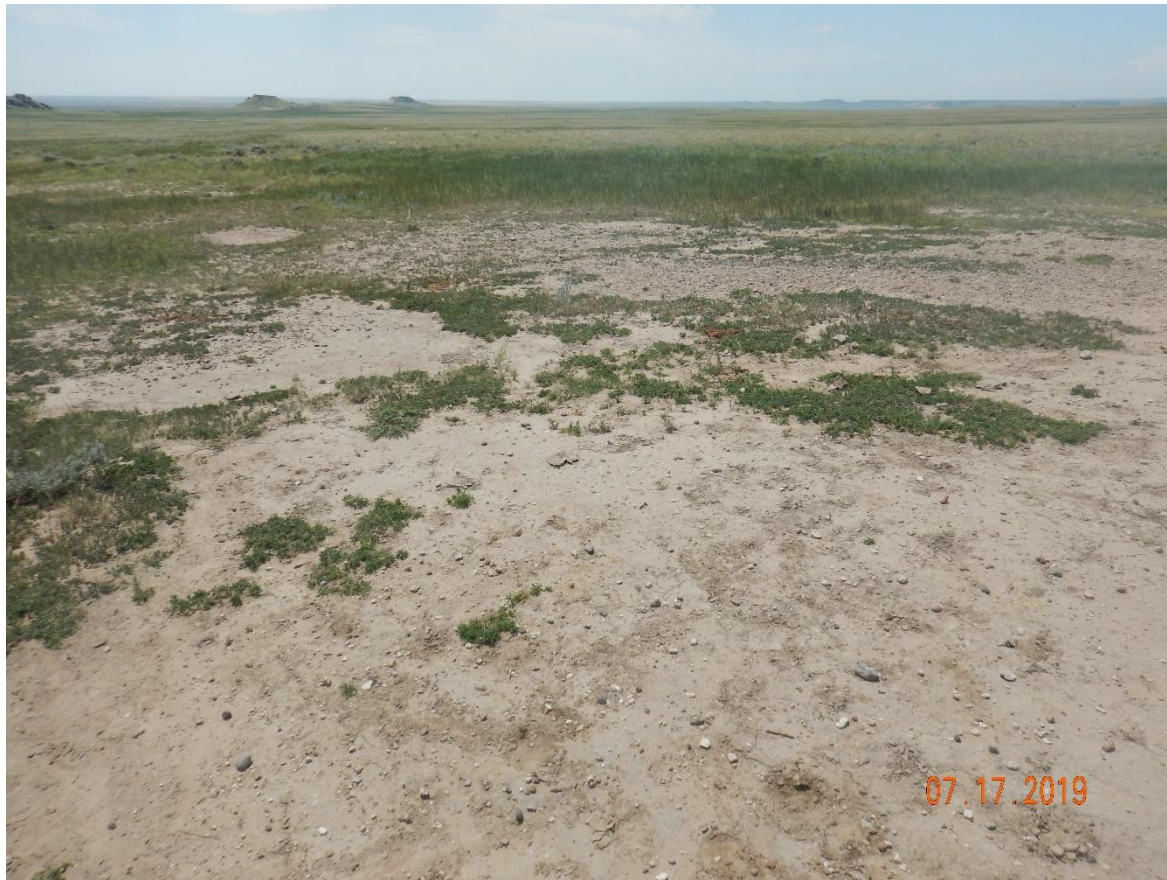
**Photo 5:** Photo taken from the east end of the battery location, facing southwest. See comments under photo 4.

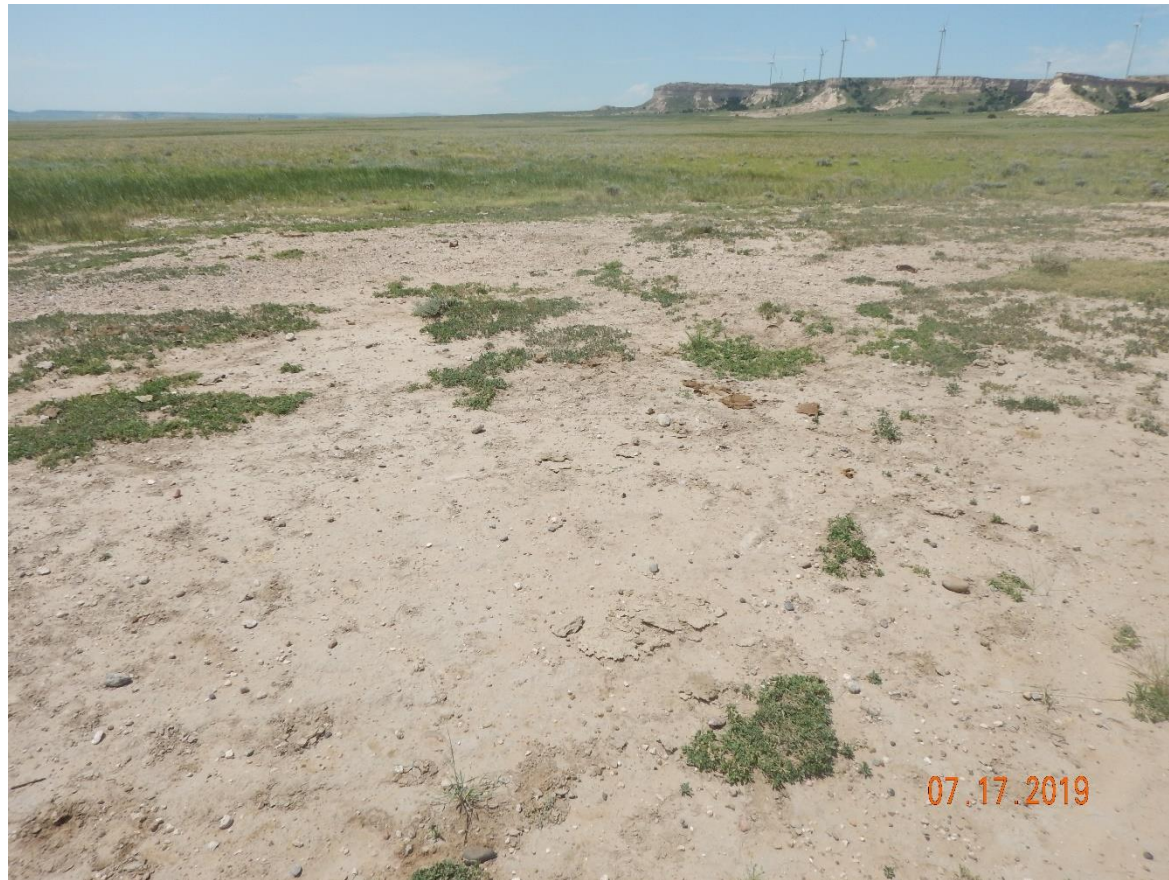
**Photo 6:** Photo taken from the east end of the battery location, facing northwest. See comments under photo 4.

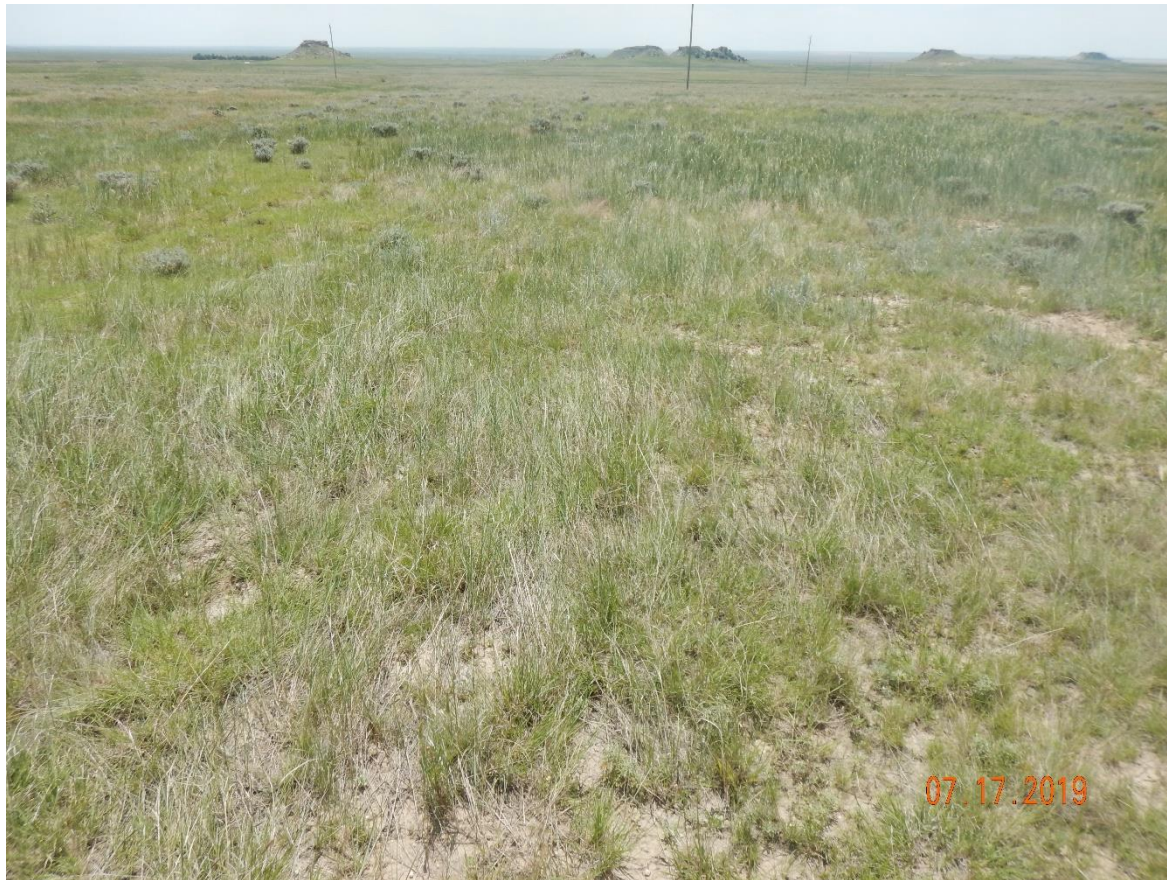
**Photo 7:** Photo taken from the adjacent reference area. Photo shows well and battery location is not reflective of the reference area.
