# Final Reclamation Inspection

Operator: KERR MCGEE OIL & GAS ONSHORE LP #47120

API: 05-123-11497

Inspection Photos  
Location Name: GENESIS #2  
API: 05-123-11497

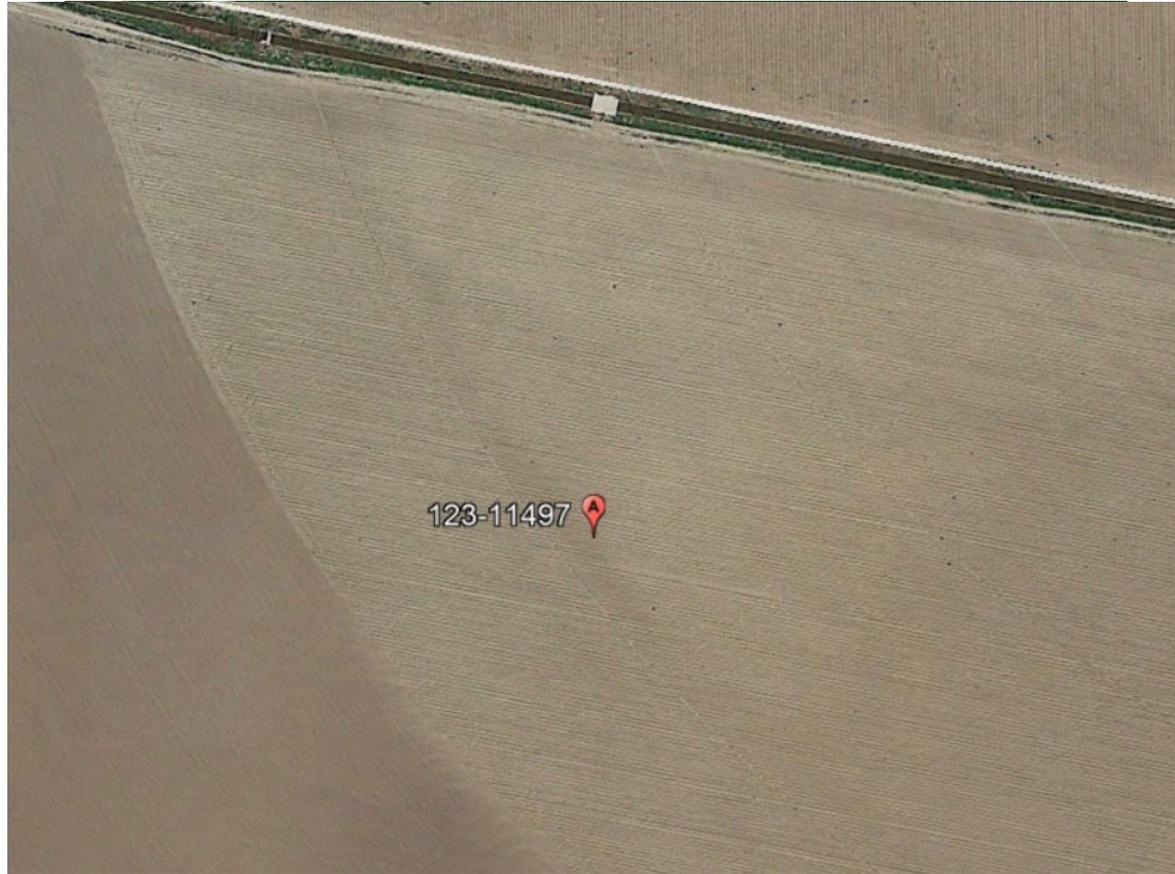
Google Earth aerial imagery taken 6/19/2014. Aerial imagery indicates the well location and access road appear to meet Rule 1004 standards. Field Inspection Report Doc. #200054044 conducted on 5/7/2004 passed Final Reclamation.

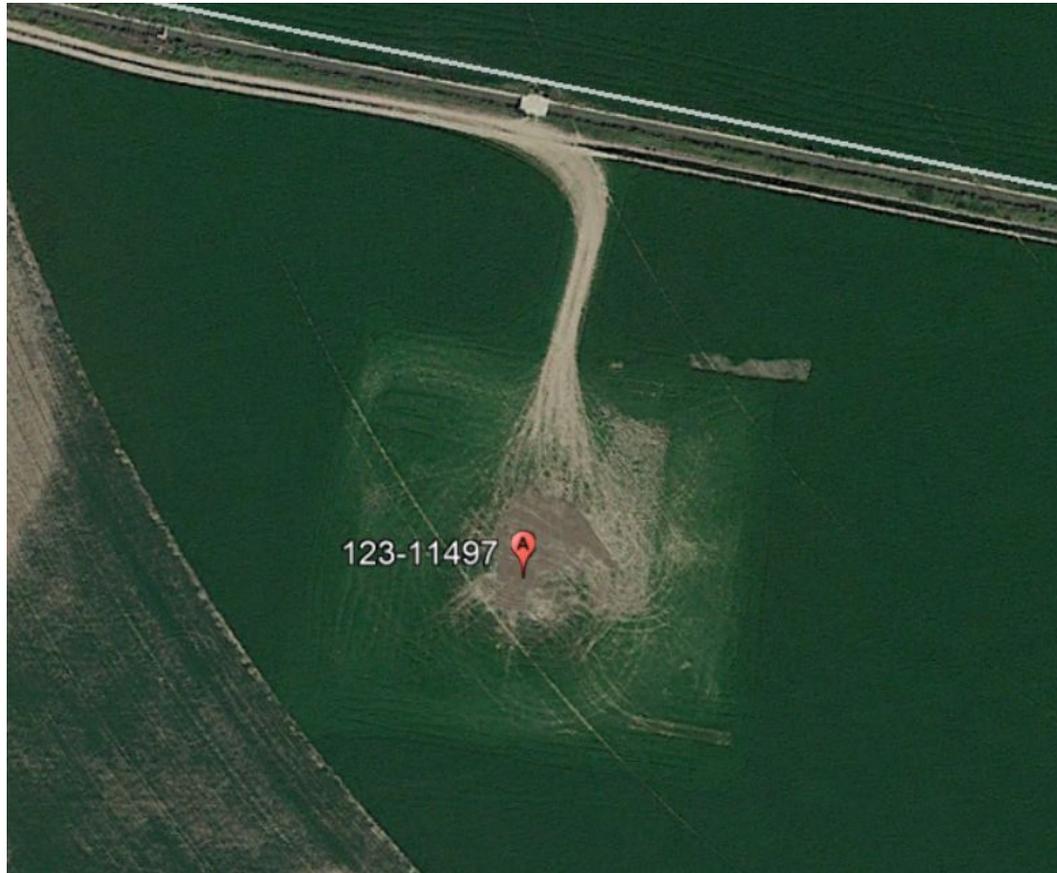
Google Earth aerial imagery taken 9/7/2016. Well was re-plugged by another Operator (Kerr McGee) on 9/2/2016 to comply with current rules and regulations. Since the well location passed Final Reclamation previously it is the responsibility of Kerr McGee to meet Rule 1004 standards.

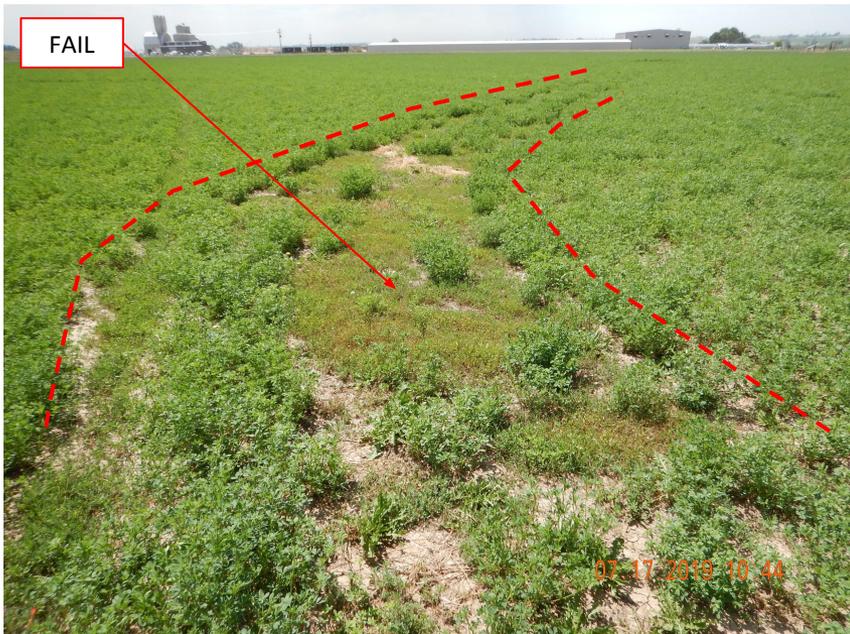
**Photo 1.** Photo taken from the western access road, facing South. Photo illustrates access road is not reflective of reference crop areas.

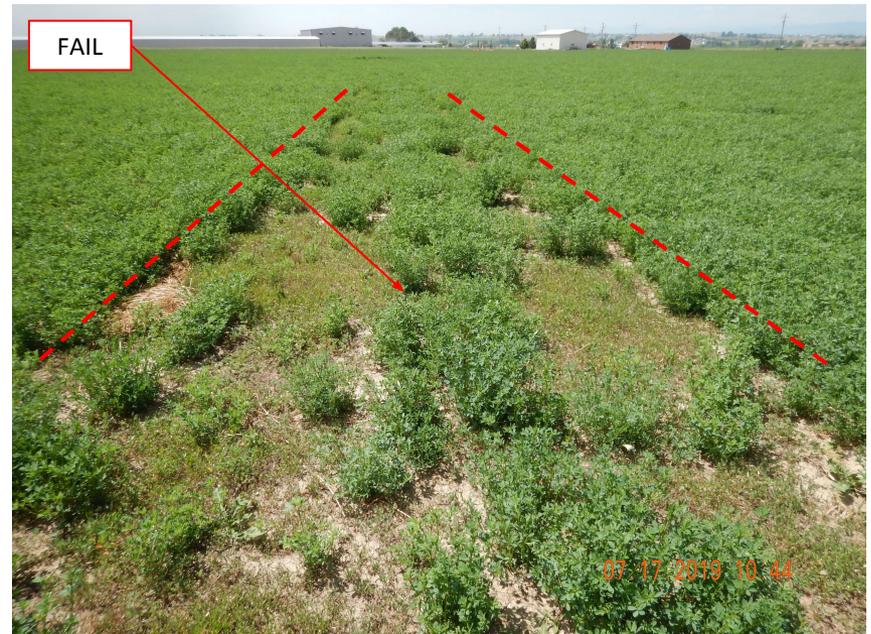
**Photo 2.** Photo taken from a portion of the access road, facing South. See comments under Photo 1.

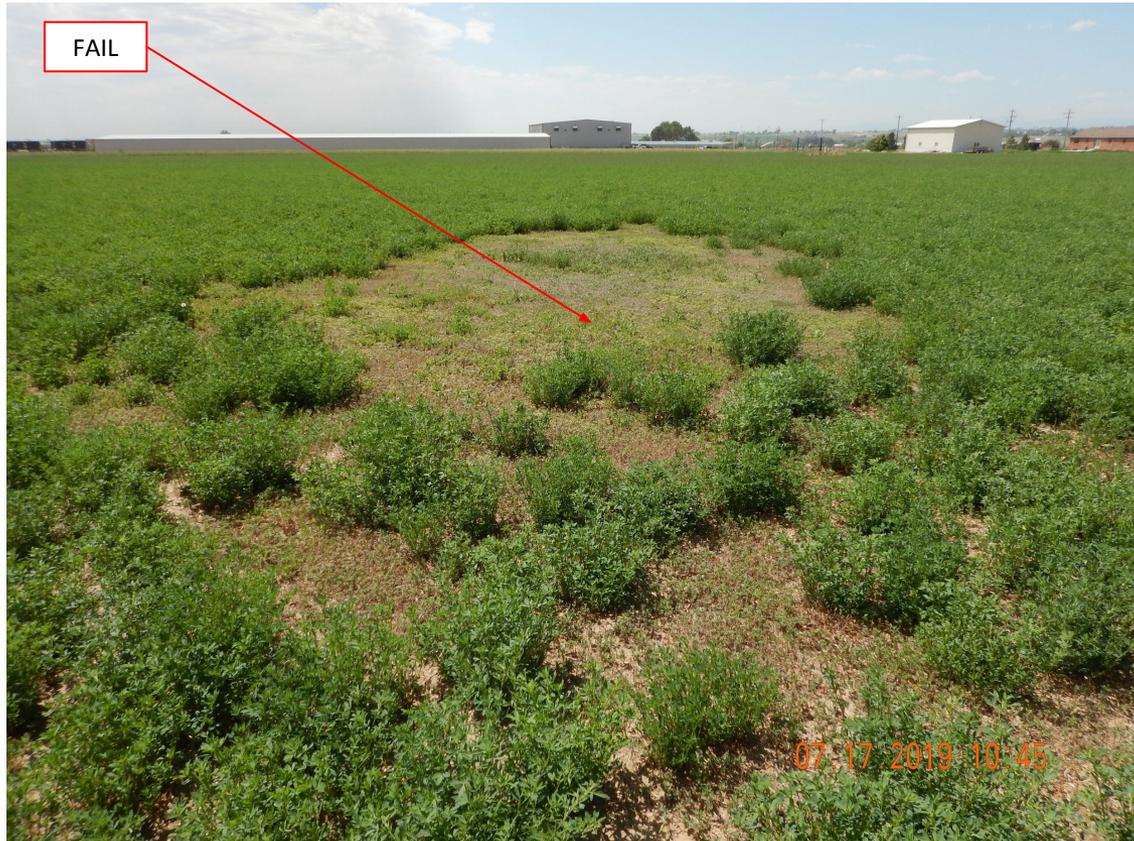
**Photo 3.** Photo taken from the well location, facing South. See comments under Photo 1.

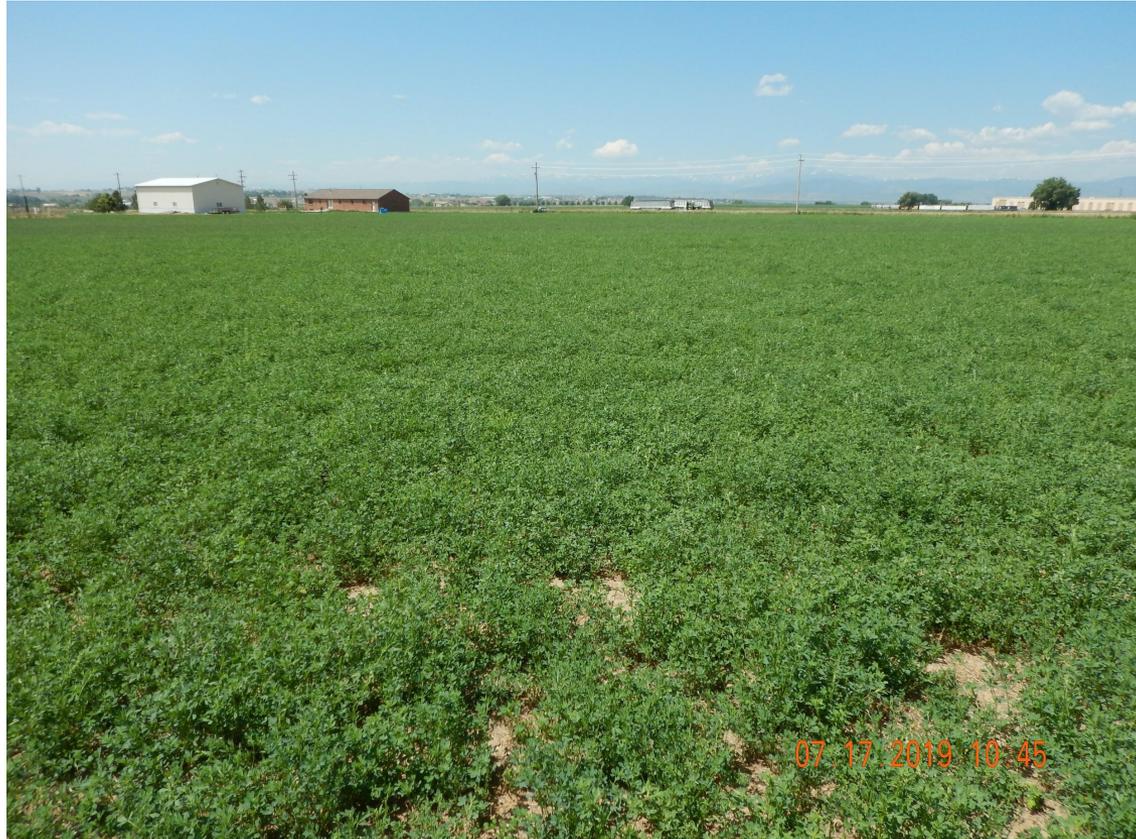
**Photo 4.** Reference photo taken southwest of well location, facing West. See comments under Photo 1.
