Inspection Photos
Operator: BP America
Location/API #: 067-06357
Date: 7-11-2019

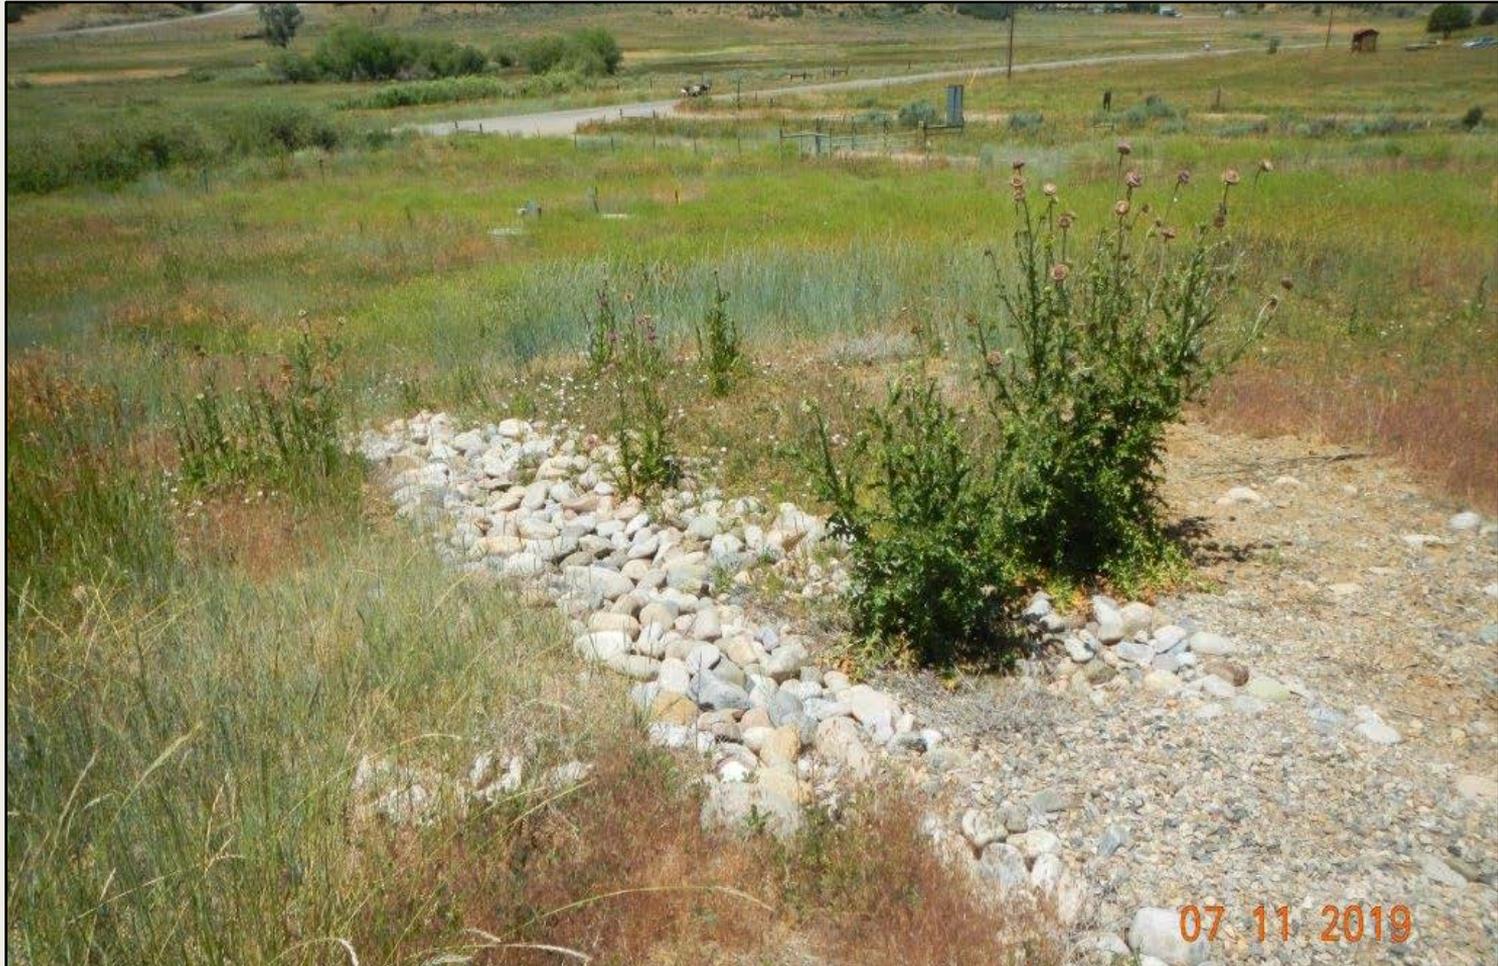
Photo 1. View of discharge point in the western project area. It appears gravel is being carried off of the well pad from high energy flows. This needs to be stabilized. Additionally approximately 200 musk thistles observed.

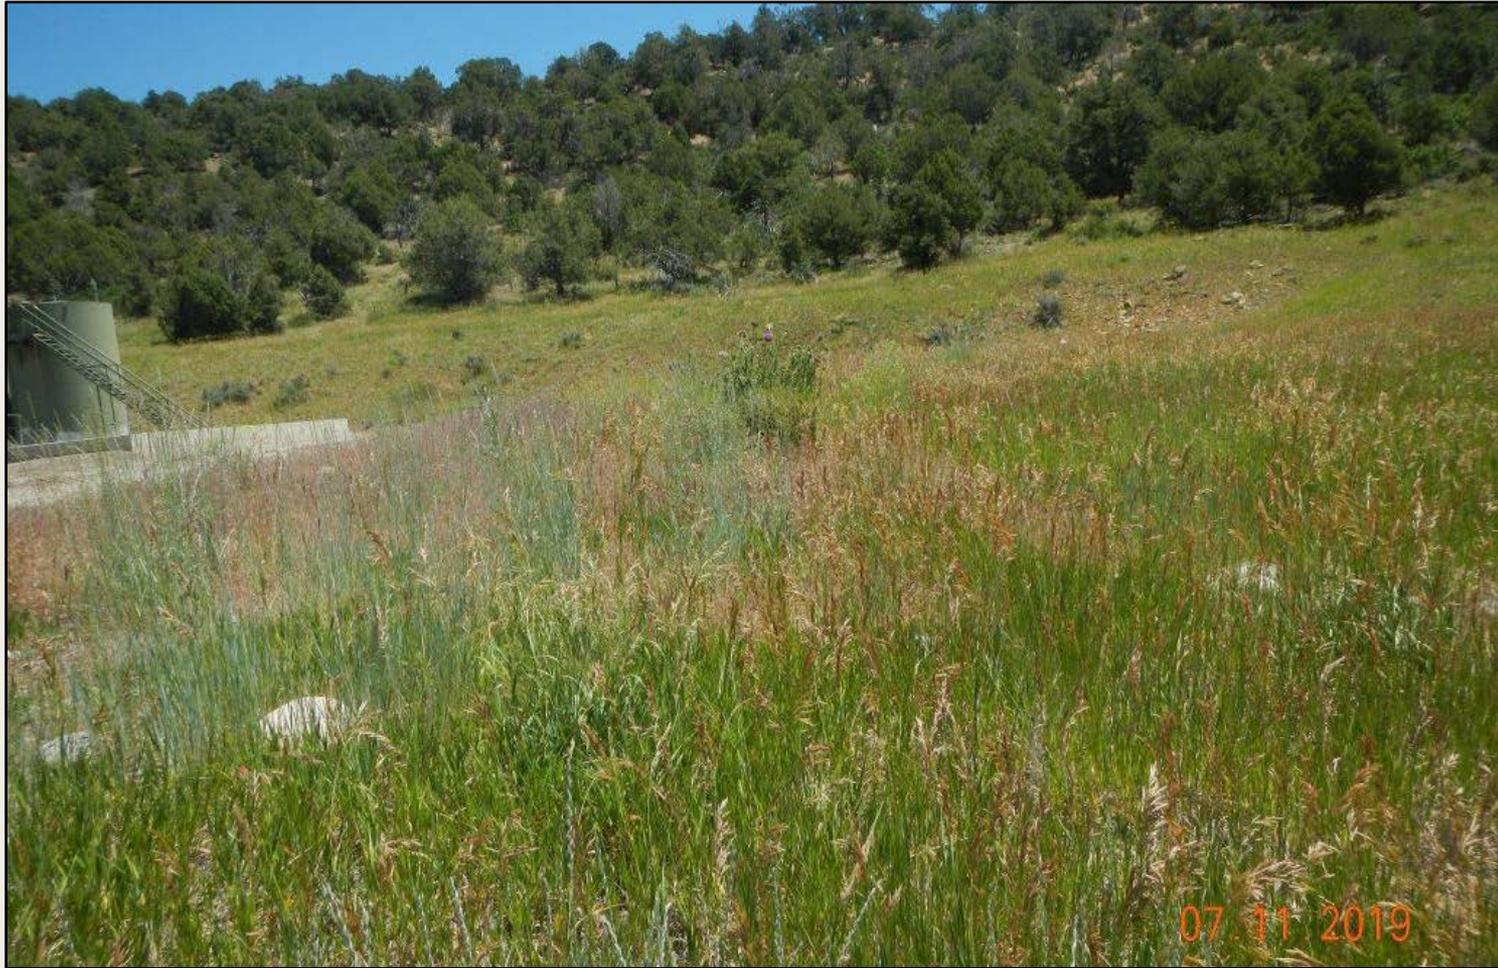
Photo 2. View of the southern project area from the southwestern edge facing eastward.
