**Inspection Photos**  
**Location Name: WORM 33-36**  
**API#: 05-071-06826**  
**INSP. #: 695101103**

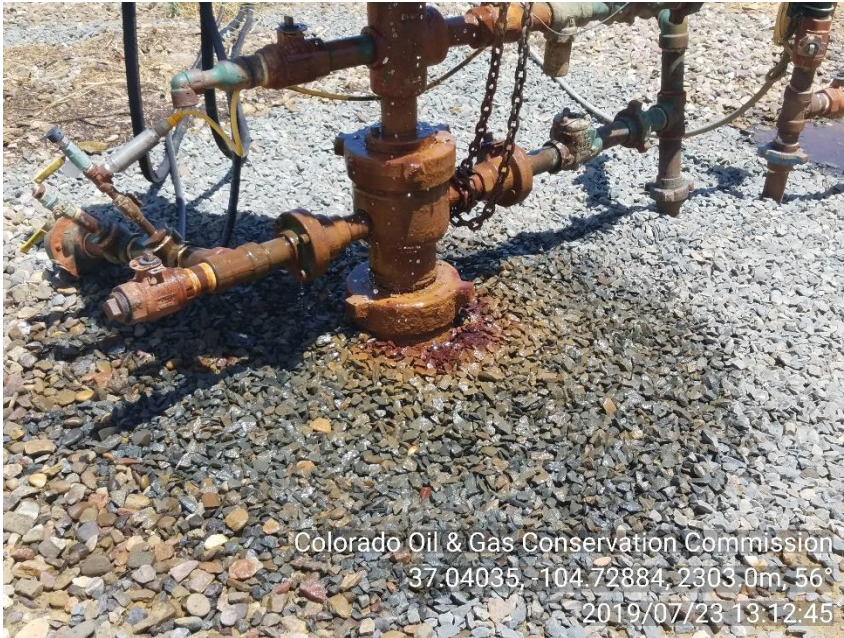
**PHOTO 3: ACTIVE ONGOING RELEASE AT WELLHEAD  
APPEAR TO BE GREATER 1 BBL PRODUCED WATER. NO  
CONTAINMENT. **IMEDIATELY CONTROL RELEASE, RESPOND  
TO SPILL AND CONTACT COGCC EPS STAFF AND FILE SPILE  
REPORT AS REQUIRED BY RULE 906. CA DATE 7-24-19.****

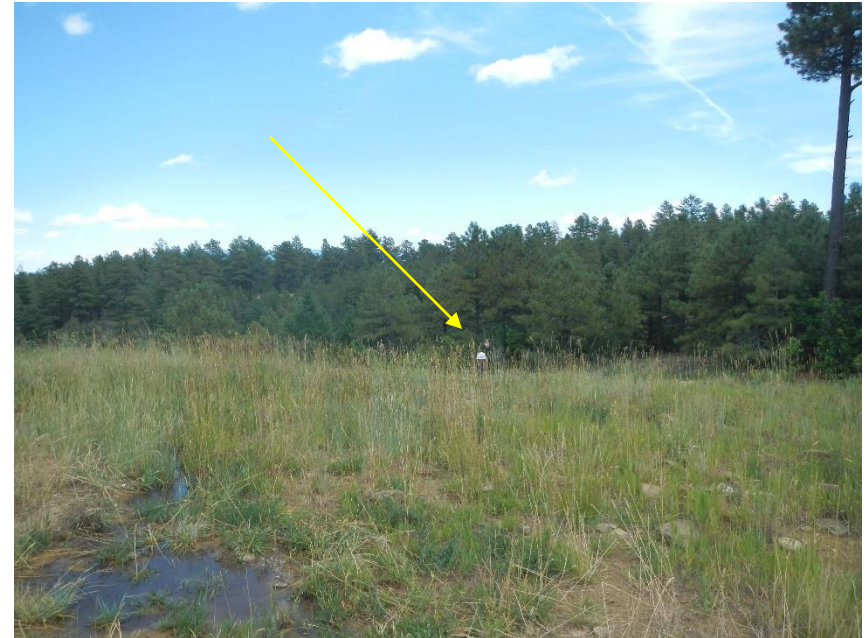
**PHOTO 4: PRODUCED WATER RELEASE TRAVELED TO THE  
SOUTH, SOUTHEAST OF LOCATION IMAGE SHOWS DISTANCE  
OF IMPACTED AREA APPROXIMATELY 74' LONG BY 4' WIDE.**

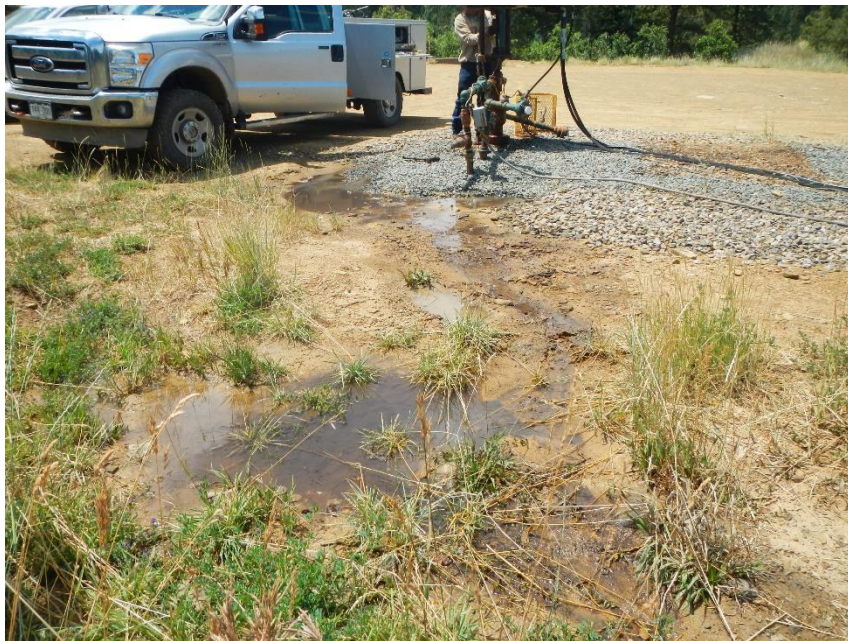
**PHOTO 5: IMAGE SHOWING PRODUCED WATER POOLING ON LOCATION ALONG THE IMPACTED AREA APPROXIMATELY 3" DEEP IN SPOTS.**

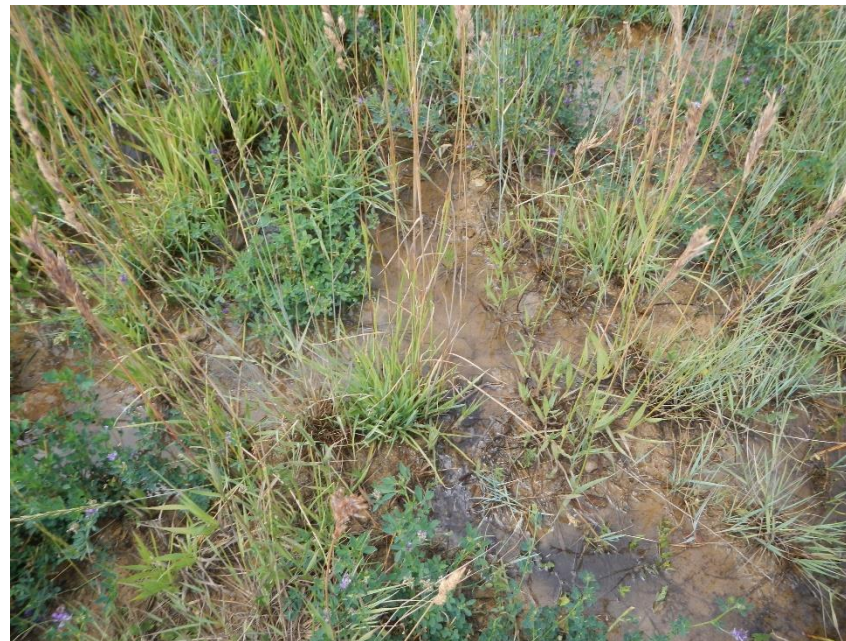
**PHOTO 6: IMAGE SHOWING PRODUCED WATER POOLING ON LOCATION ALONG THE IMPACTED AREA APPROXIMATELY 3" DEEP IN SPOTS.**

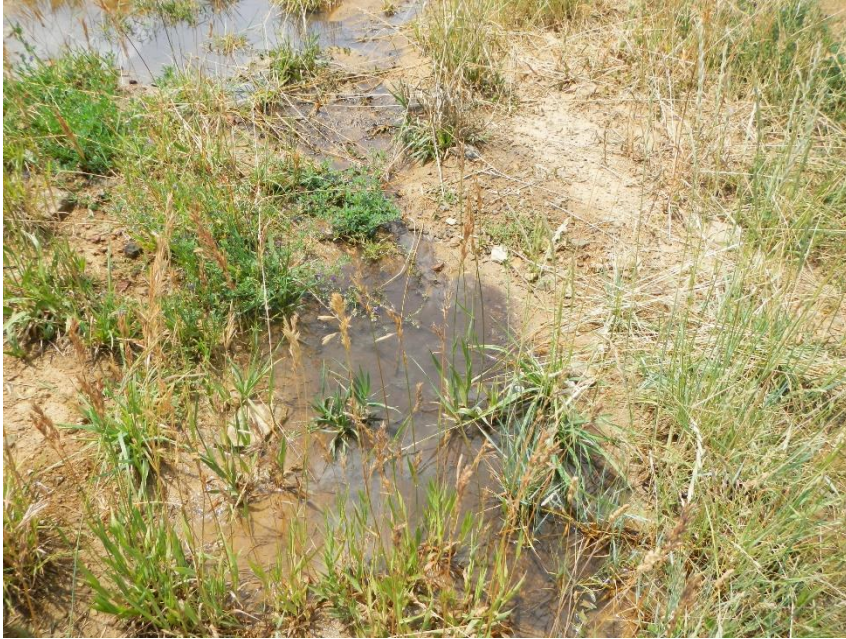
**PHOTO 7: IMAGE SHOWING PRODUCED WATER POOLING  
ON LOCATION ALONG THE IMPACTED AREA APPROXIMATELY  
3" DEEP IN SPOTS.**

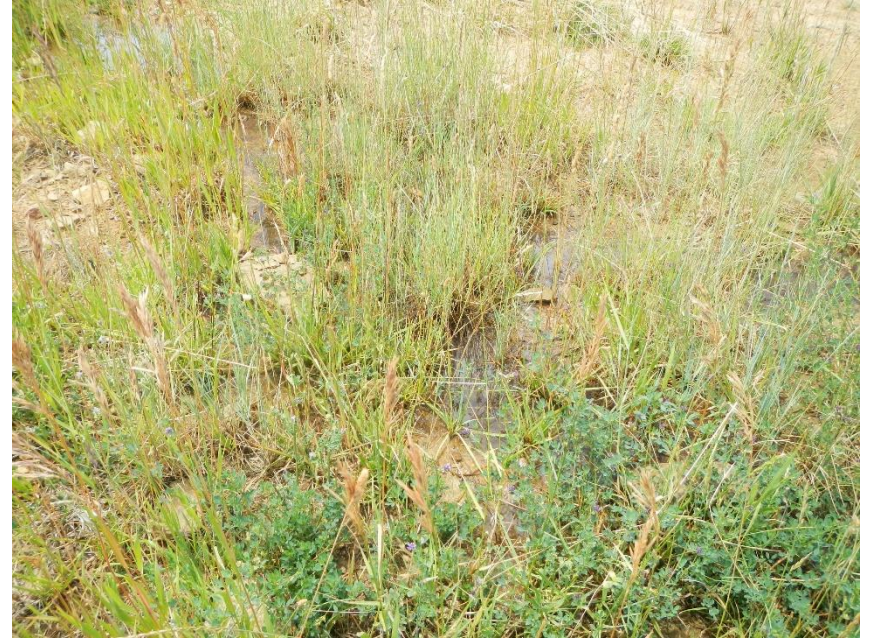
**PHOTO 8: IMAGE SHOWING PRODUCED WATER POOLING  
ON LOCATION ALONG THE IMPACTED AREA APPROXIMATELY  
3" DEEP IN SPOTS.**
