Inspection Photos

07/23/2019

Operator: GRAND MESA OPERATING CO #
35080

Location ID: 466147
Lincoln County, CO

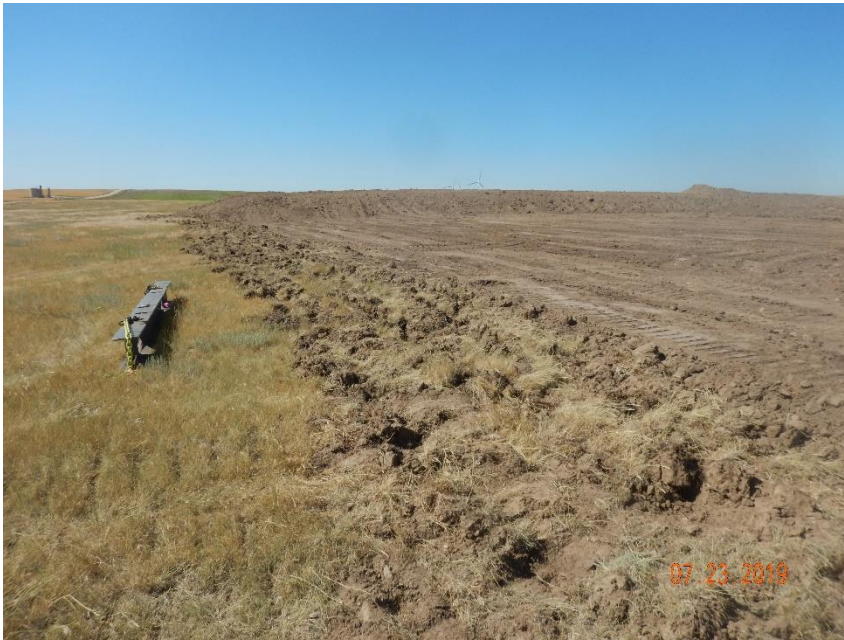
Photo 1: Photos 1-4 taken from the east end of the location, facing south, southwest, northwest to north. Photos show construction in process. Photos also show surface roughening stormwater BMP has been installed along perimeter of the location/disturbance.

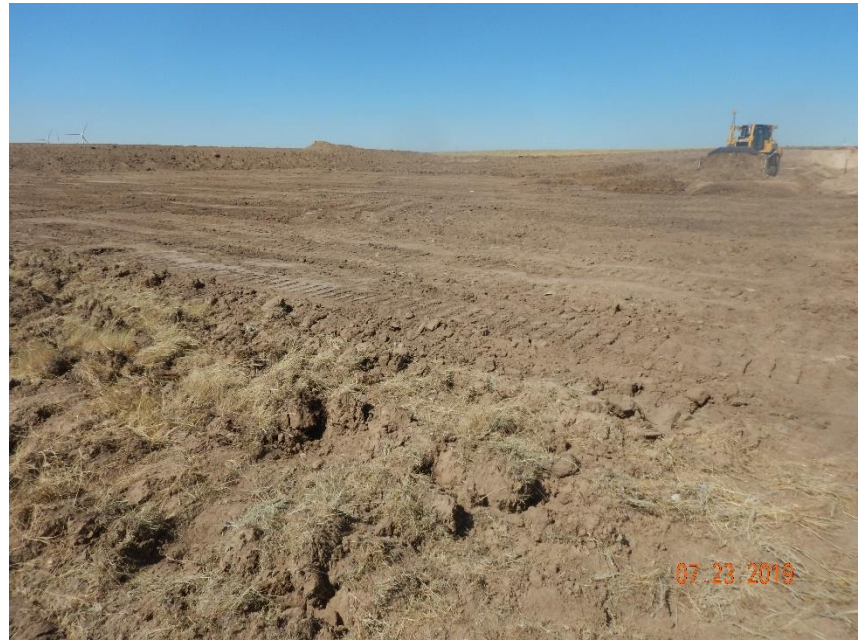
Photo 2: See comments under photo 1.

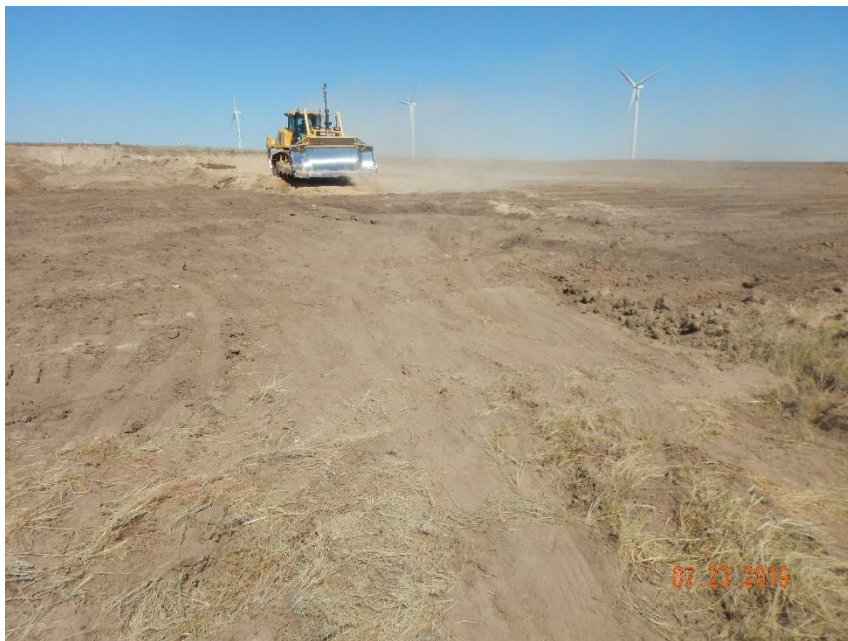
Photo 3: See comments under photo 1.

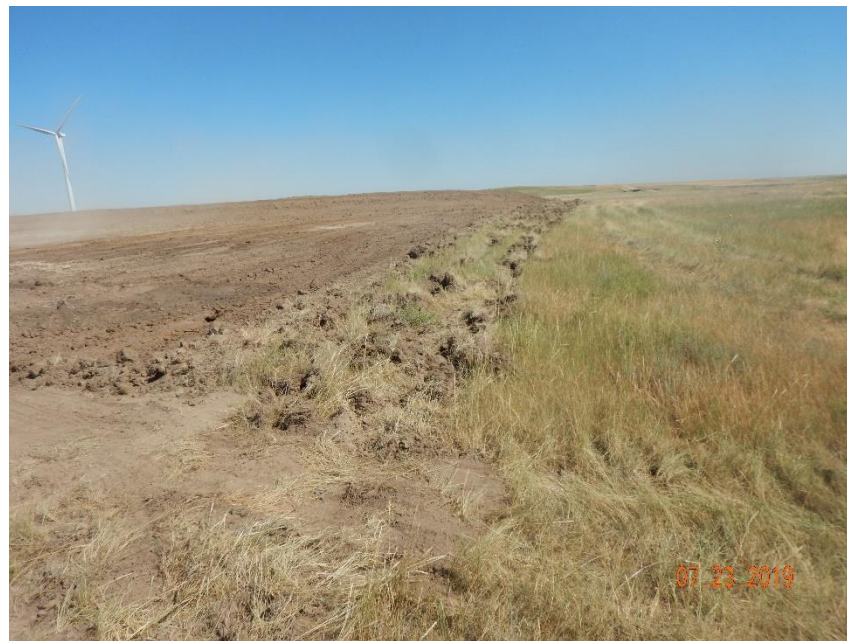
Photo 4: See comments under photo 1.

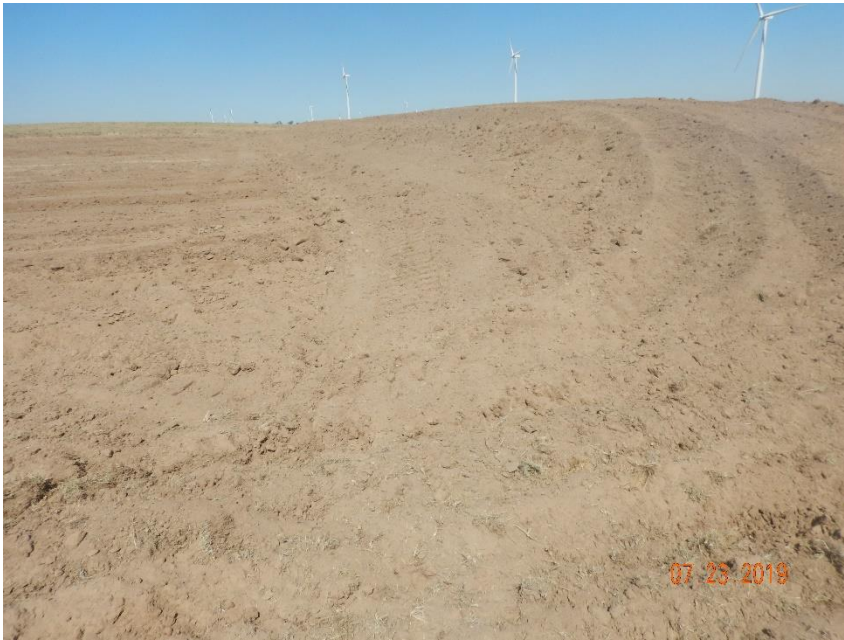
Photo 5: Photo taken from the north end of the location, facing northwest. Photo shows topsoil stockpile. Soil salvage in process at time of inspection. Stabilization BMPs will need to be installed to protect from stormwater/wind have not been installed in accordance with 1002.c

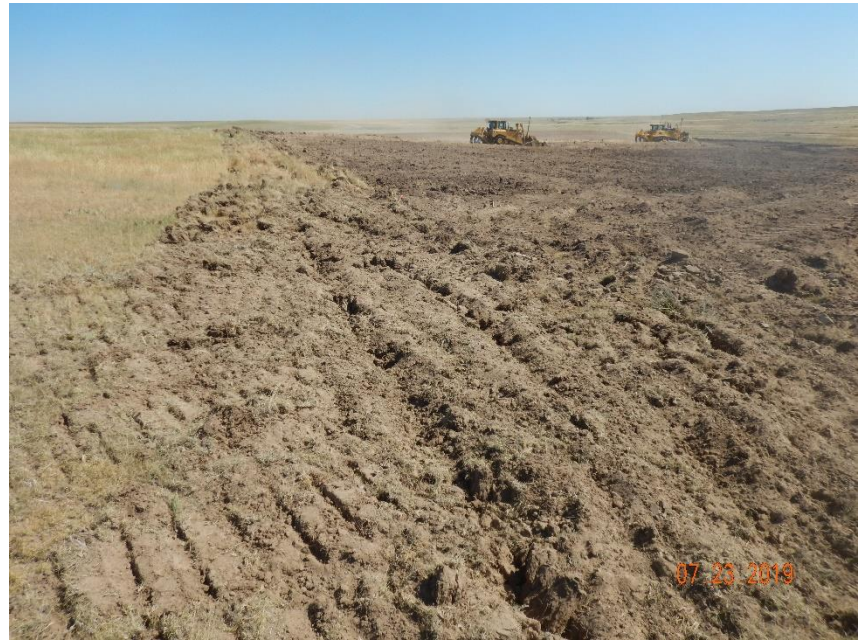
Photo 6: Photo taken from the southwest corner of the location, facing north. Photo shows construction in process. Photo also show surface roughening stormwater BMP has been installed along perimeter of the location/disturbance.

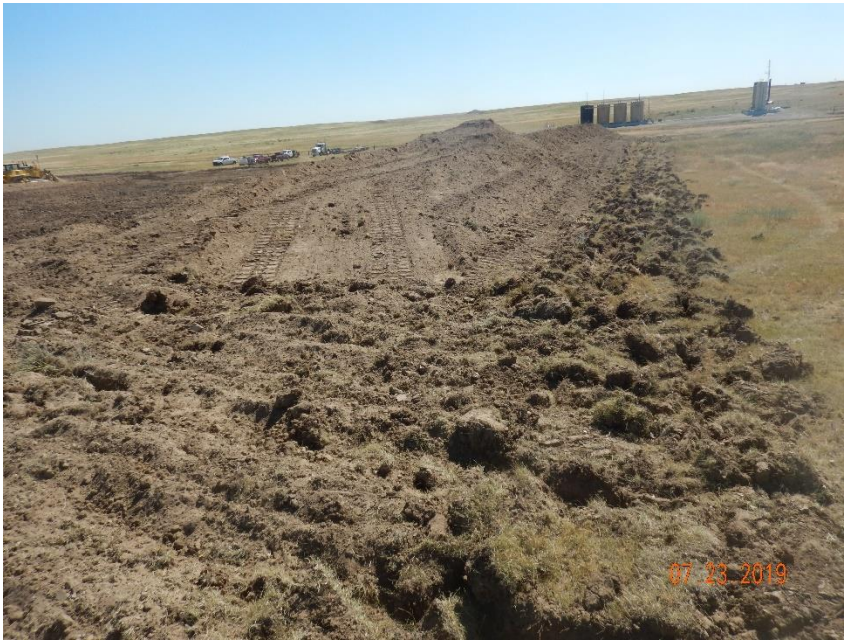
Photo 7: Photo taken from the southwest corner of the location, facing east. Photo shows construction in process. Photo also show surface roughening stormwater BMP has been installed along perimeter of the location/disturbance.

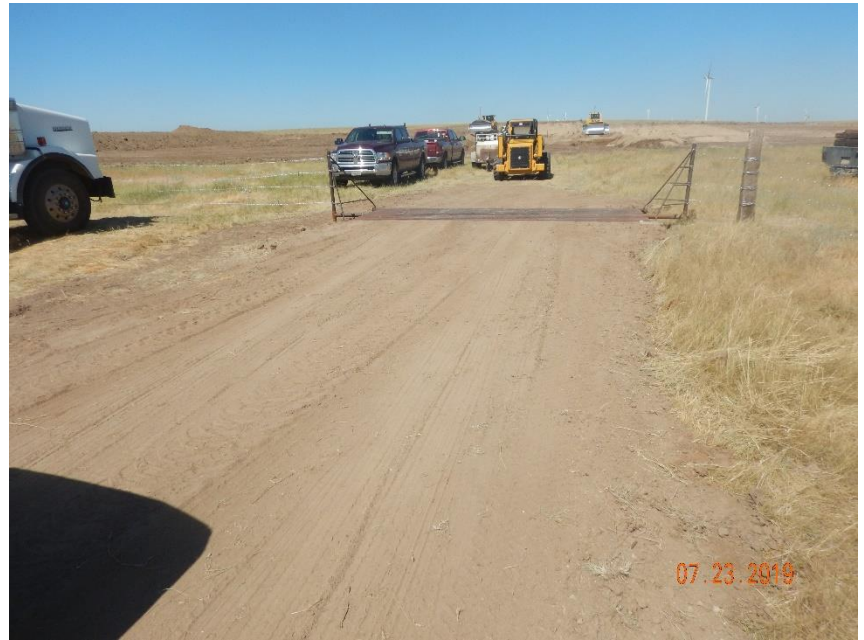
Photo 8: Photo taken from the access road entrance. Photo of cattle guard.
