# Inspection Photos

Operator: GRAND MESA OPERATING CO #  
35080

Location ID: 463974  
Lincoln County, CO

Aaron Trujillo  
NE Reclamation Specialist  
COGCC

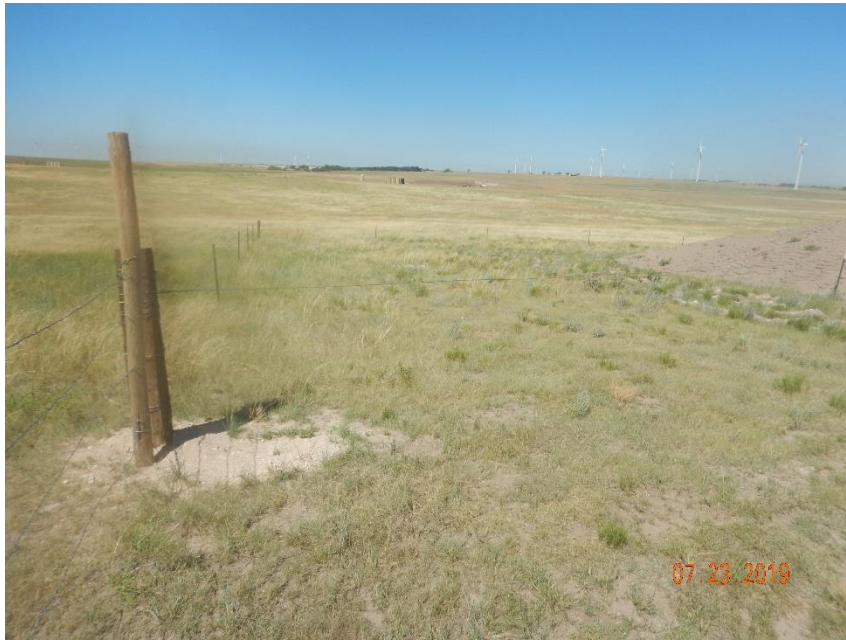
**Photo 1:** Photos 1-4 taken from the south end of the location, facing west, northwest, northeast to east. Photos show overview of the location. Location subject to final reclamation in accordance with 1004.a. No final reclamation activities appear to have been conducted at time of inspection. Location and access road will require, at a minimum, pit closure, removal of cattle guard, compaction alleviation (cross ripping to a minimum of 18 inches), recontouring/regrading (returning soils) and revegetation activities on the access road and location will need to be conducted

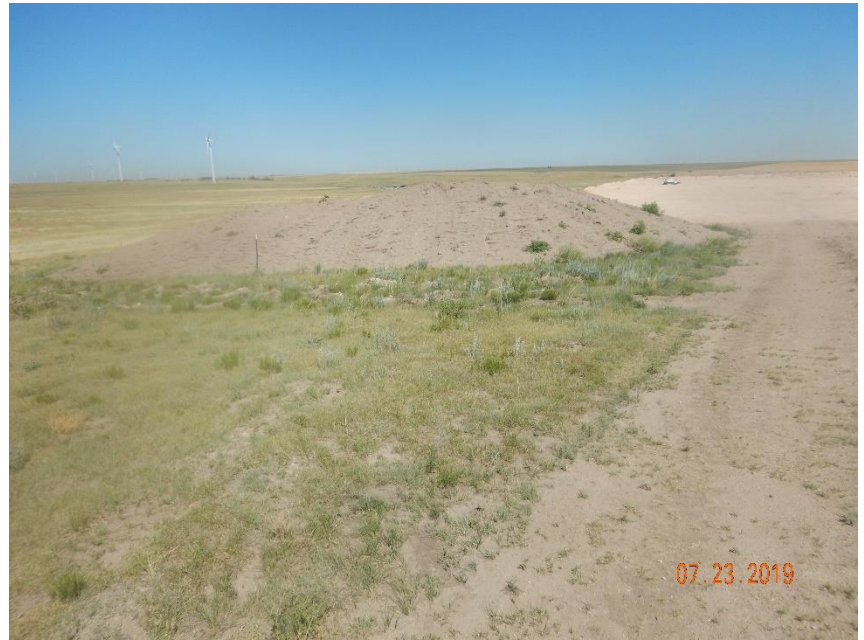
**Photo 2:** See comments under photo 1.

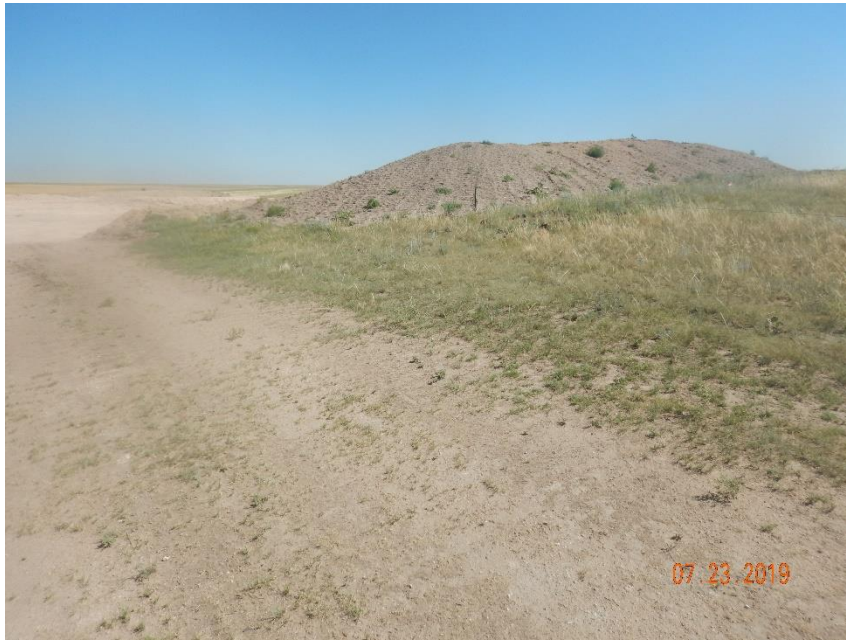
**Photo 3:** See comments under photo 1.

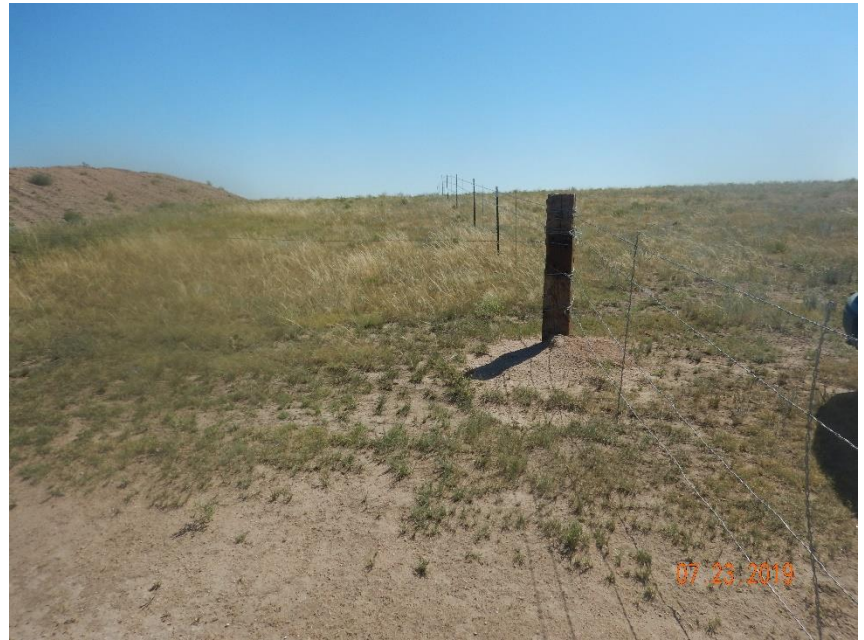
**Photo 4:** See comments under photo 1.

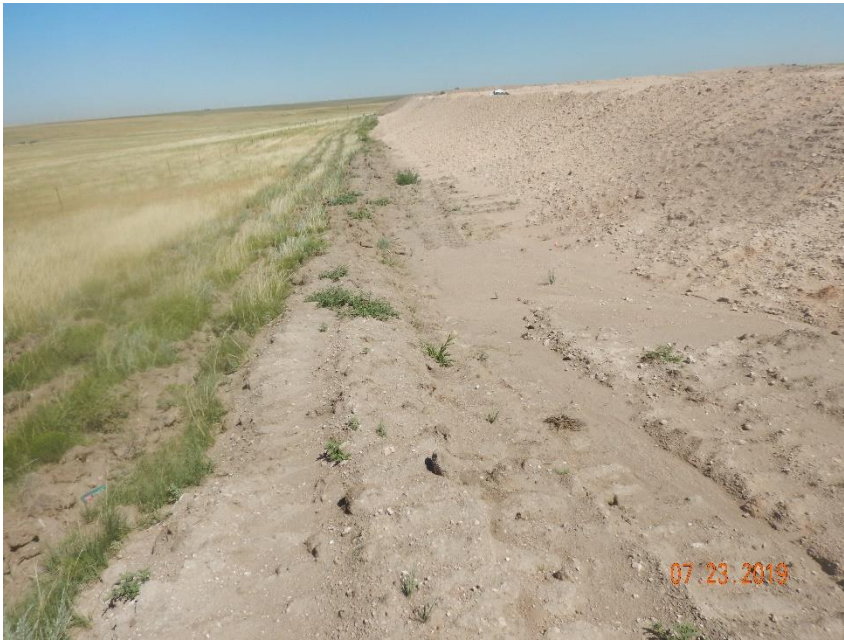
**Photo 5:** Photo taken from the west end of the location, facing north. Photo shows ditch/berm stormwater BMP, surface roughening (ripping) and tracking stormwater controls.

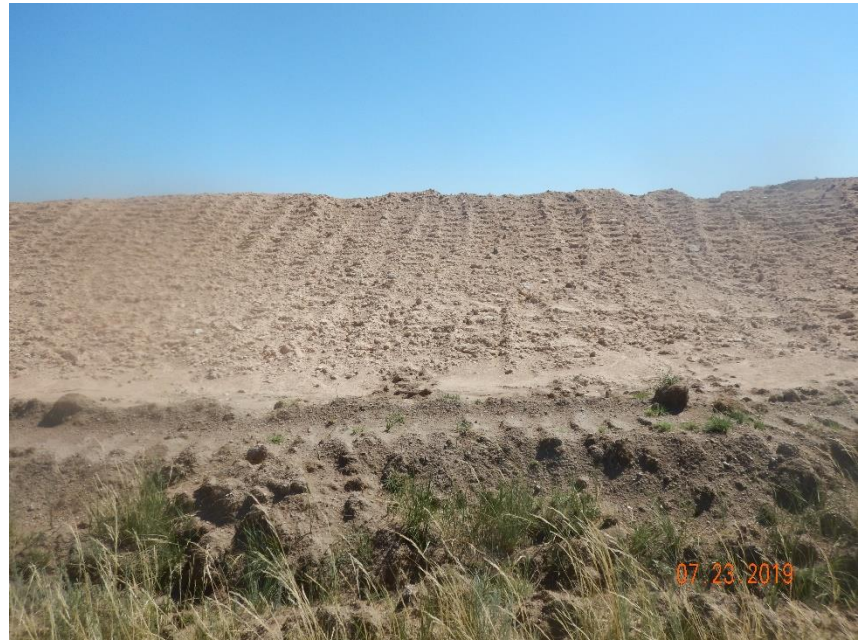
**Photo 6:** Photo taken from the west end of the location, facing east. Photo shows tracking on slopes appear to be in proper functioning condition.

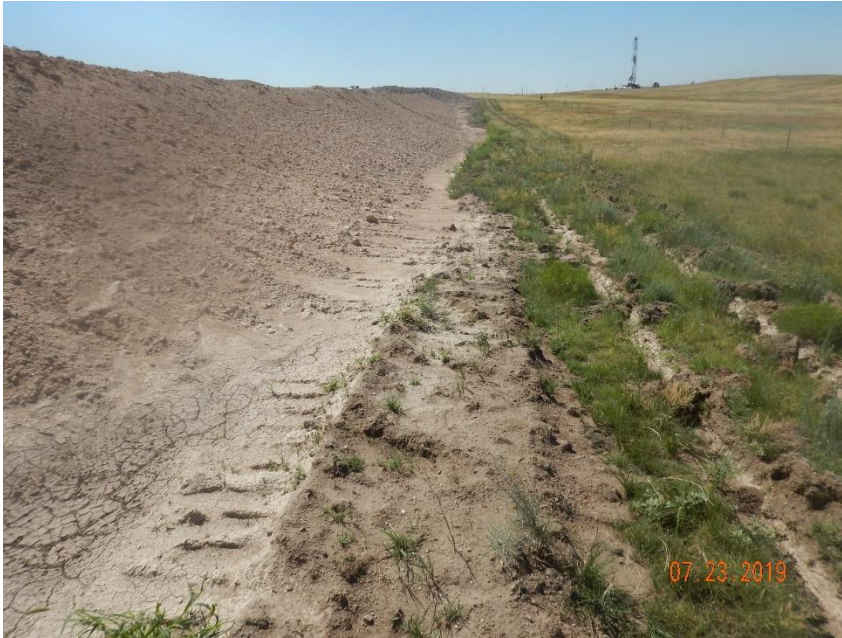
**Photo 7:** Photo taken from the northwest corner of the location, facing north. Photo shows stormwater erosion has filled the ditch with sediment. BMP requires maintenance.

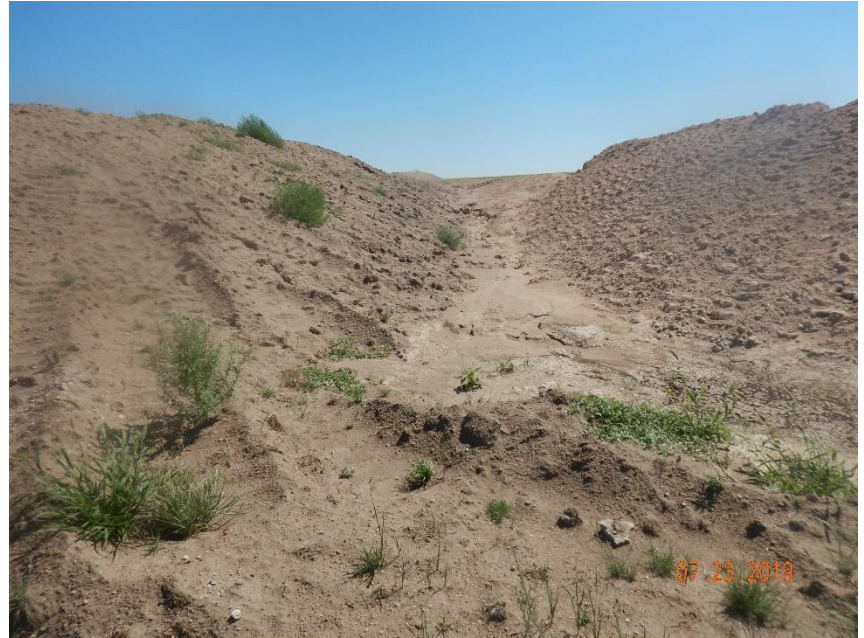
**Photo 8:** Photo taken from the northwest corner of the location, facing east. Photo shows erosion degradation evident between the pad and the topsoil stockpile on the northwest end of the location.

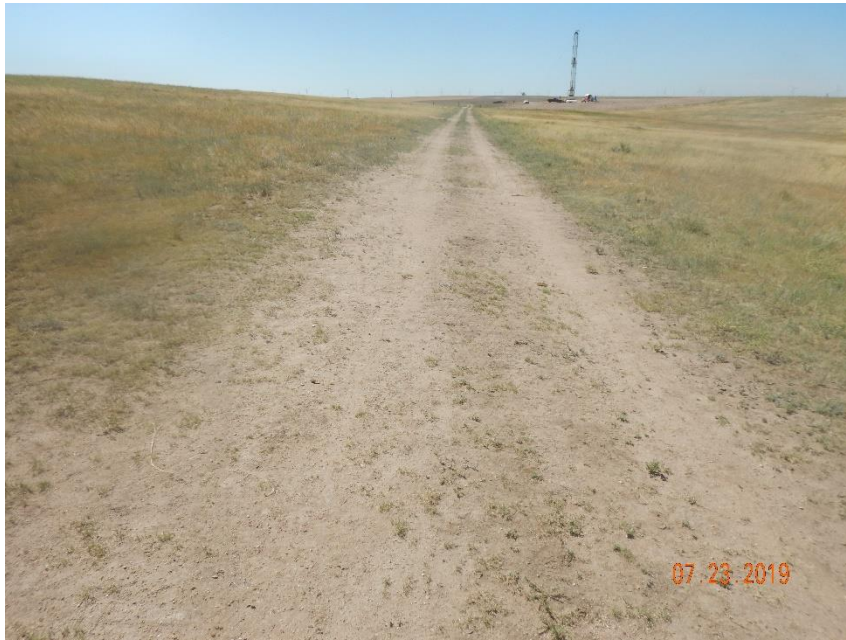
**Photo 9:** Photo taken from the access road, facing south. Access road requires reclamation in accordance with 1004.a including, but not limited to, compaction alleviation (cross-ripping to a depth of 18 inches), recontouring/regrading and revegetating.

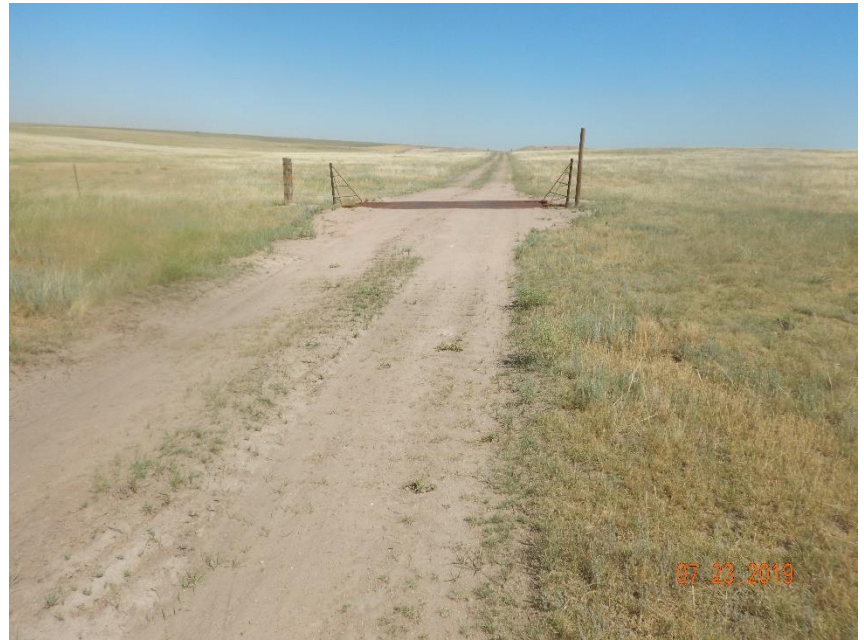
**Photo 10:** Photo taken from the access road. Photo shows cattle guard. Cattle guard will need to be removed and access road reclaimed in accordance with 1004.a
