# Final Reclamation Inspection

Operator: PDC ENERGY INC - 69175

API: 05-123-12447

Inspection Photos  
Location Name: SCHNEIDER #1  
API: 05-123-12447

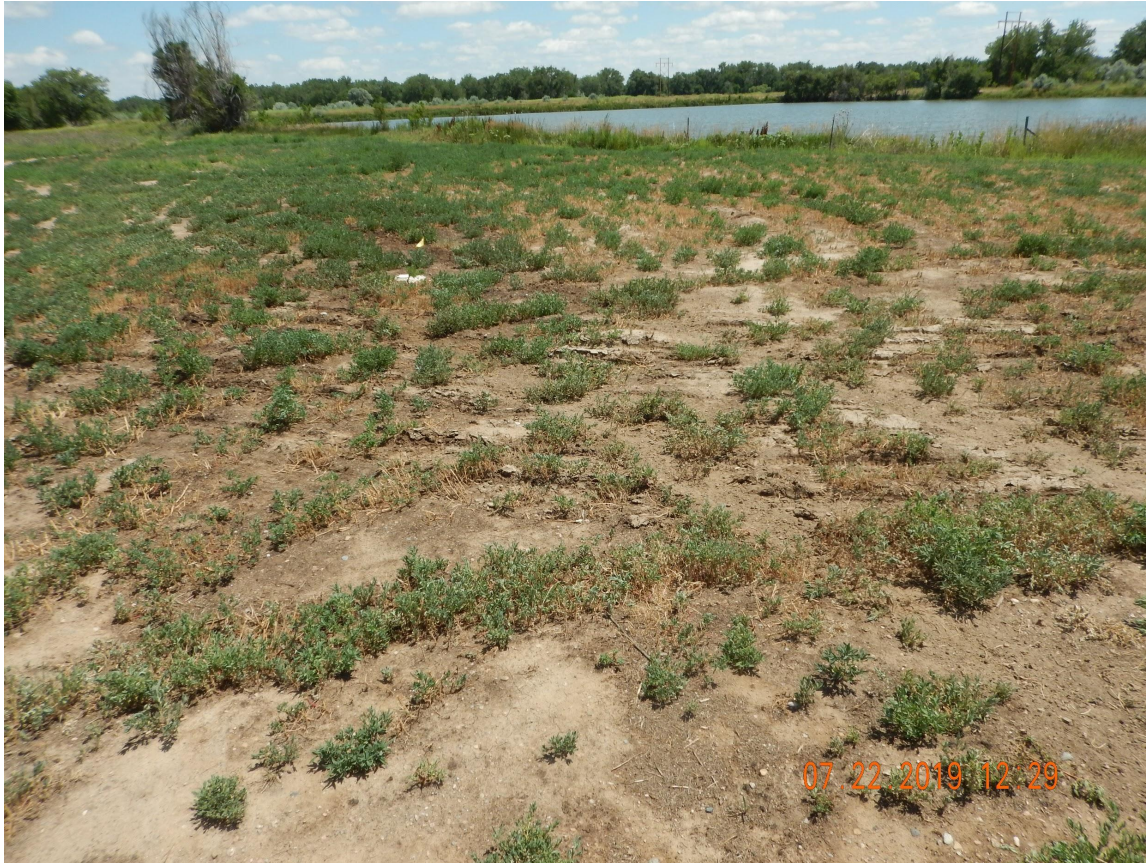
**Photo 1.** Photo taken from the western location, facing Southeast. Appears the Operator has performed final reclamation activities; however, there is not sufficient establishment of desirable vegetative growth. Photo illustrates undesirable, weedy annual vegetation mostly consisting of Kochia. Operator shall perform additional reclamation activities.

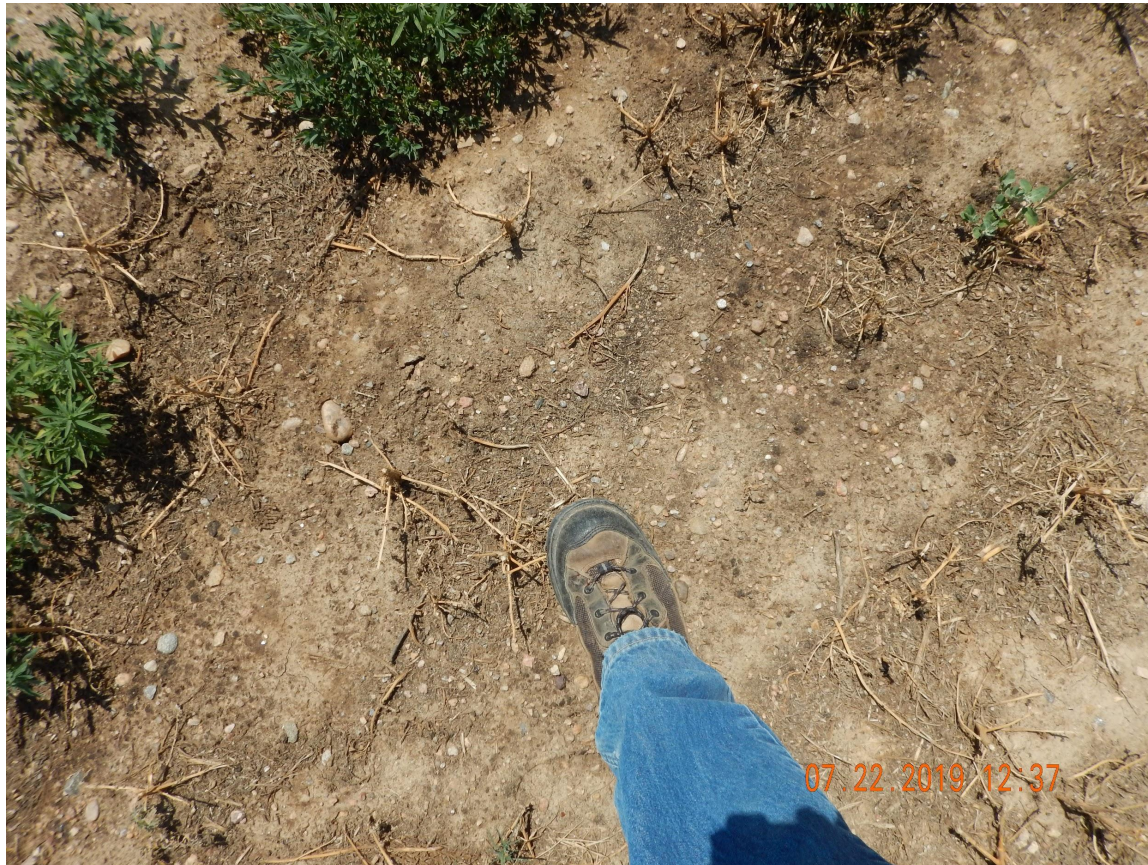
**Photo 2.** Photo taken from the location illustrating no desirable vegetative growth, only undesirable, weedy annual growth of Kochia.

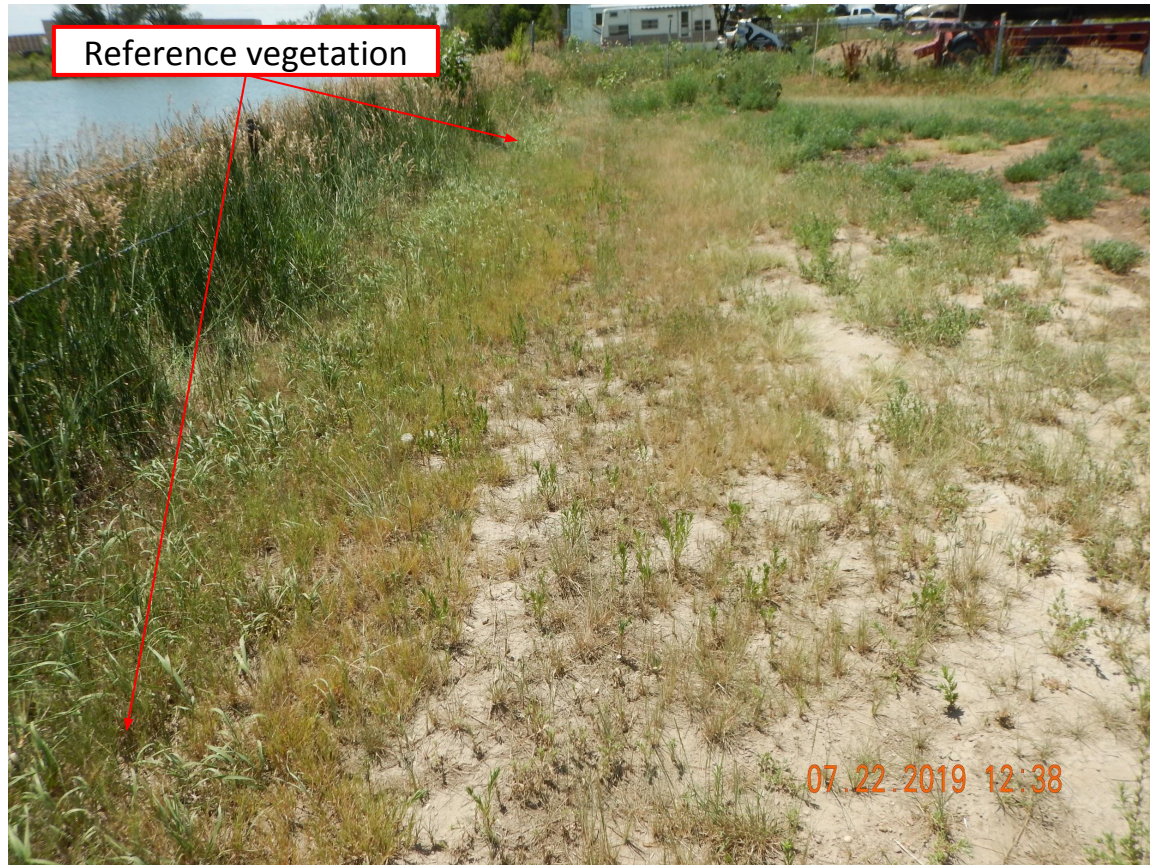
**Photo 3.** Reference photo taken along the southern perimeter of location, facing West. See comments under Photo 1.

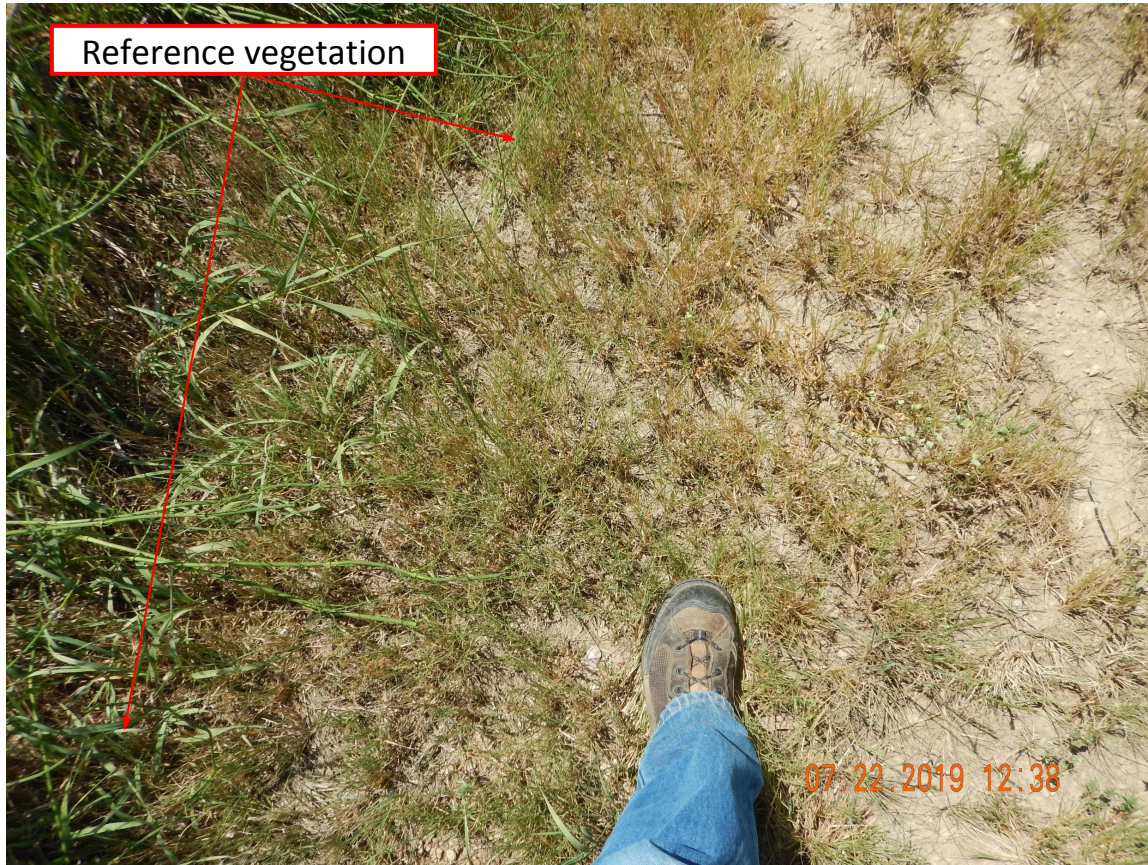
**Photo 4.** Reference vegetation appears to be but not limited to Smooth brome and Alkali sacaton grass.
