Final Reclamation Inspection

Operator: PDC ENERGY INC - 69175

API: 05-123-16090

Inspection Photos
Location Name: SCHNEIDER #22-21
API: 05-123-16090

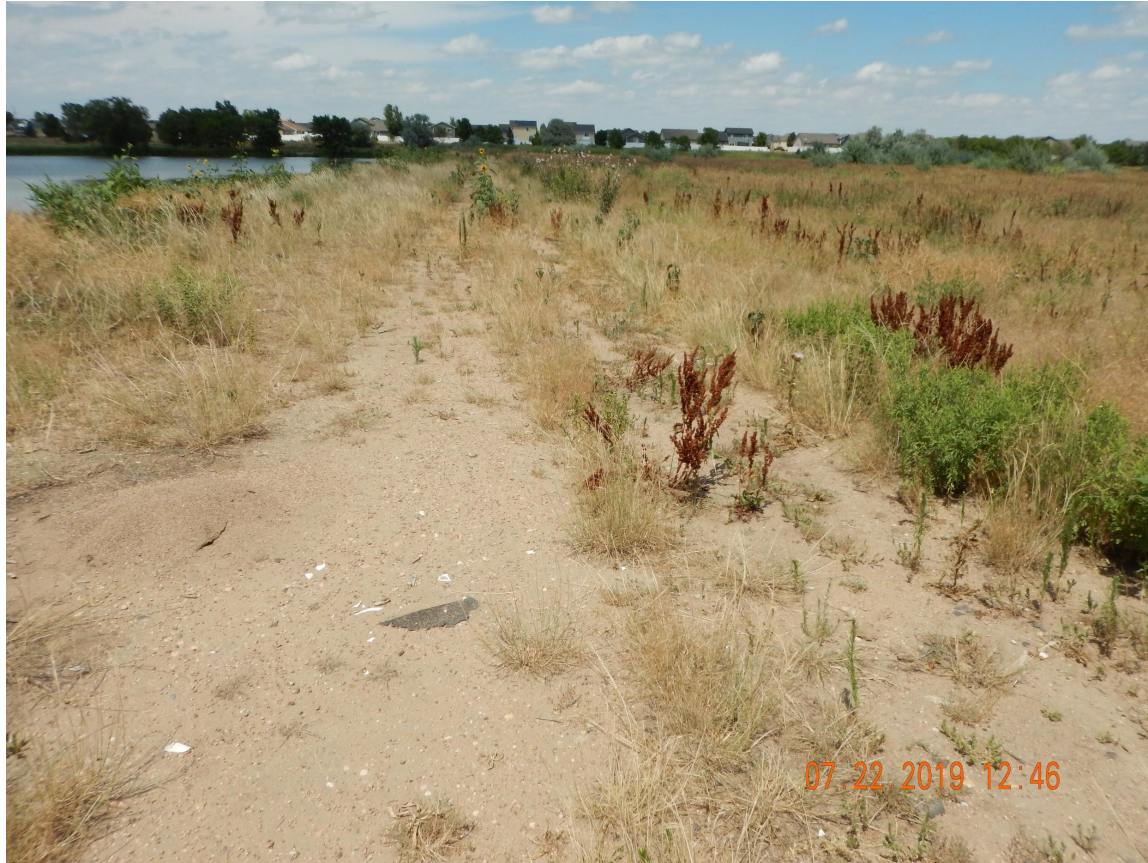
Photo 1. Photo taken from a portion of the access road, facing North. Operator has failed to perform final reclamation activities throughout the access road. Photo illustrates the access road with gravel and no evidence that final reclamation activities occurred. In addition, noxious weeds (Musk and Scotch thistle) were observed throughout portions of the access road and well location.

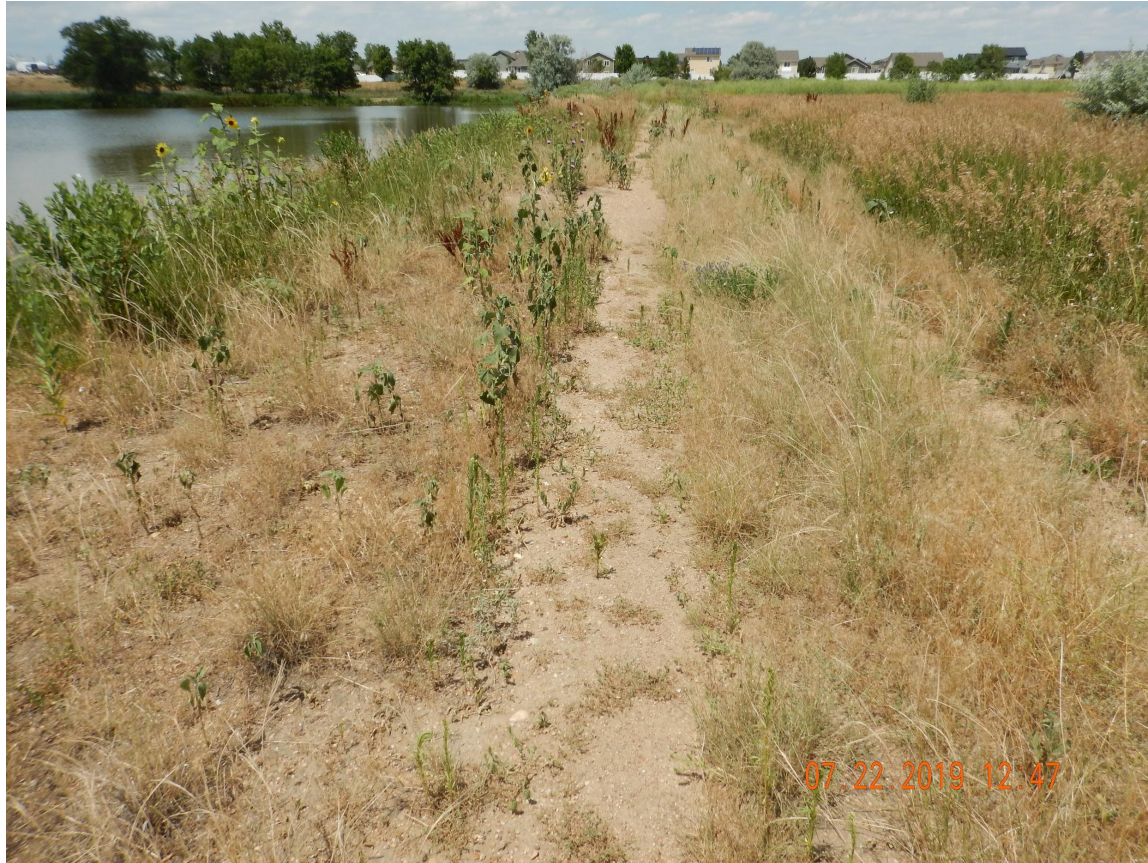
Photo 2. Photo taken from a portion of the access road, facing North. See comments under Photo 1.

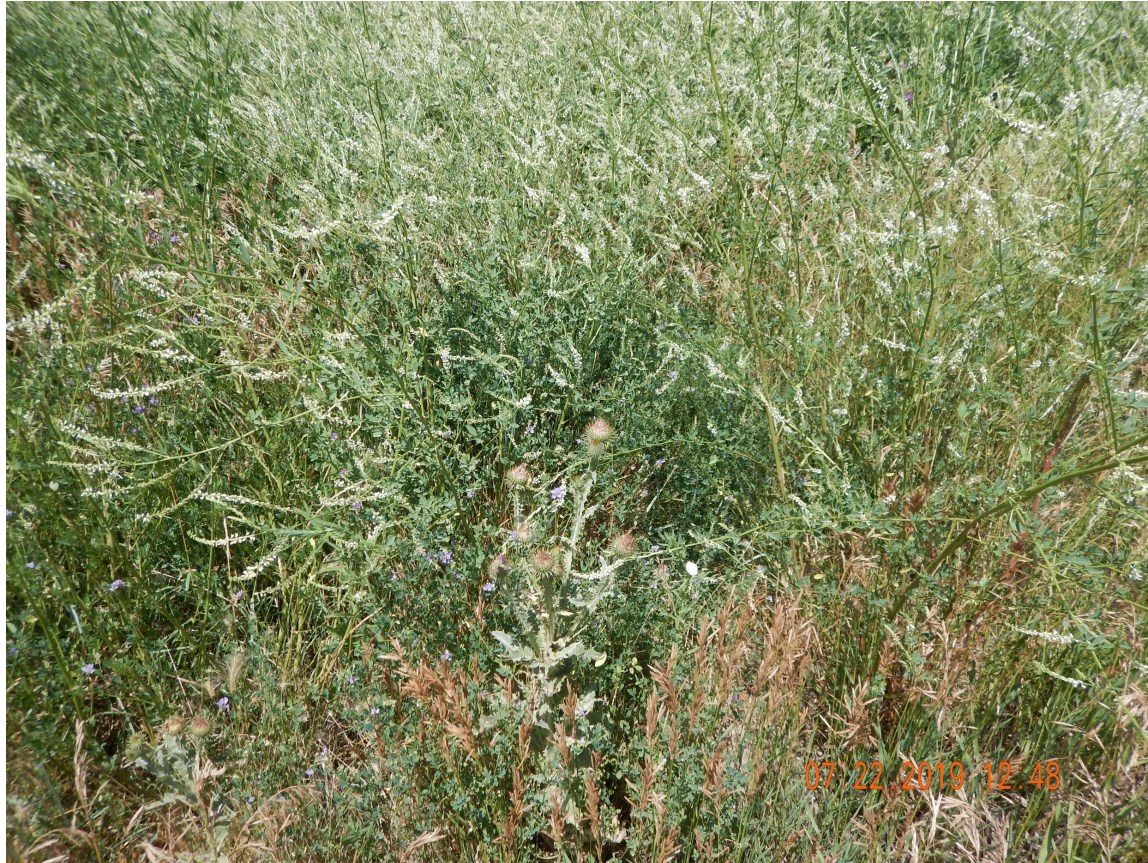
Photo 3. Photo taken from the western well location. Operator has failed to control and manage noxious weeds. Photo illustrates noxious weeds (Scotch thistle).
