Final Reclamation Inspection

Operator: NOBLE ENERGY INC - #100322

Location ID: 327046

Inspection Photos
Location Name: BRAGG PM F #21-11
Location ID: 327046

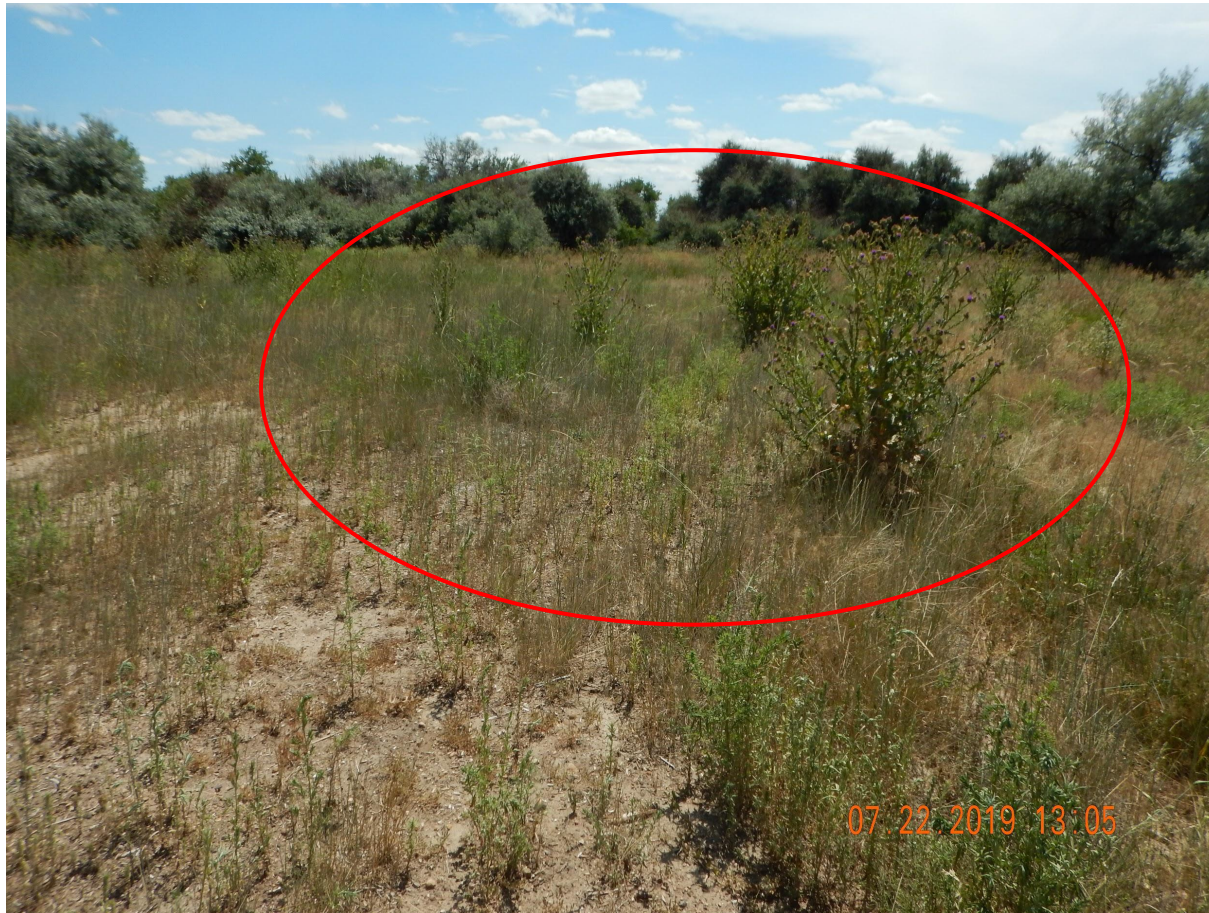
Photo 1. Photo taken from the offsite associated tank battery, facing West. Appears the Operator has performed final reclamation activities; however, Operator has failed to control and manage noxious weeds (Scotch thistle).

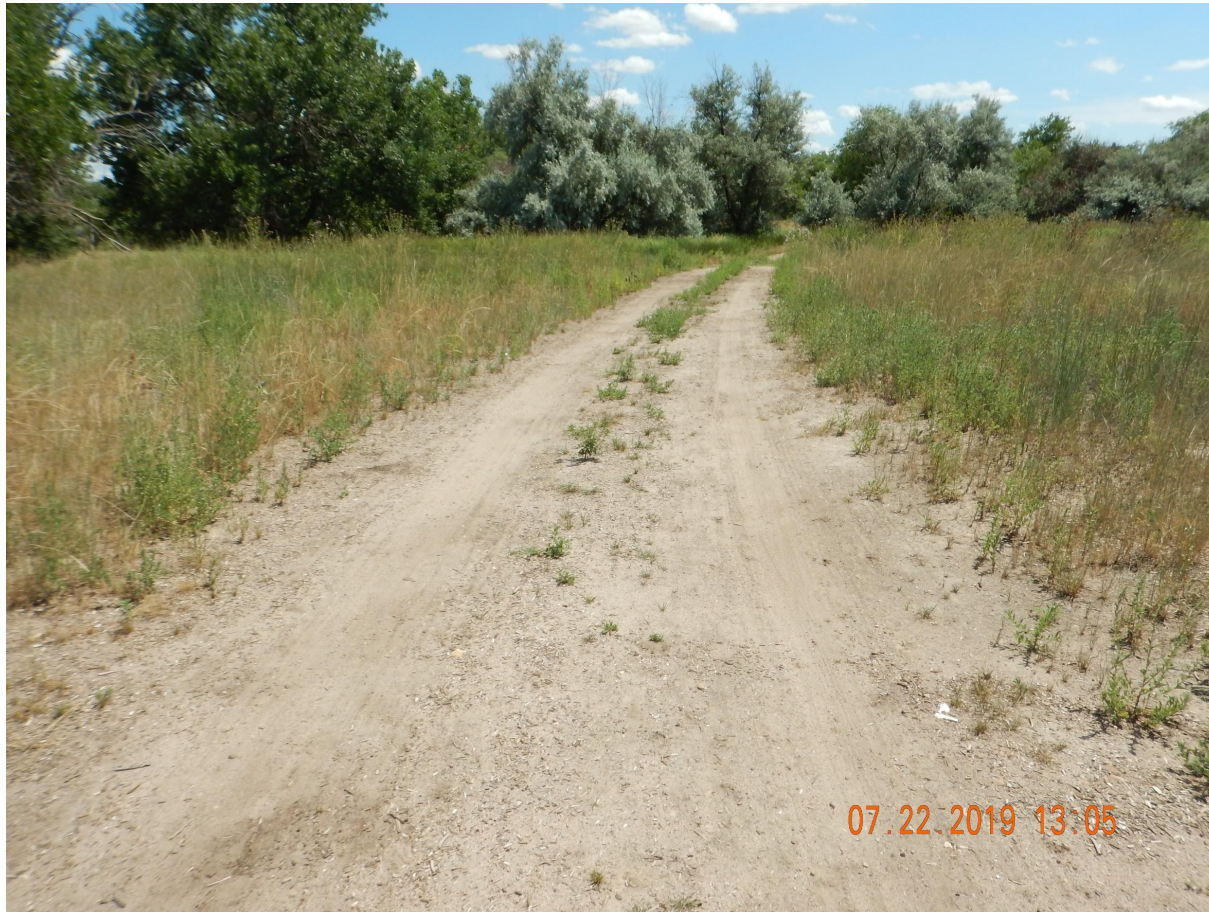
07.22.2019 13:05

Photo 2. Photo taken from a portion of the access road, facing South. Operator has failed to perform Final Reclamation activities on the access road.

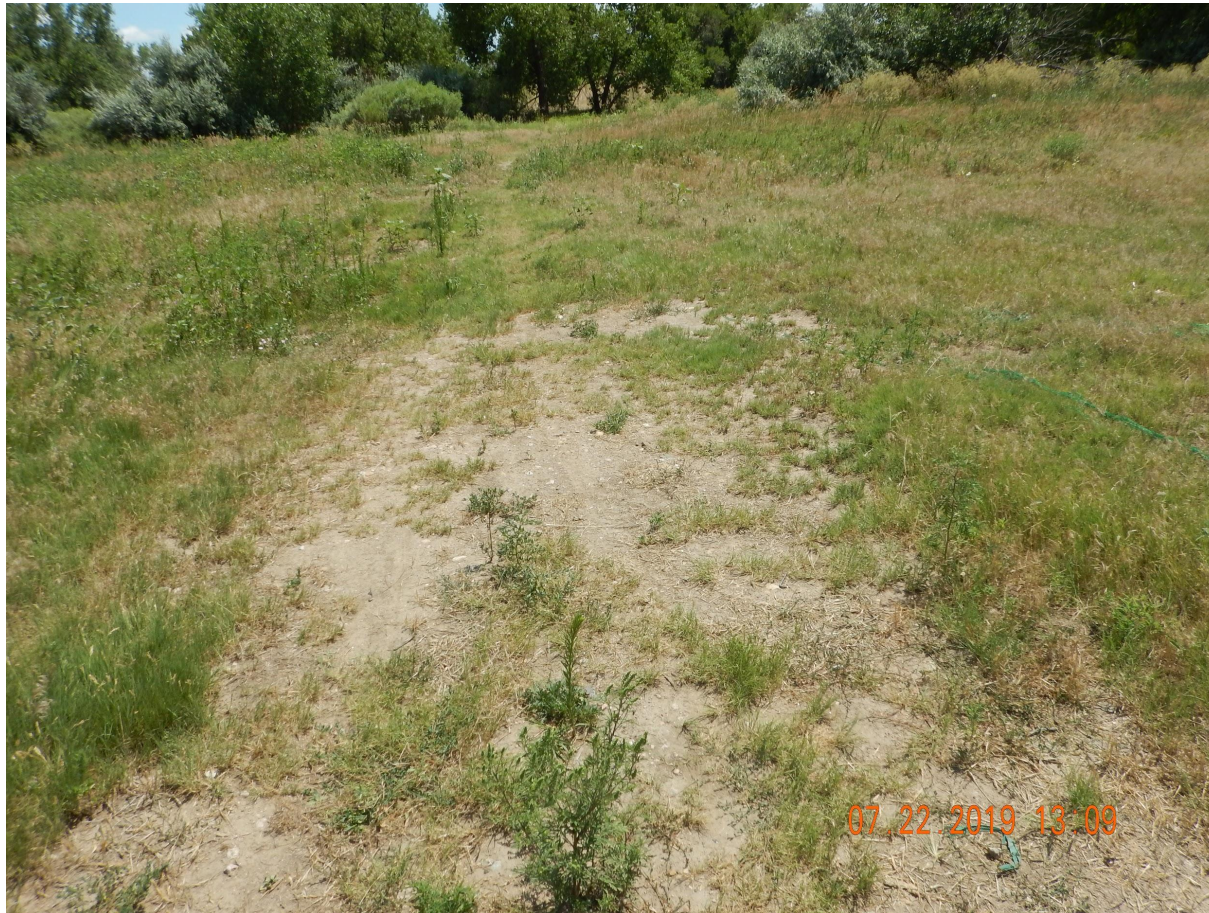
Photo 3. Photo taken from the well location, facing South. Appears the Operator needs to perform additional final reclamation activities as the well location lacks growth and is not reflective of reference areas.
