Inspection Photos

Operator: MAGPIE OPERATING INC - 52530

Location ID: 401718

COLORADO
Oil & Gas Conservation
Commission
Department of Natural Resources

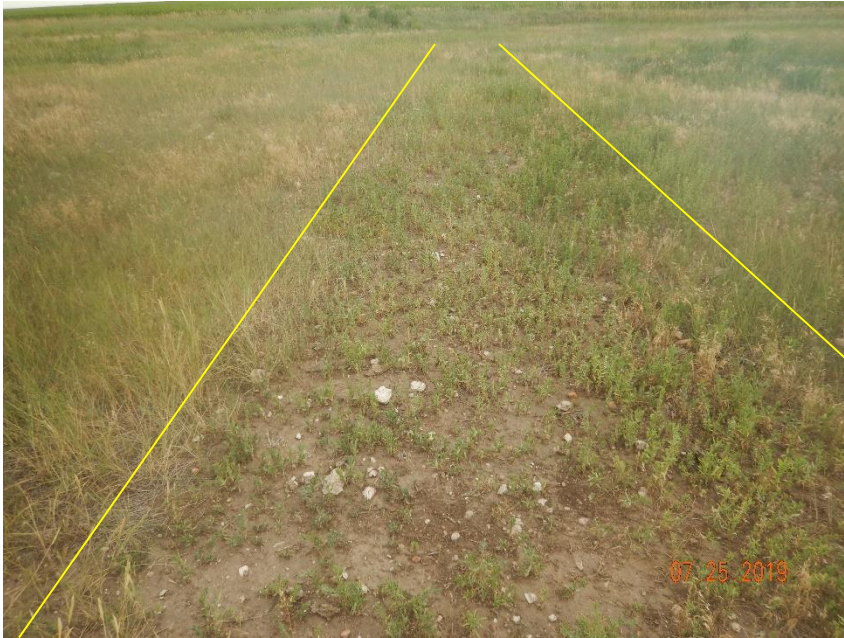
Photo 1: Photo taken from the pits, facing north. Photo shows pit walls remain evident. There are areas of the pits and pit walls that remain bare, or vegetated by undesirable weedy plant species not reflective of the reference area. Vegetation observed in photo predominantly Kochia, and undesirable weedy annual.

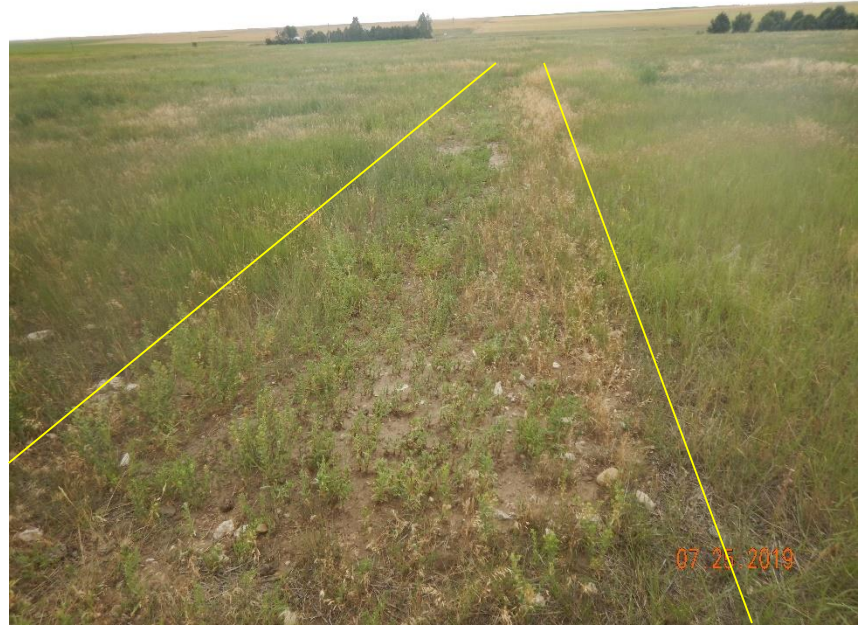
Photo 2: See comments under photo 1.

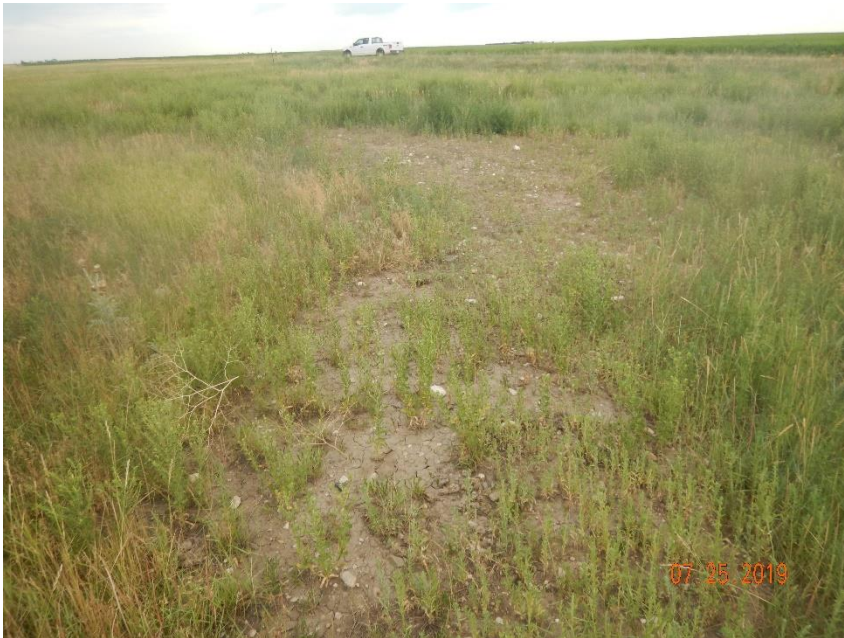
Photo 3: Photo taken from the northwestern end of the battery/pits location, facing northeast. Photo shows large areas of the location that remain bare, or vegetated by undesirable weedy plant species not reflective of the reference area. Vegetation observed in photo predominantly Kochia, and undesirable weedy annual.

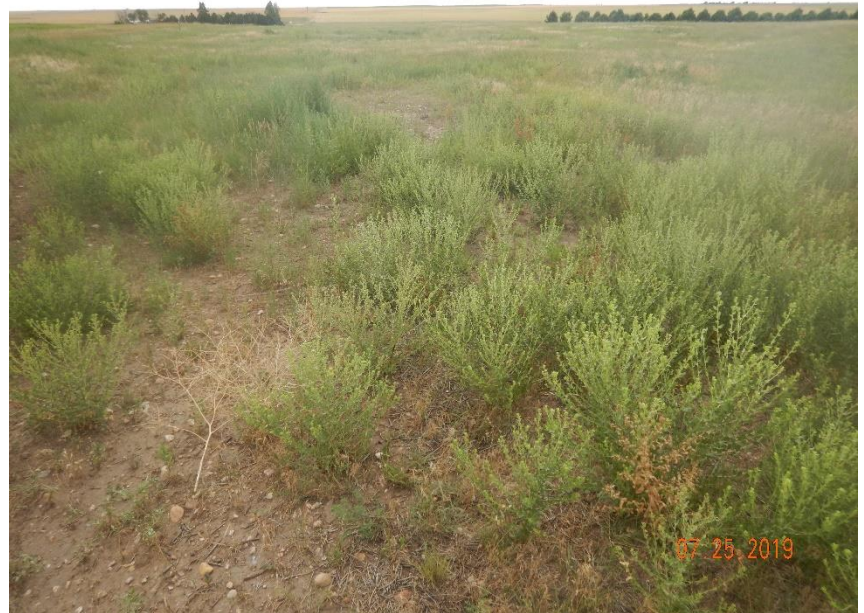
Photo 4: Photo taken from the north end of the battery/pits location, facing south. See comments under photo 3.

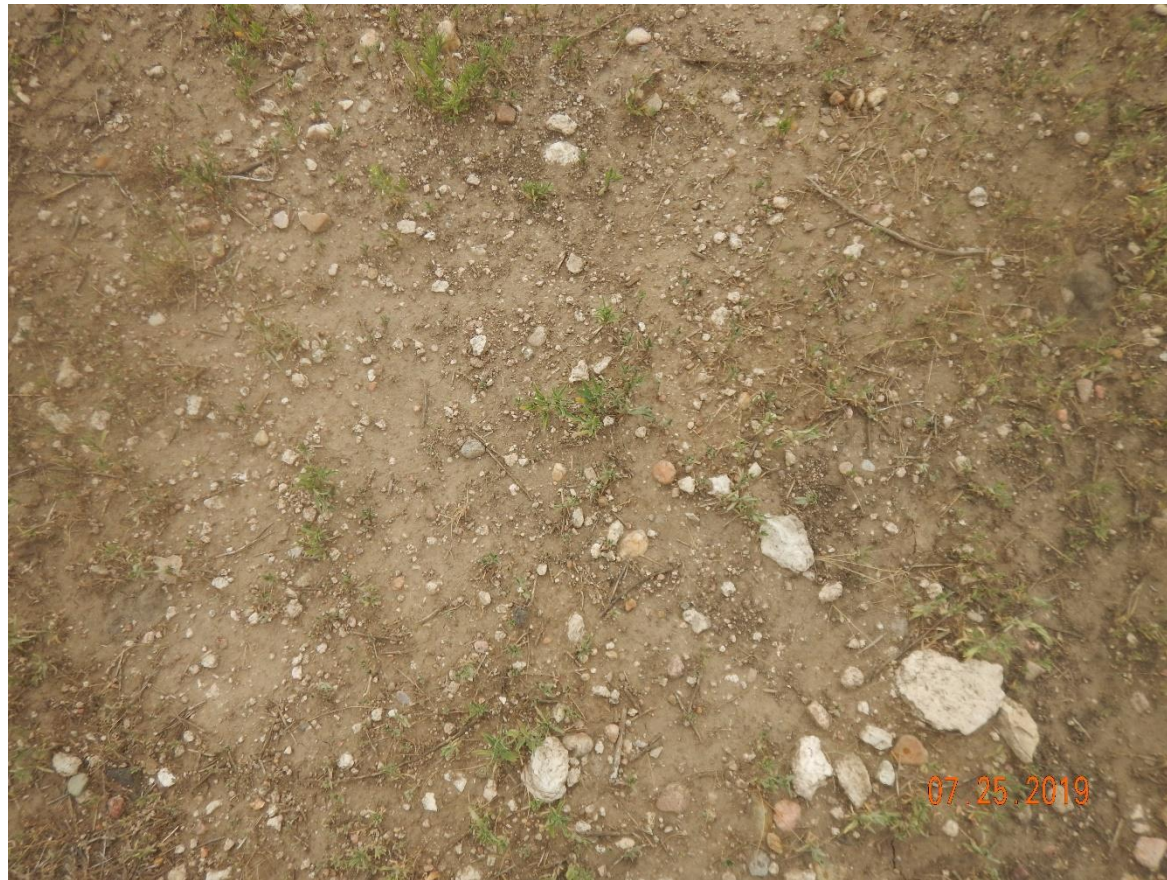
Photo 5: Continued from photo 4. Photo taken from the north end of the location. Photo shows soil surface of areas of the location that have not achieved a uniform desirable perennial vegetative cover.
