# Inspection Photos

Operator: BEREN CORPORATION - 7800

Location ID: 317052

Washington County, CO

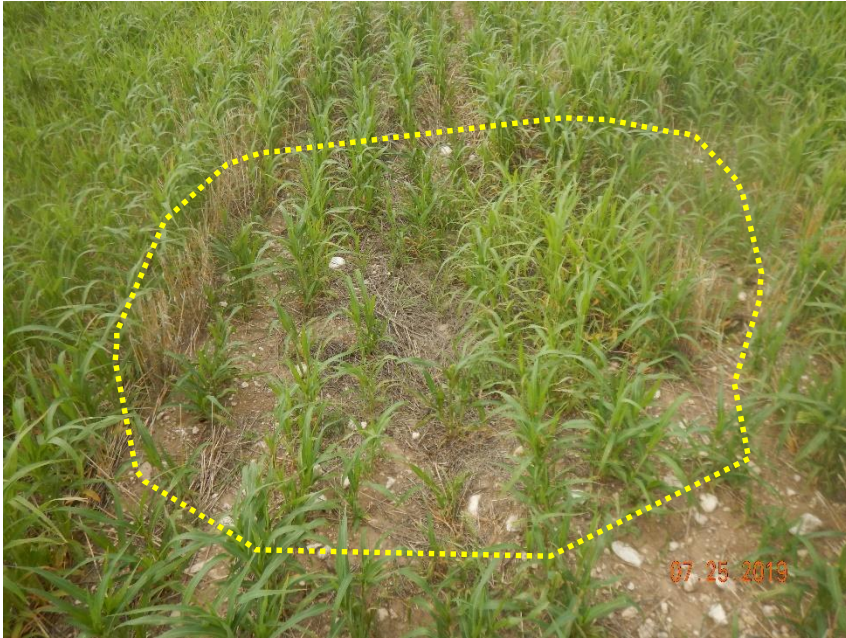
**Photo 1:** Photo taken from the well. Subsidence remains evident at the well location.

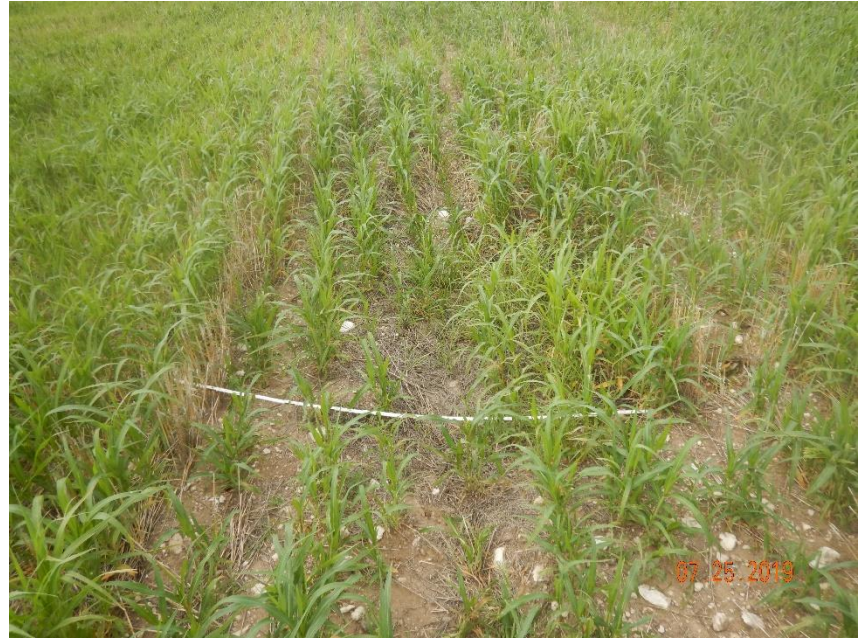
**Photo 2:** Continued from photo 1. Photo shows subsidence concerns remains evident at the well. 6 foot measuring stick for reference.

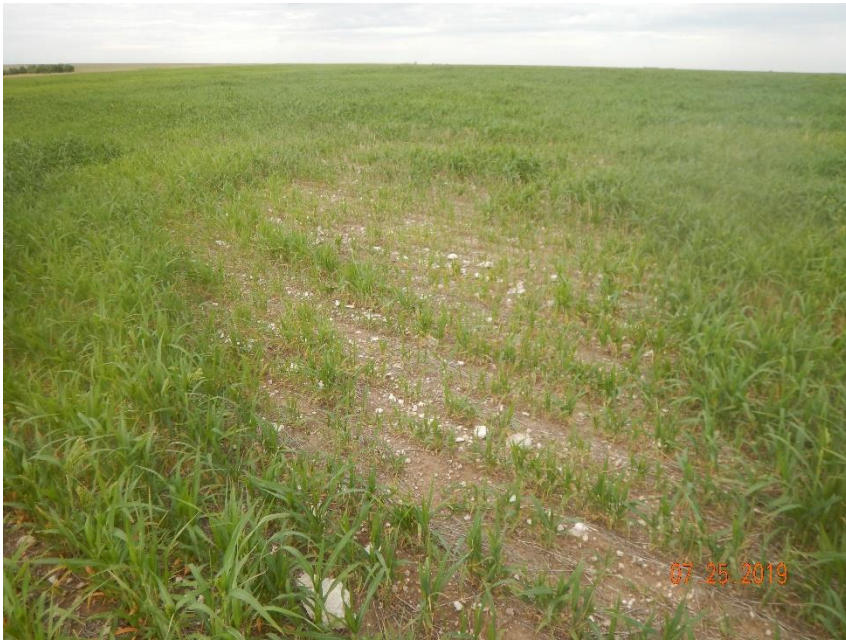
**Photo 3:** Photo taken from the well location, facing northwest. Photo shows crop establishment on the location is stunted, and not reflective of the reference area. Reclamation concerns remain evident.

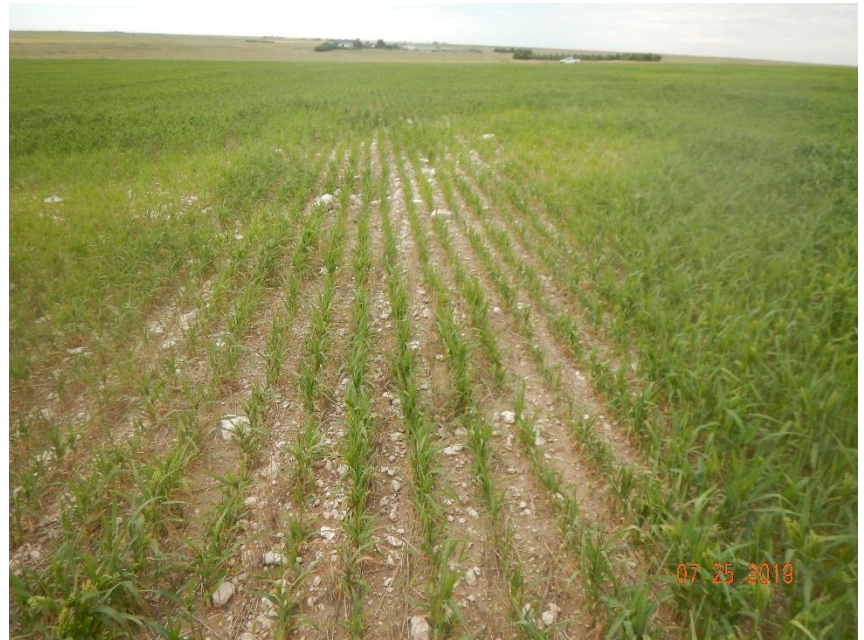
**Photo 4:** Photo taken from the well location, facing west. Photo shows crop establishment on the location is stunted, and not reflective of the reference area. Reclamation concerns remain evident.

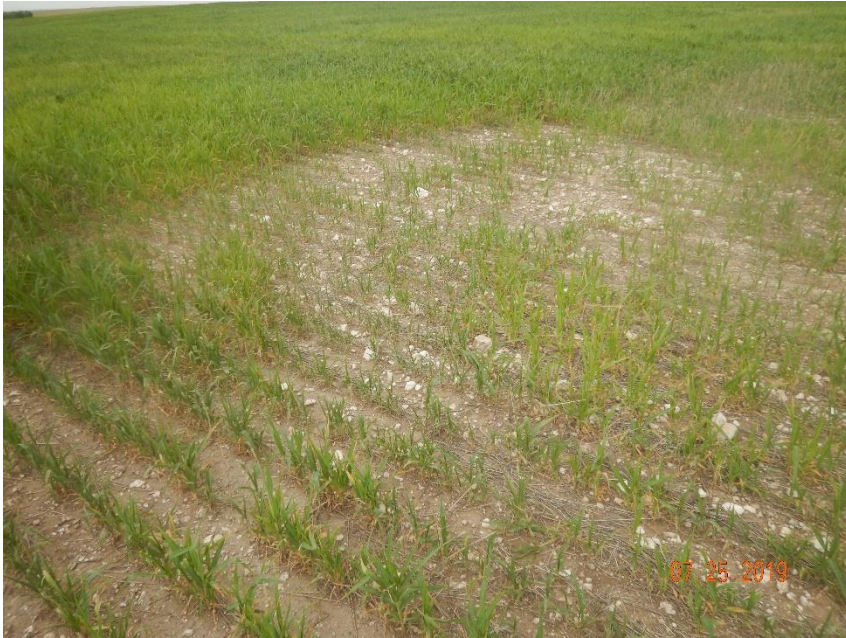
**Photo 5:** Photo taken from the well location, facing south. Photo shows crop establishment on the location is stunted, and not reflective of the reference area. Reclamation concerns remain evident.

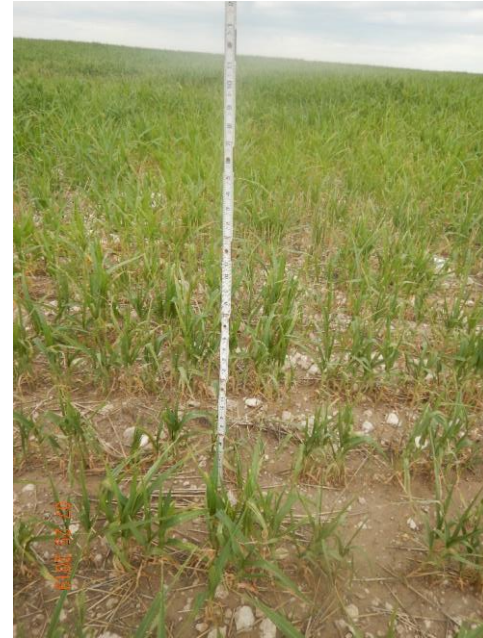
**Photo 6:** Photo taken from the well location. Photo shows crop establishment on the location is stunted, and not reflective of the reference area. Reclamation concerns remain evident. Crop height on location seen in picture ~8-10 inches. 6 foot measuring stick for reference.

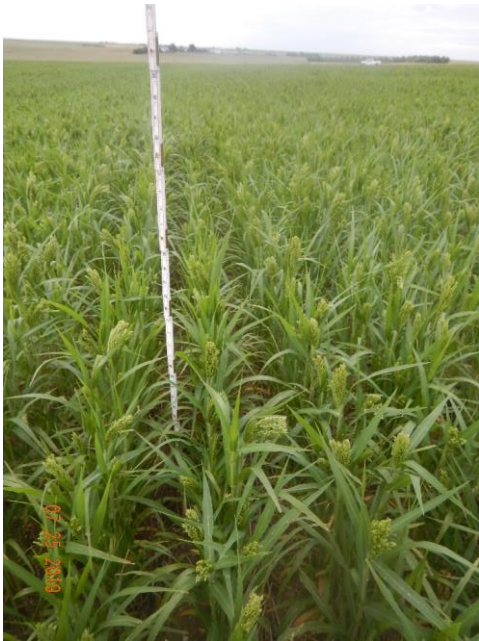
**Photo 7:** Photo taken from the adjacent reference area. Photo shows crop establishment on the location/disturbance area is not reflective of the reference. Crop height on location seen in picture ~24 inches. 6 foot measuring stick for reference.
