Inspection Photos

Operator: BEREN CORPORATION - 7800

Location ID: 317053

Washington County, CO

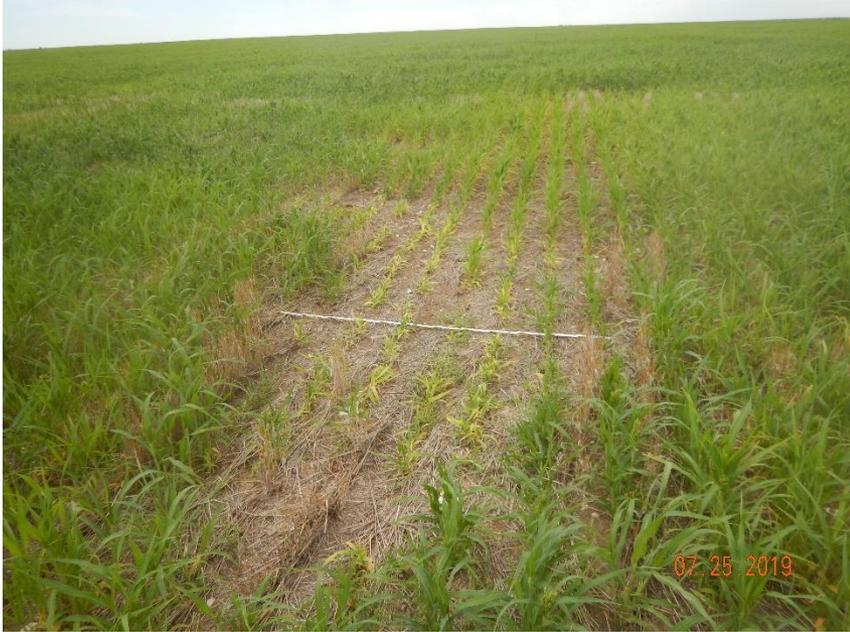
Photo 1: Photo taken from the well location, facing north. Photo shows crop establishment on the location is stunted, and not reflective of the reference area. Reclamation concerns remain evident.

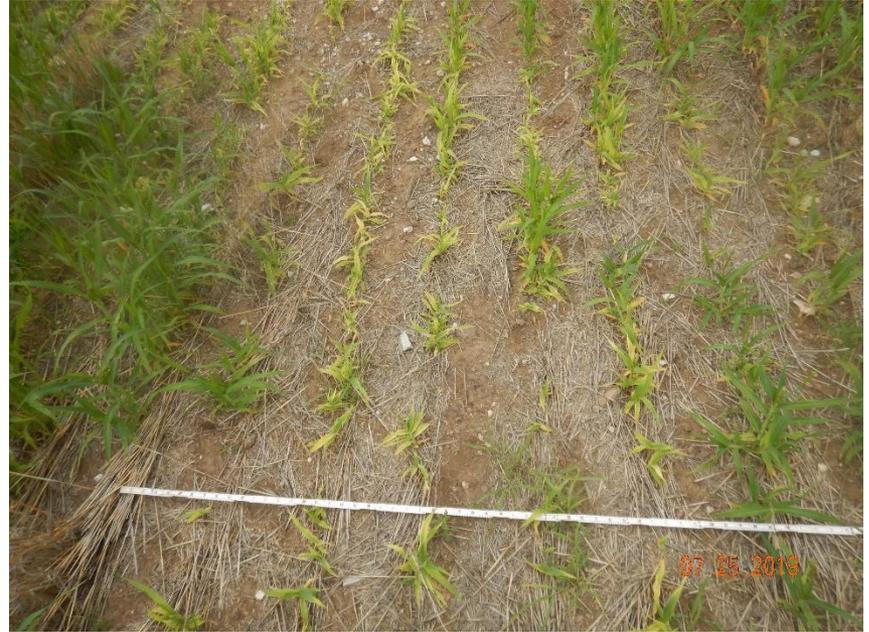
Photo 2: Continued from photo 1. Photo shows subsidence concerns remains evident at the well. 6 foot measuring stick for reference.

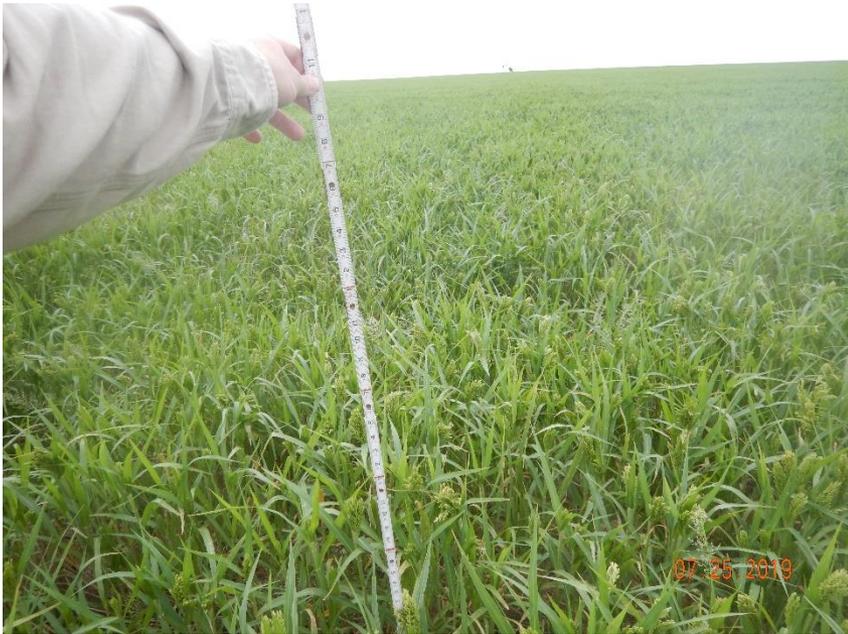
Photo 3: Photo taken from the adjacent reference area. Photo shows crop establishment on the location/disturbance area is not reflective of the reference. Crop height on location seen in picture ~36 inches. 6 foot measuring stick for reference.

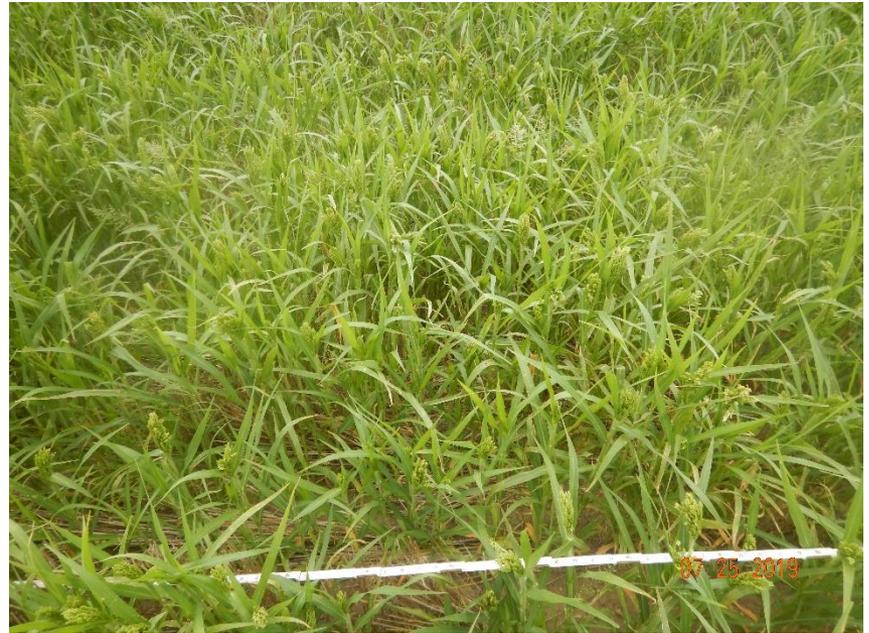
Photo 4: Photo taken from the adjacent reference area. Photo shows crop establishment on the location/disturbance area is not reflective of the reference. 6 foot measuring stick for reference.

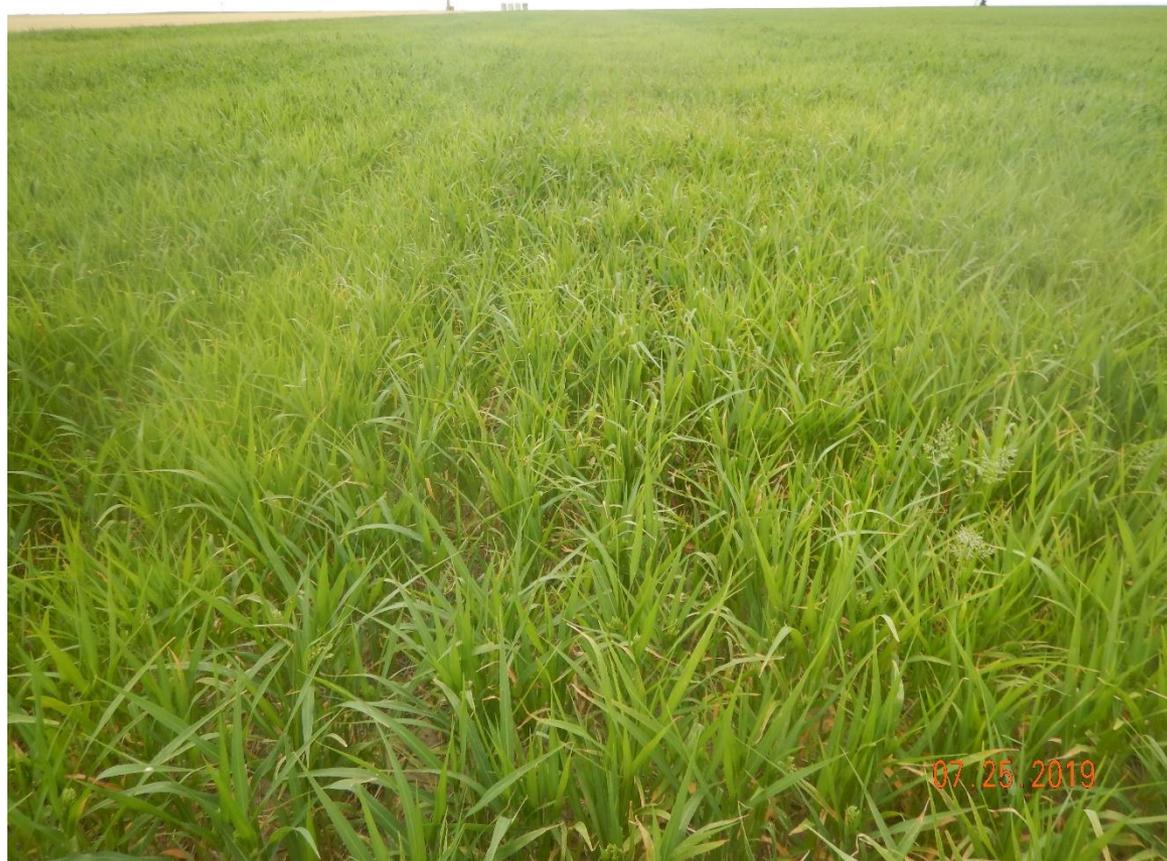
Photo 5: Photo taken from the adjacent reference area. Photo shows crop establishment on the location/disturbance area is not reflective of the reference. 6 foot measuring stick for reference.
