Inspection Photos
Operator: Red Mesa
Location/API #: 067-05392
Date: 7-24-2019

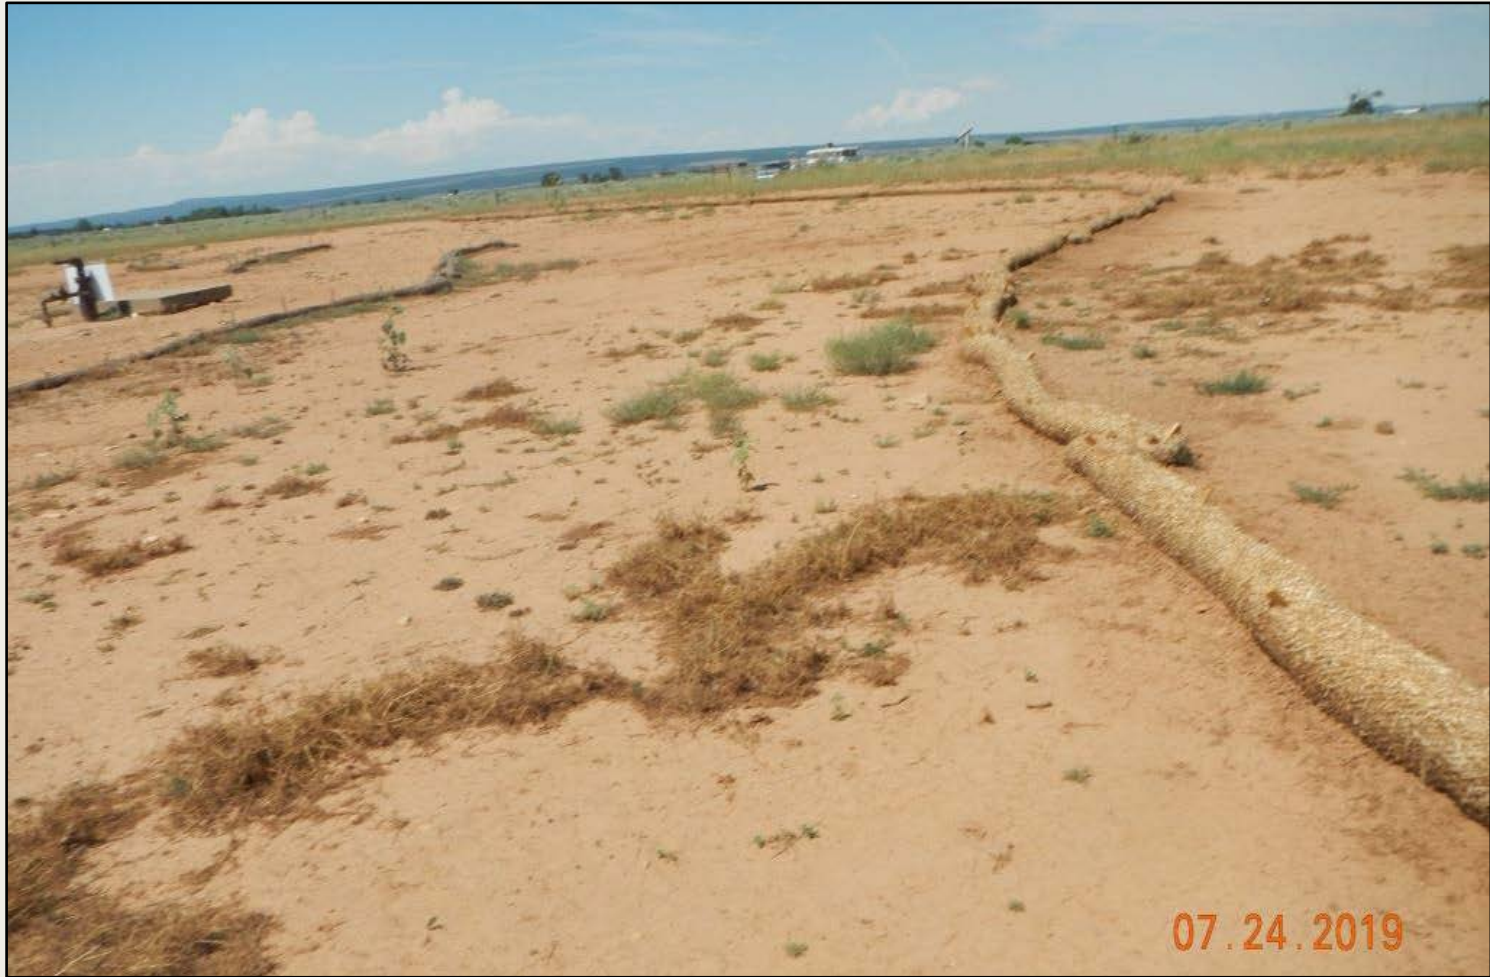
Photo 1. View of perimeter wattle in the northern project area facing westward.

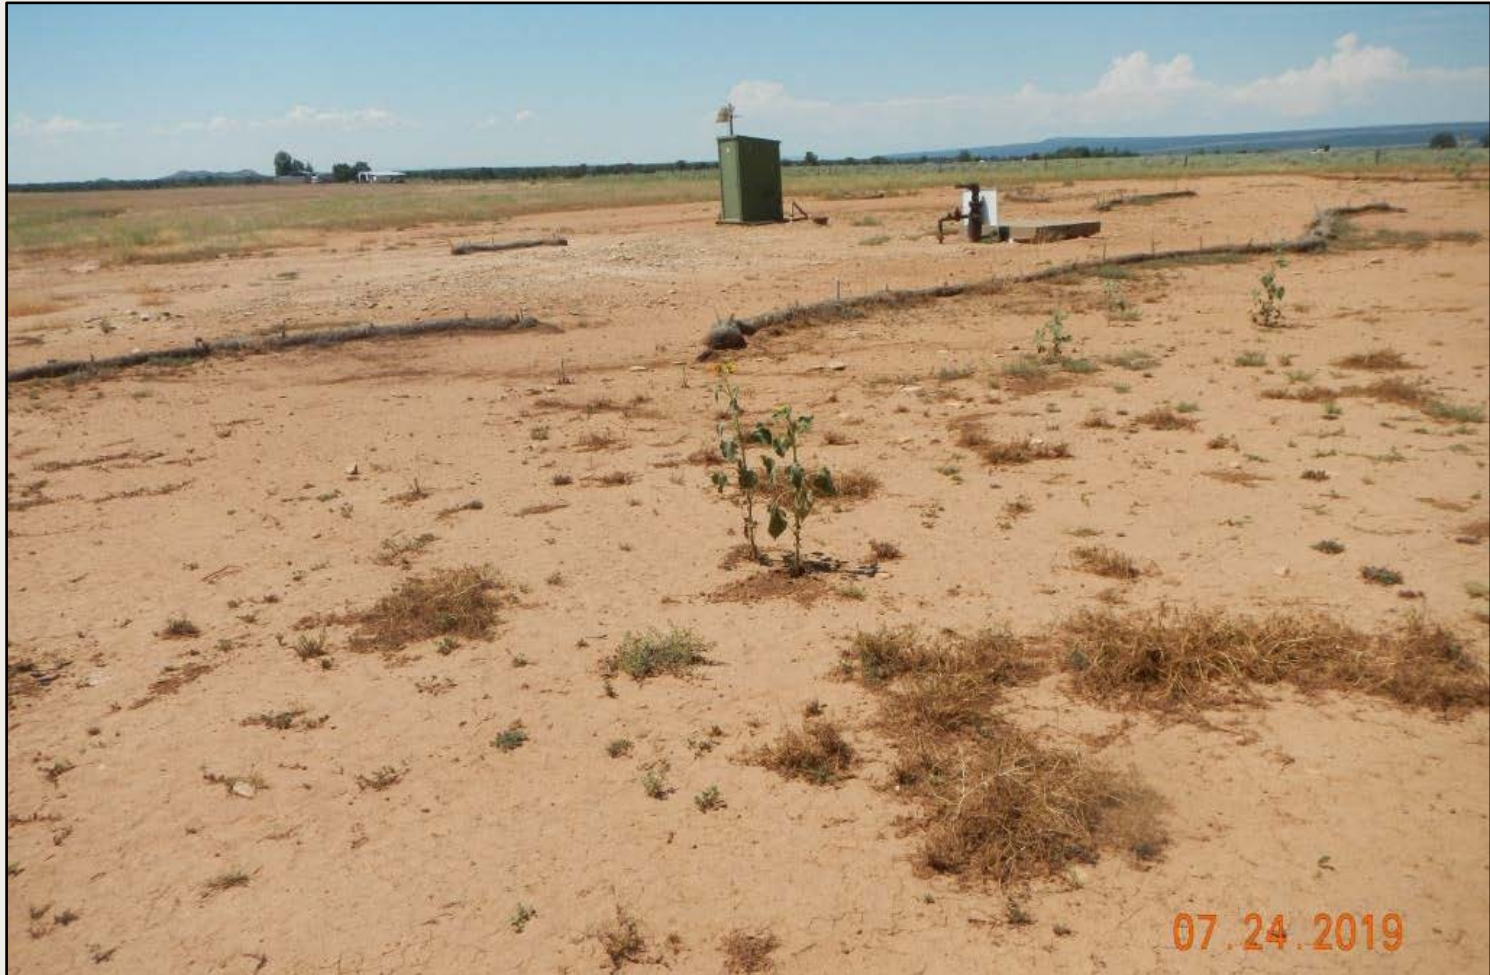
Photo 2. View of project area from the northern edge facing center. Wattles are largely functioning. Minor new erosion observed where wattles are not sufficient to de-energize surface flows.
