Final Reclamation Inspection

Operator: NOBLE ENERGY INC- #100322

Location ID: 322634

Inspection Photos
Location Name: DAVIS #2-33
Location ID: 322634

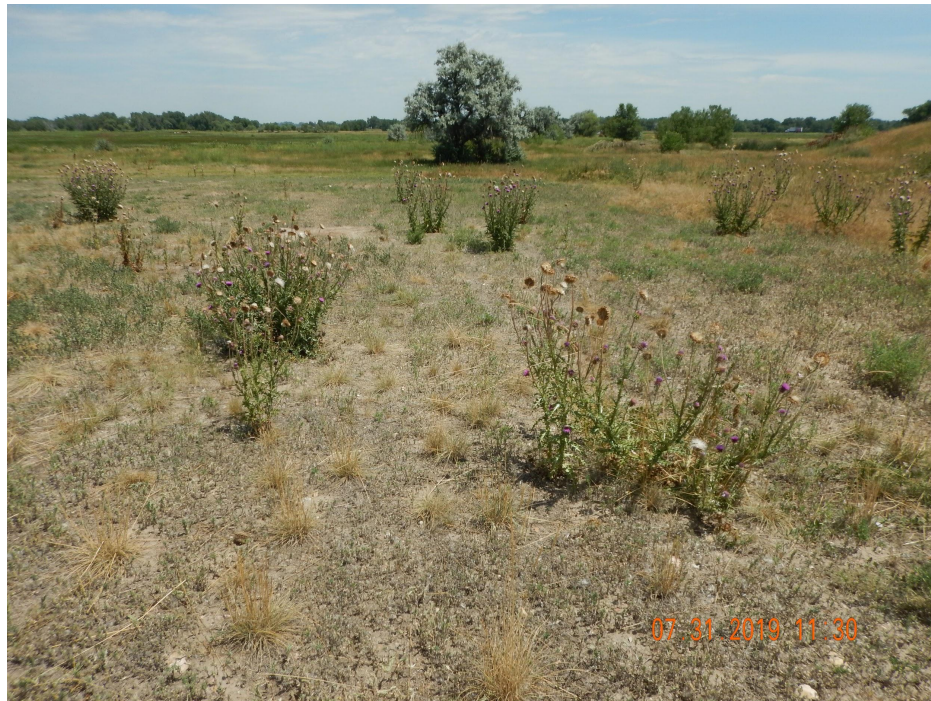
Photo 1. Photo taken from the entrance of location, facing East. Photo illustrates a List B Colorado noxious weed, Musk thistle. Operator indicated that additional reclamation was performed; however, little germination of desirable species was observed.

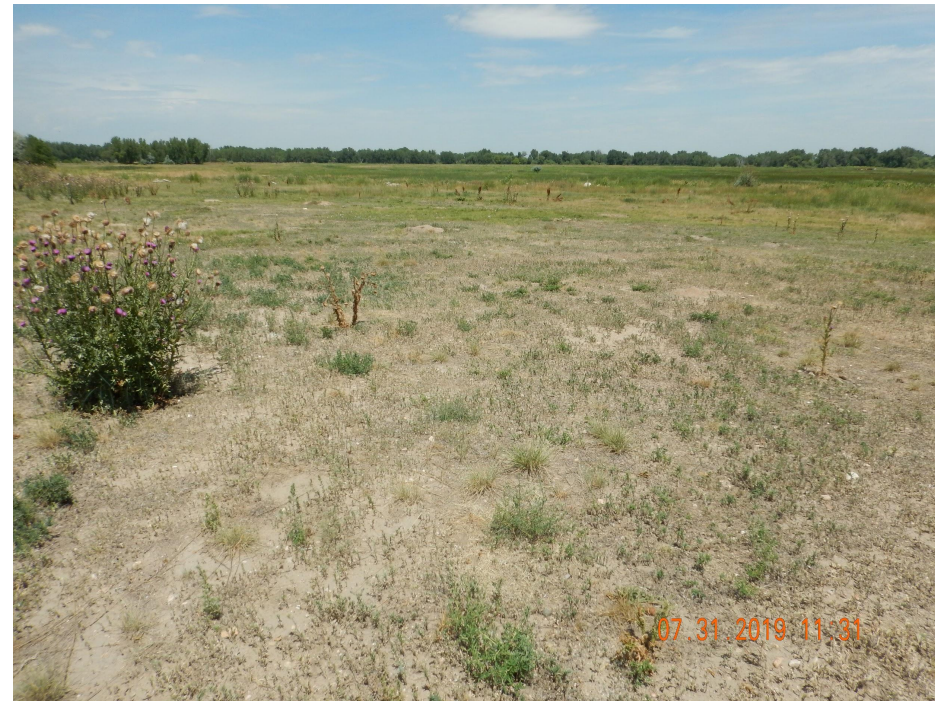
Photo 2. Photo taken from the central location, facing North. See comments under Photo 1.

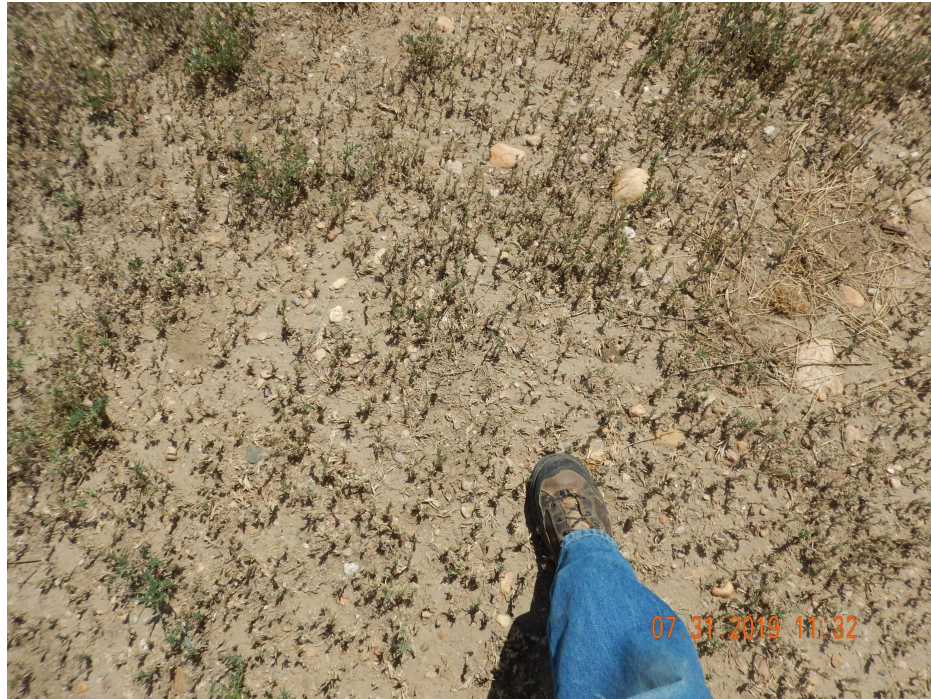
Photo 3. Close up photo taken from the central location. Photo illustrates little germination of desirable species.

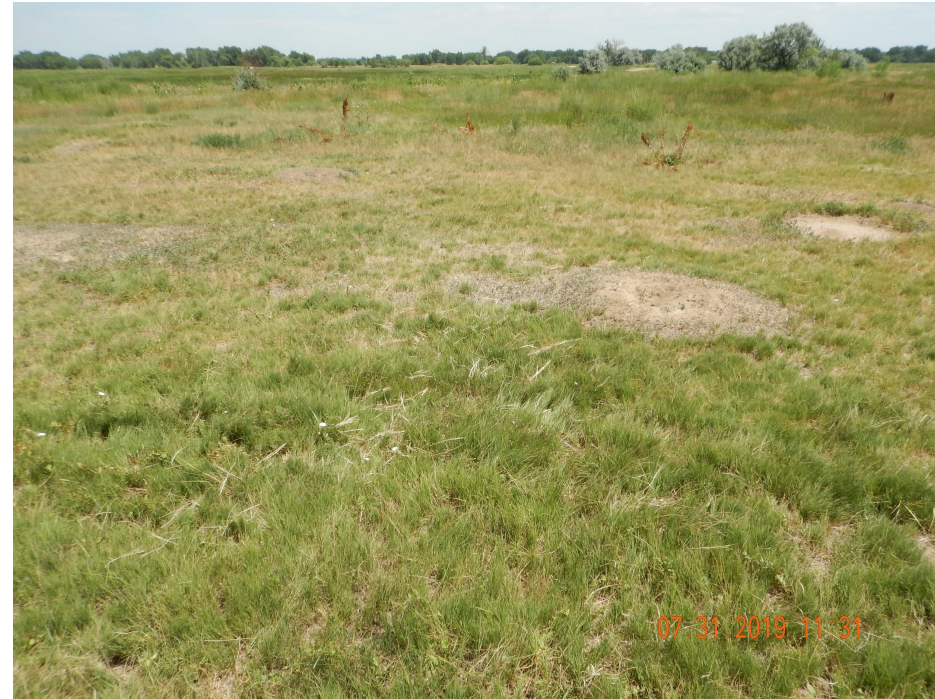
Photo 4. Reference photo taken northeast of location, facing Northeast. Photo illustrates the location is not reflective of reference area vegetative levels.
