Inspection Photos

Operator: FOUNDATION ENERGY
MANAGEMENT LLC - 10112

Location ID: 330359
Weld County, CO

Aaron Trujillo
NE Reclamation Specialist
COGCC

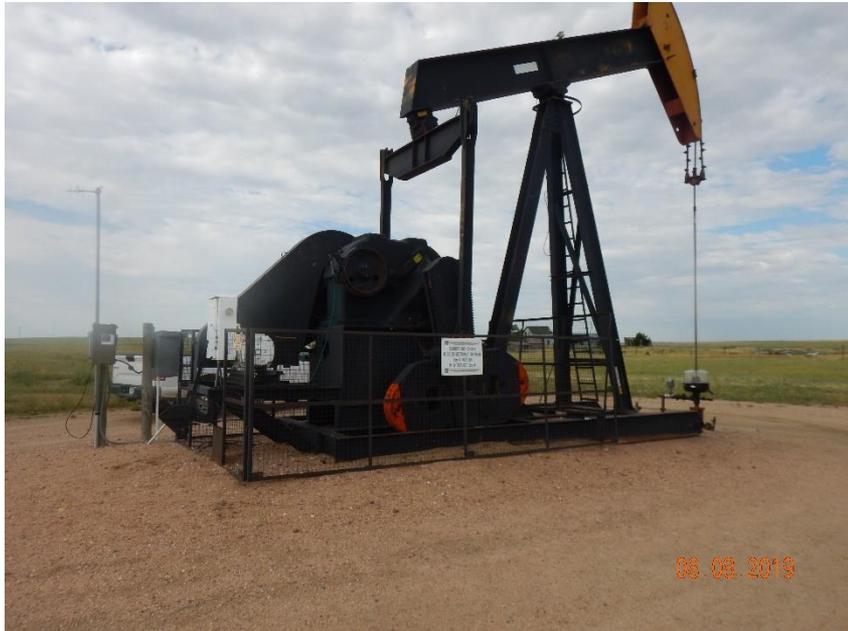
Photo 1: Photo taken from the north end of the location, facing southwest. Photo shows well and production area.

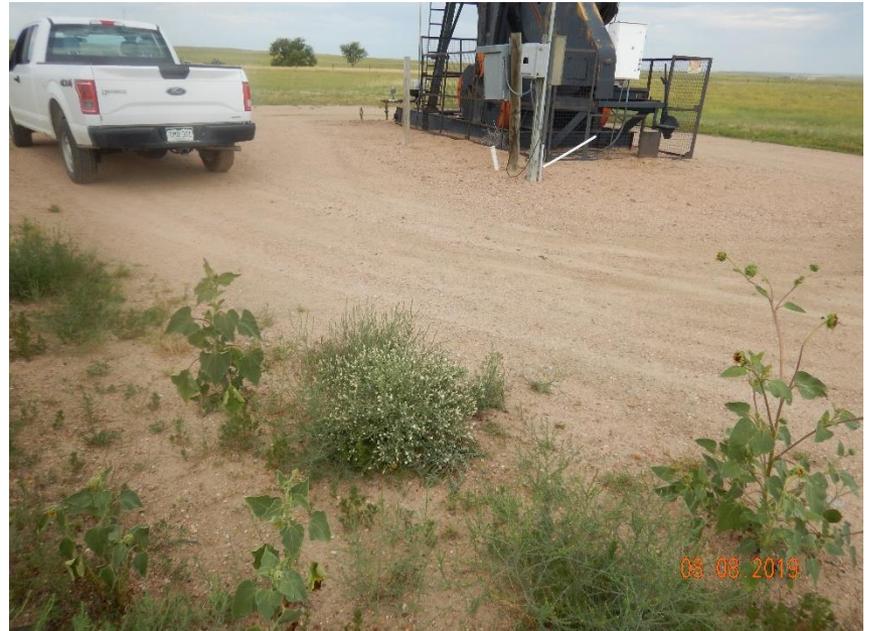
Photo 2: Photo taken from the southeast end of the location, facing northwest. Photo shows Diffuse Knapweed (Plants with white flowers in photo) has re-established on the location. Sufficient and on-going weed management does not appear to be occurring.

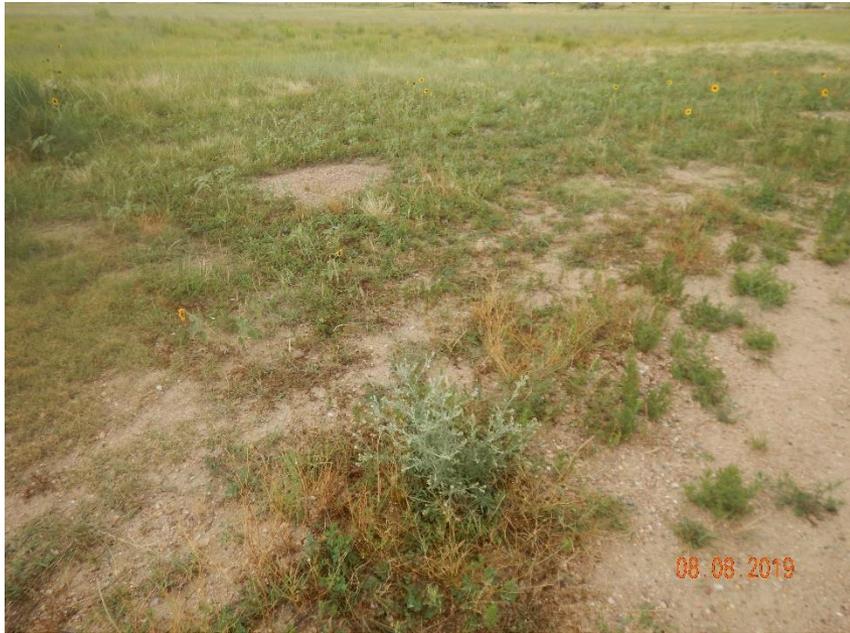
Photo 3: Photo taken from the southwest end of the location, facing northwest. Photo shows Diffuse Knapweed (Plants with white flowers in photo) has re-established on the location. Sufficient and on-going weed management does not appear to be occurring.

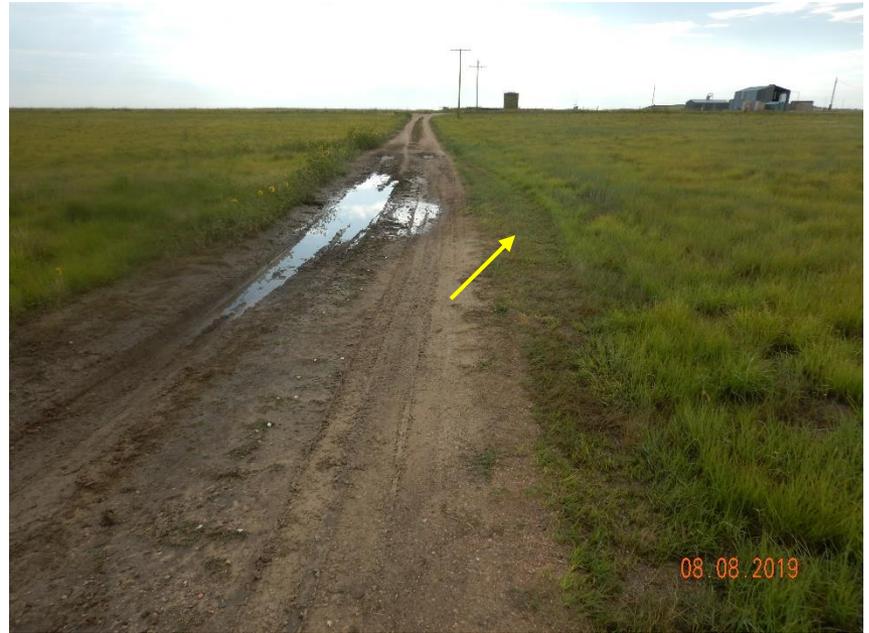
Photo 4: Photo taken from the access road, facing east. Photo shows operator has travelled beyond the designated access road onto adjacent lands. This does not comply with 1002.e. Access road will need to be constructed with sufficient BMPs to allow for proper stormwater discharge to ensure existing access road remains in proper functioning condition.
