Construction and Stormwater Inspection

August 14, 2019

Operator: EXTRACTION OIL & GAS INC - #10459

Inspection Photos
Location Name: UNITED PAD
Location ID: 457722

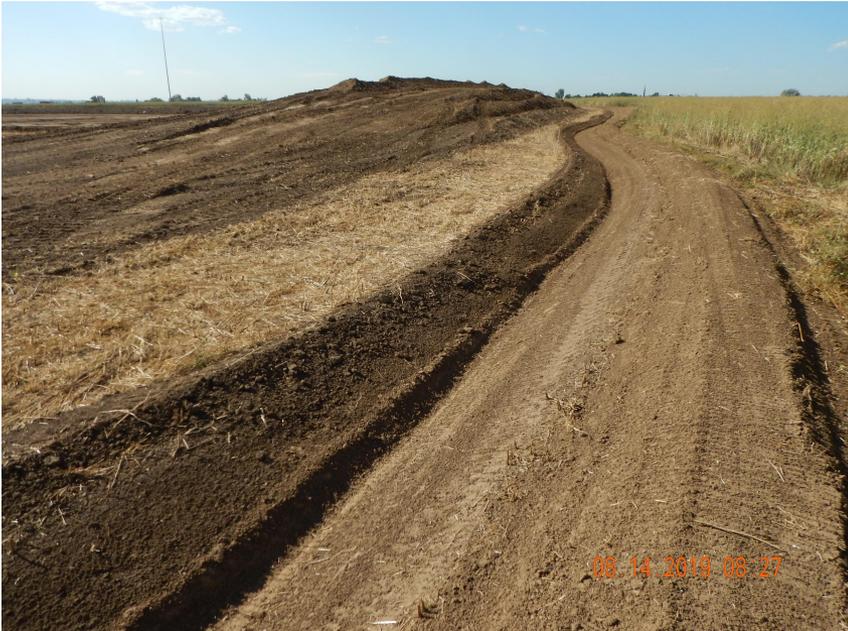
Photo 1. Photo taken from the northwestern location, facing South. Photo illustrates the perimeter ditch and berm BMP that has been installed around the entire perimeter of the location. At the time of this inspection, the perimeter BMP appears to be stabilized and in proper functioning condition during major construction activities (i.e., topsoil salvage operations).

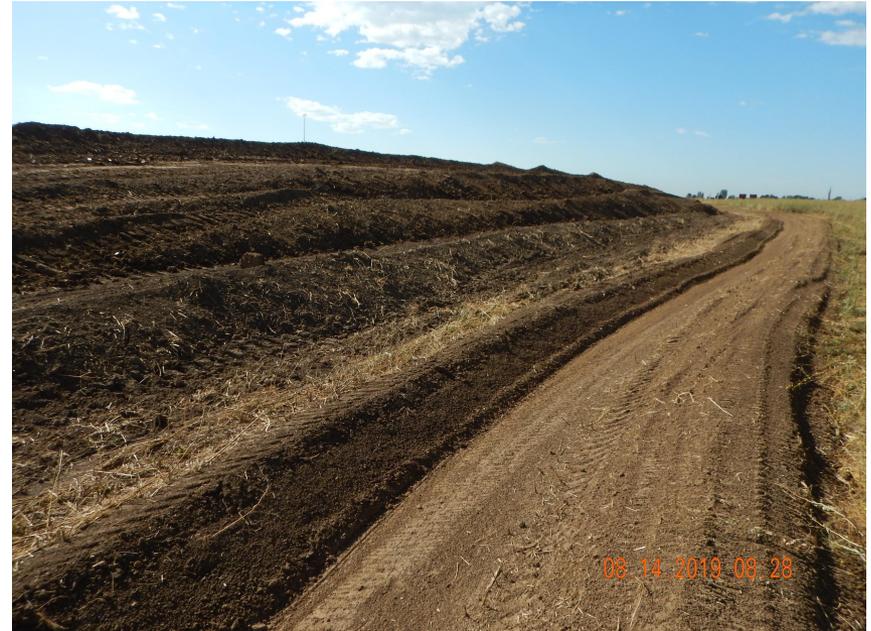
Photo 2. Photo taken from the western location, facing South. See comments under Photo 1. Photo also illustrates the topsoil stockpile. Operator was conducting topsoil salvage operations at the time of this inspection.

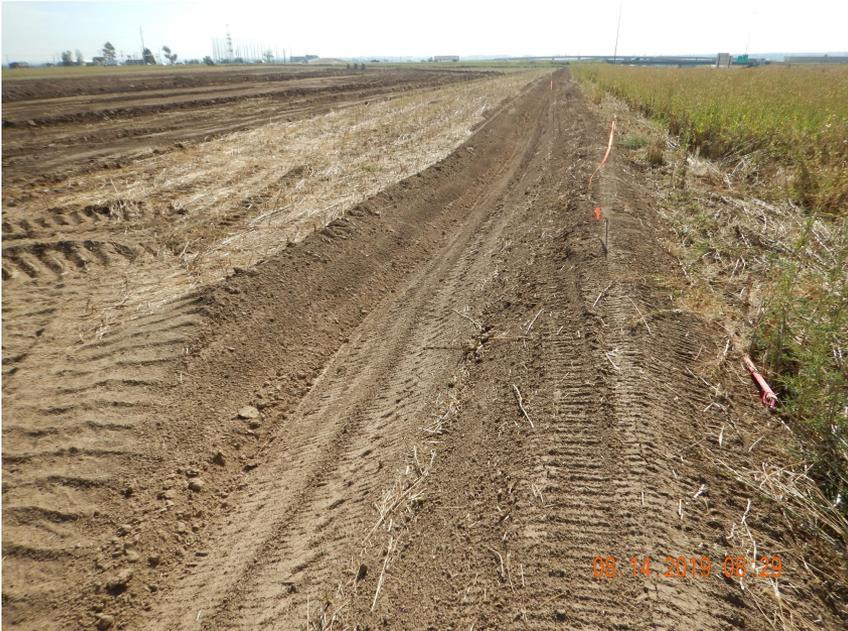
Photo 3. Photo taken from the southwestern location, facing East. See comments under Photo 1.

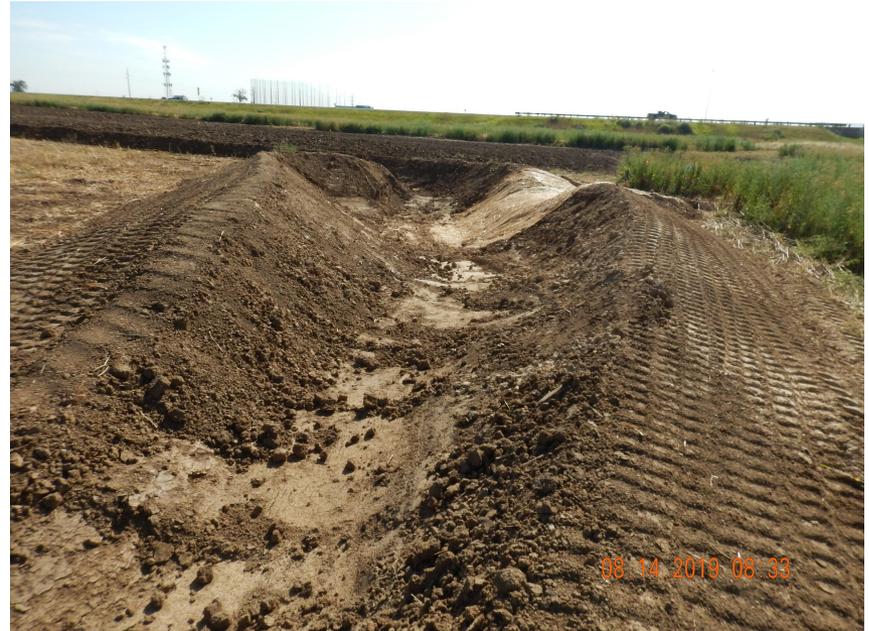
Photo 4. Photo taken from the southeastern location, facing East. Photo illustrates a sediment trap installed in conjunction with the perimeter ditch and berm BMP.

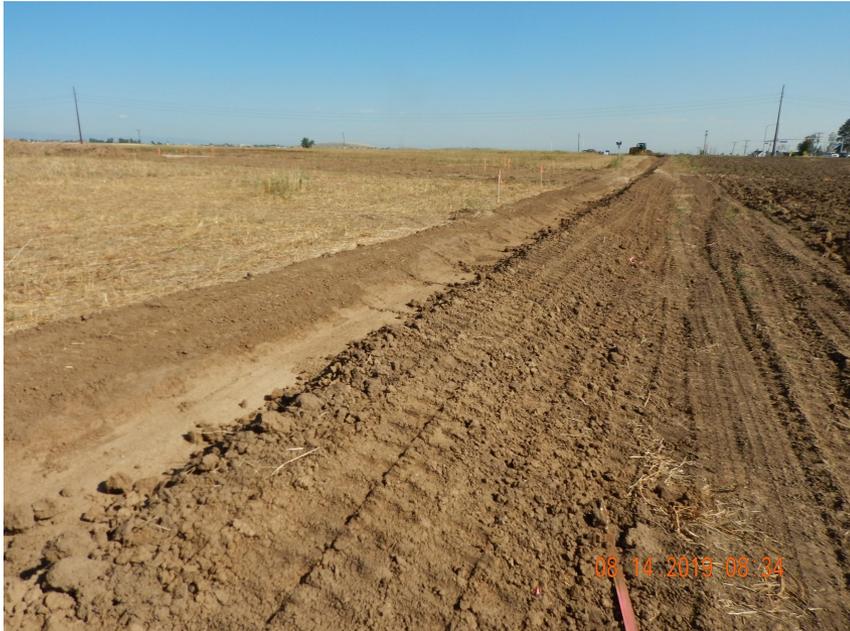
Photo 5. Photo taken from the southeastern location, facing North. See comments under Photo 1.

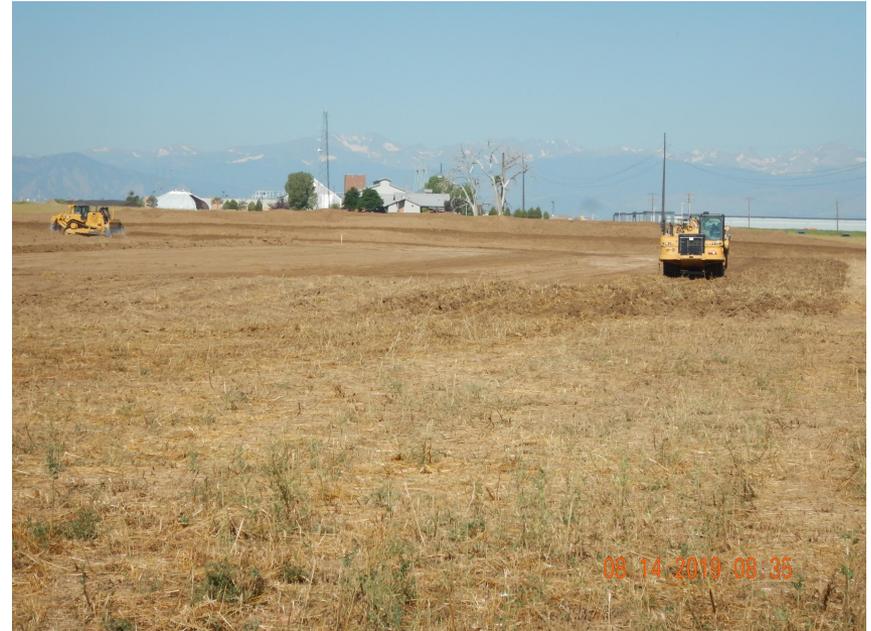
Photo 6. Photo taken from the eastern location, facing West. Photo illustrates topsoil salvage operations in-process.

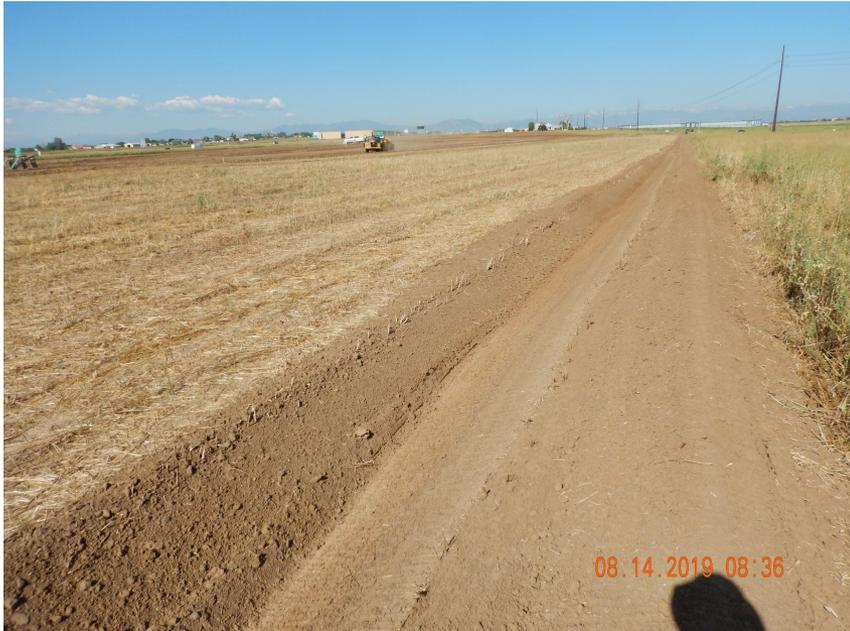
Photo 7. Photo taken from the northeastern location, facing West. See comments under Photo 1.

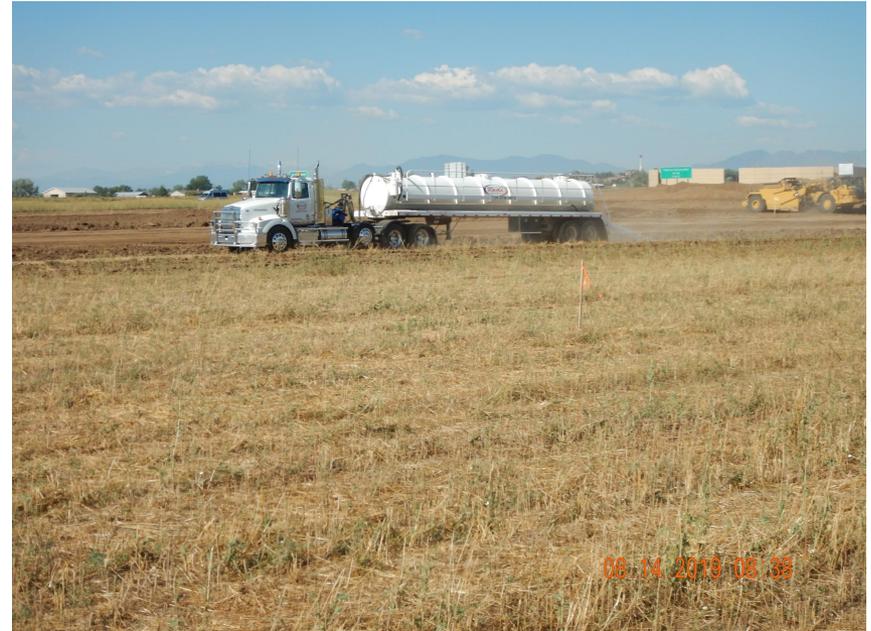
Photo 8. Photo taken from the northern location, facing Southwest. Photo illustrates a water truck on location during construction activities.

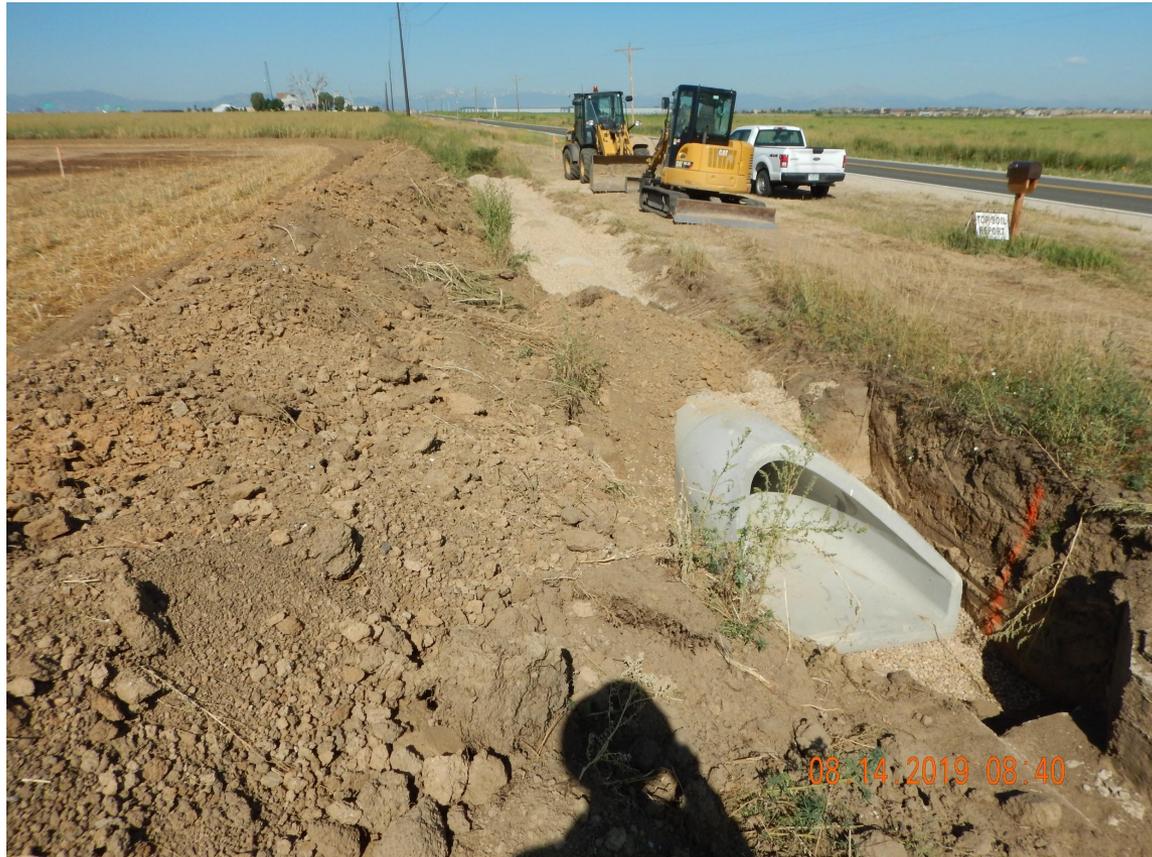
Photo 9. Photo taken from the northwestern location, facing West. Photo illustrates a culvert being installed along the roadside ditch for the access point to location.
