# Final Reclamation Inspection

API #: 05-001-06796

Adams County, CO

Inspection Photos  
Location Name: WIERMAN #1  
API #: 05-001-06796

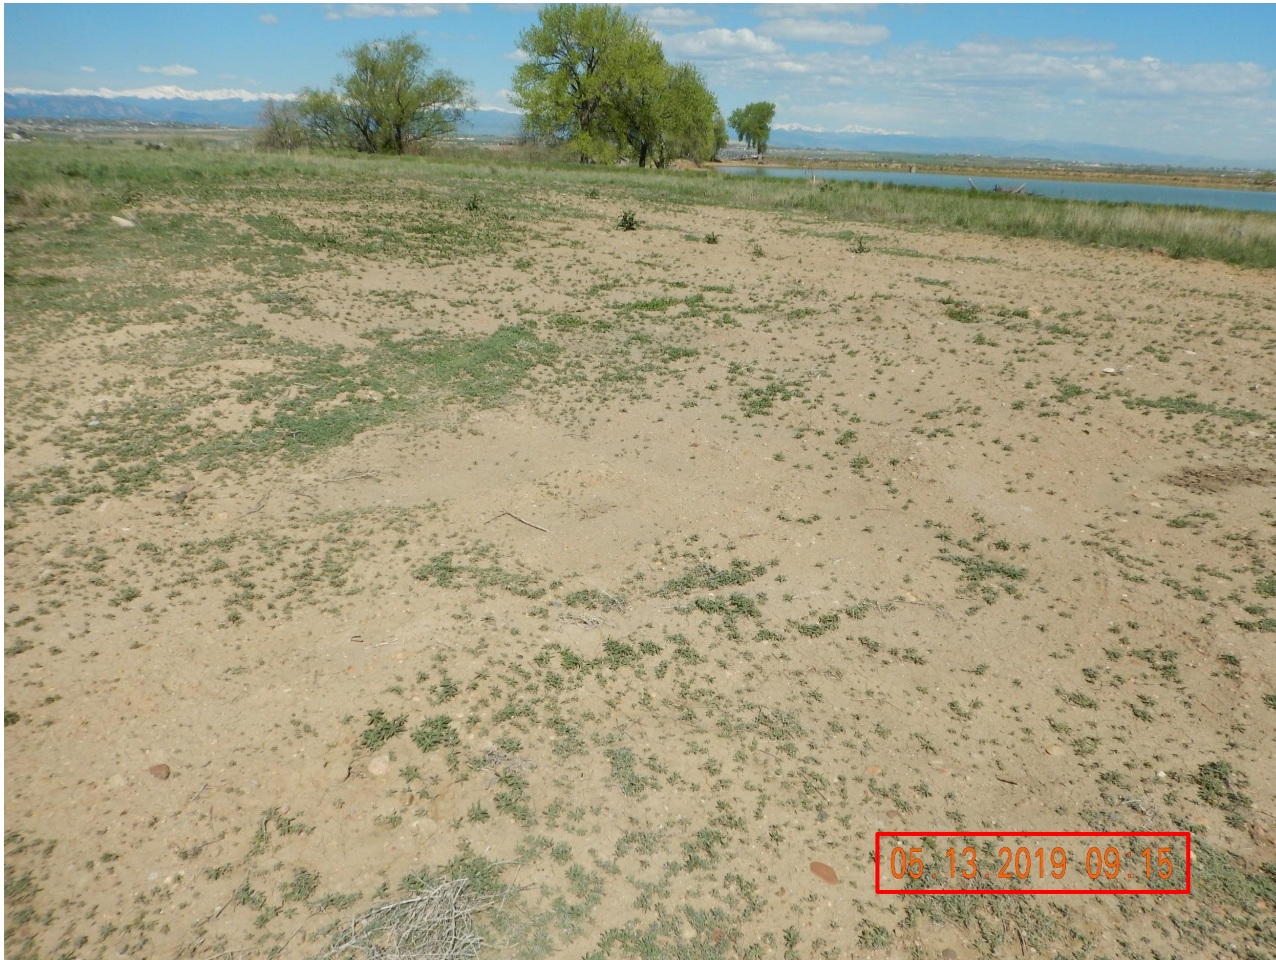
**Photo 1.** Photo taken on May 13, 2019 from the tank battery, facing Northwest. Photo illustrates Operator has not performed all Final Reclamation activities at the Location at the time of this inspection.

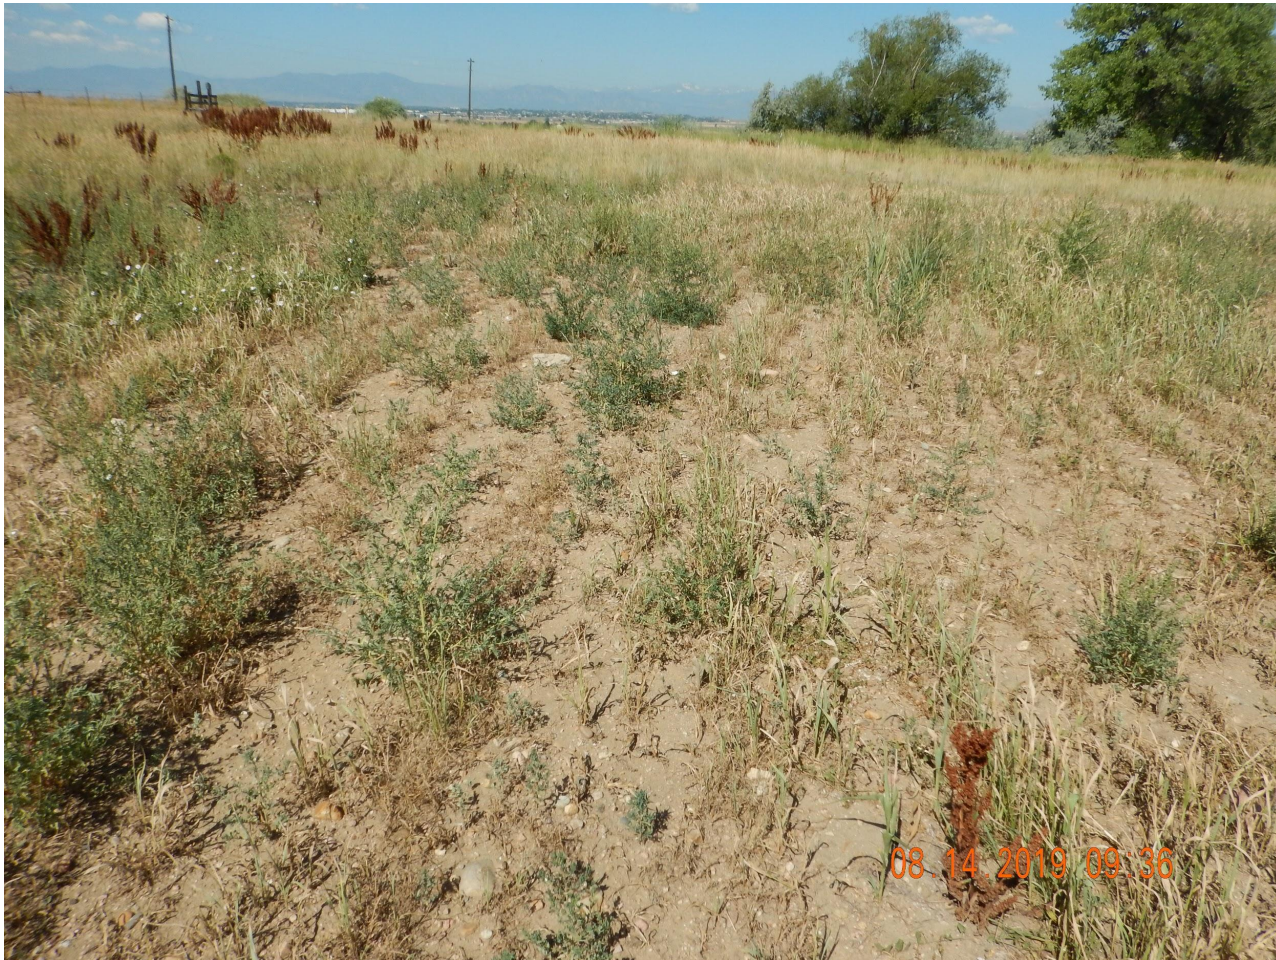
**Photo 2.** Photo taken on August 14, 2019 from the tank battery, facing West. Photo illustrates Operator has performed Final Reclamation activities but the location will remain in-process as it does not meet our vegetative standard and weed management is needed. Both undesirable and noxious weeds were observed.

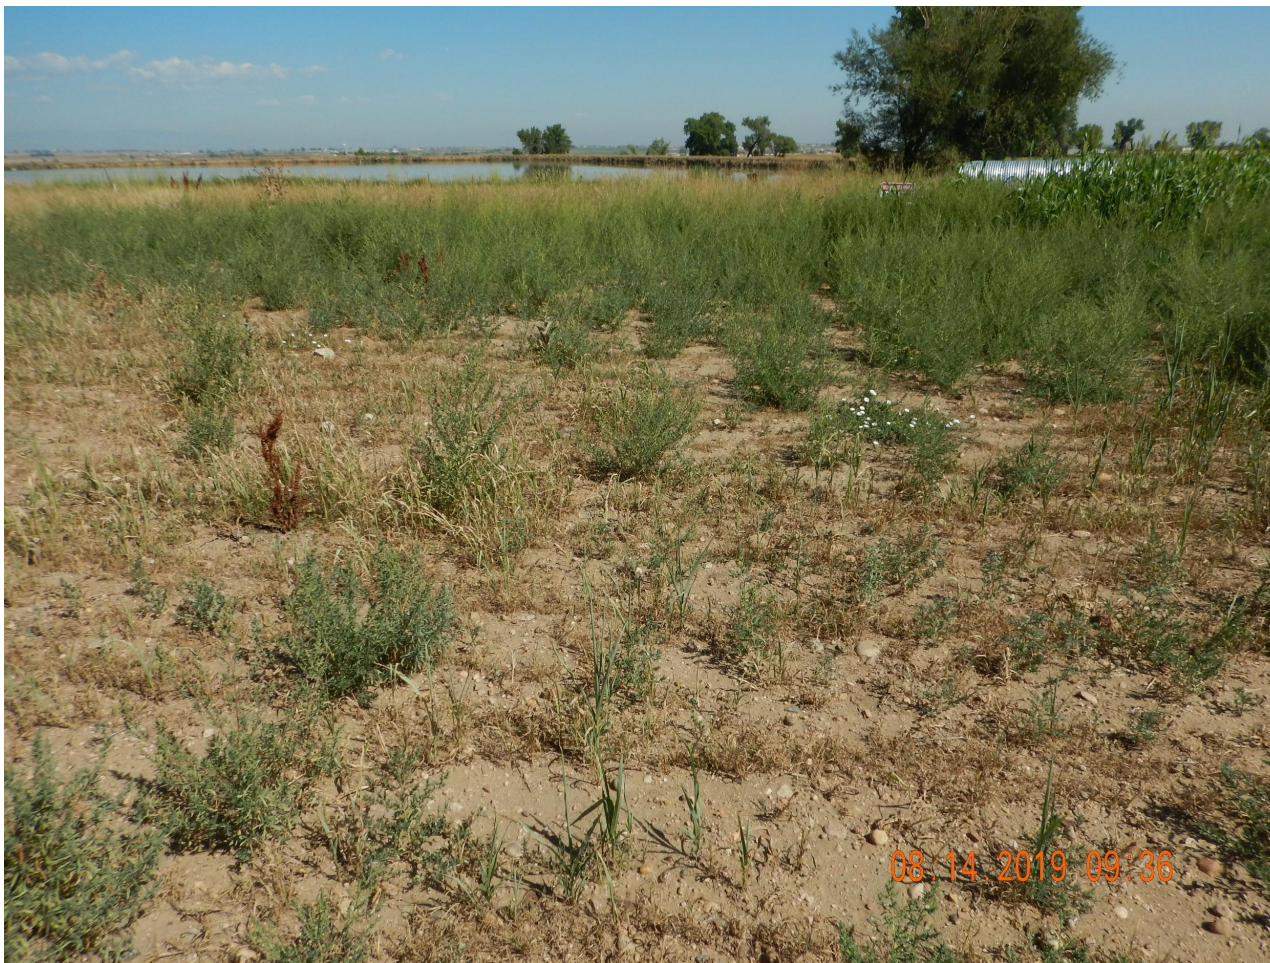
**Photo 3.** Photo taken on August 14, 2019 from the tank battery, facing North. See comments under Photo 2.

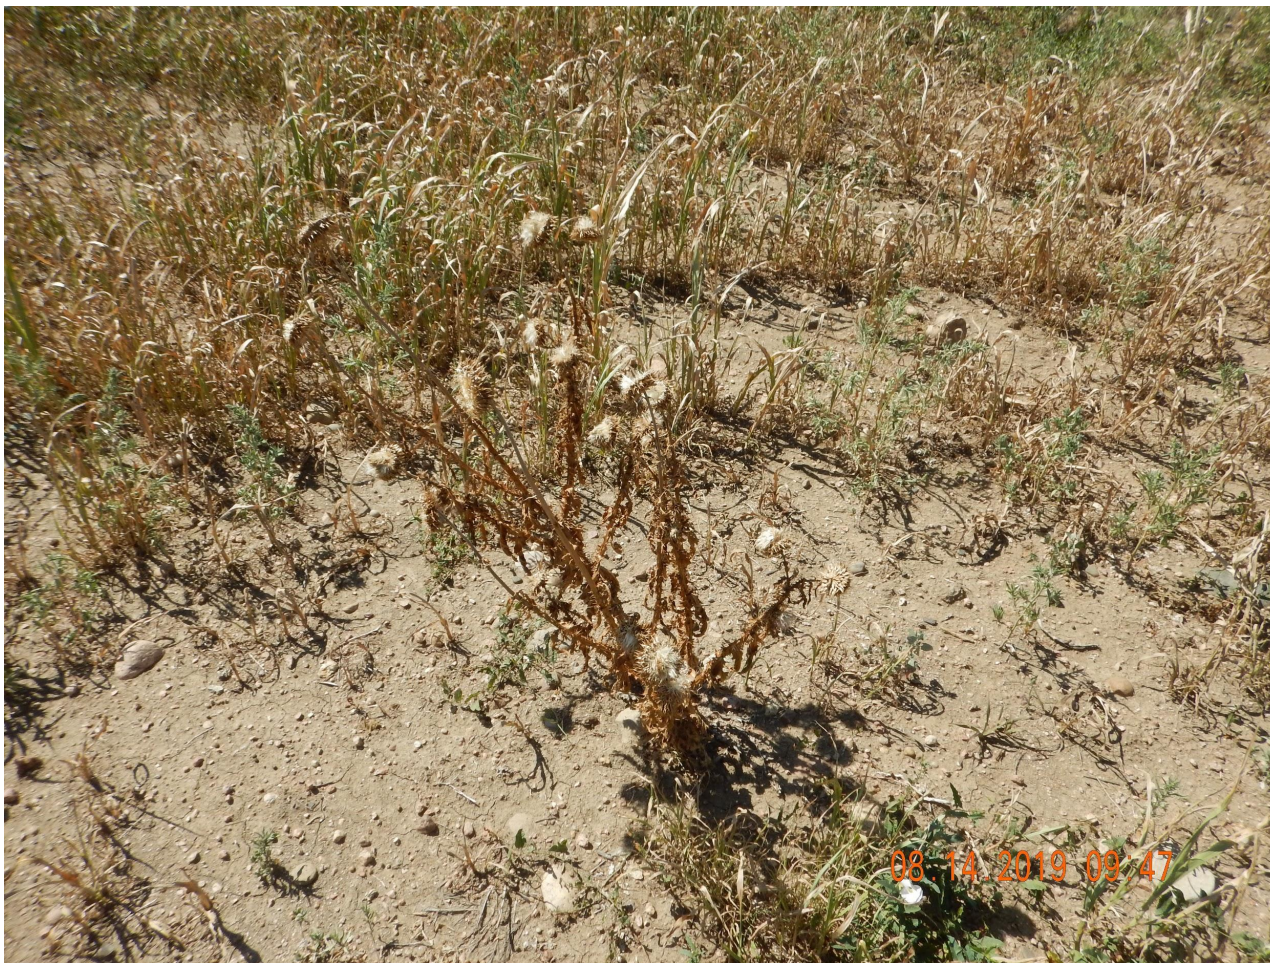
**Photo 4.** Photo taken on August 14, 2019 from the tank battery. Photo illustrates a List B Colorado noxious weed, Musk thistle.

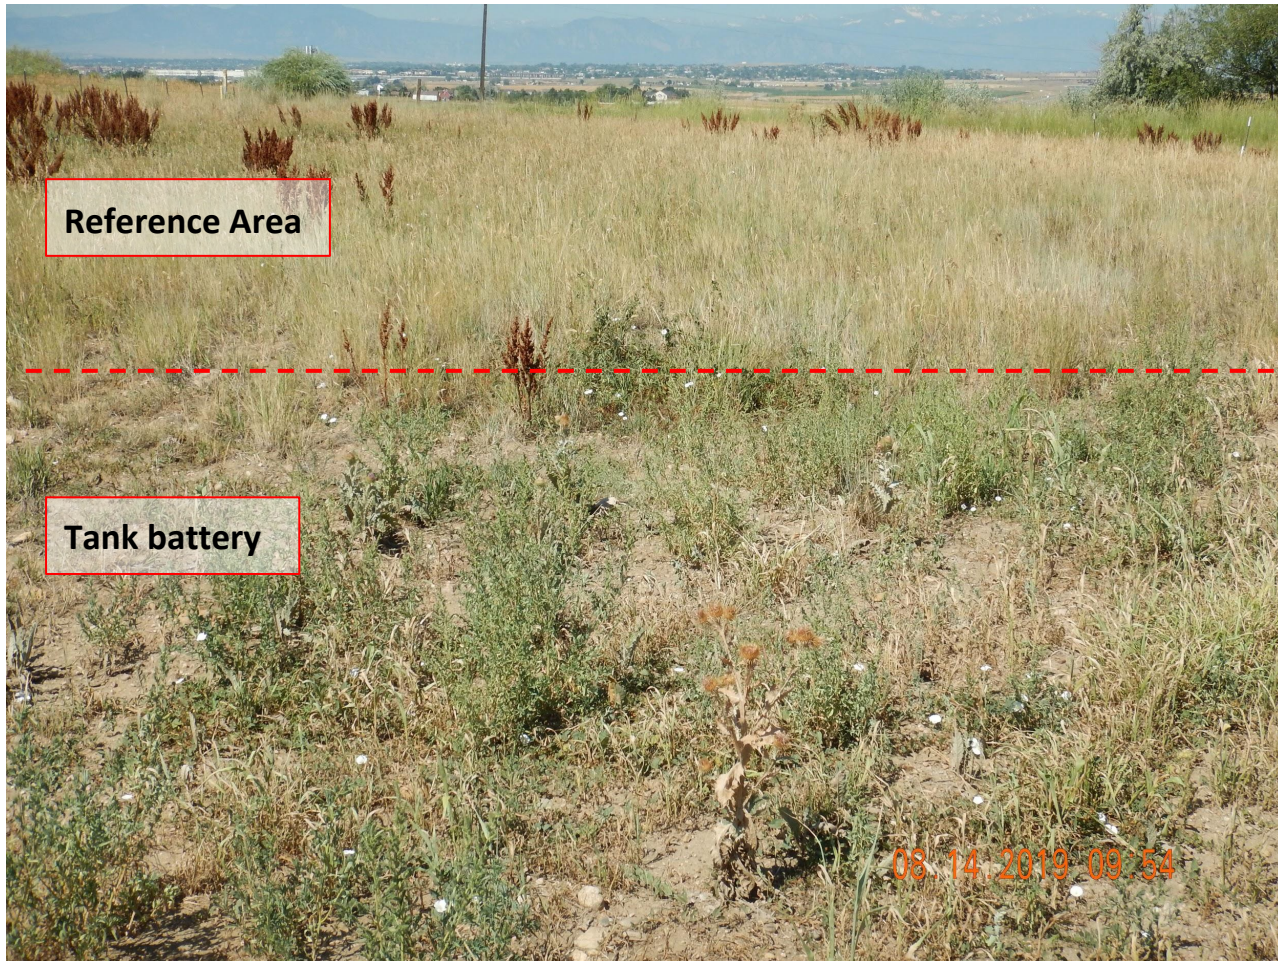
**Photo 5.** Photo taken on August 14, 2019 from the tank battery, facing West. Photo illustrates reference vegetation that will be used in evaluation for vegetative standards under Rule 1004.
