Interim Reclamation and Stormwater Inspection

Operator: PETROSHARE CORPORATION- #10454

Location ID: 451646

Inspection Photos
Location Name: Brighton Lakes /20-17
Location ID: 451646

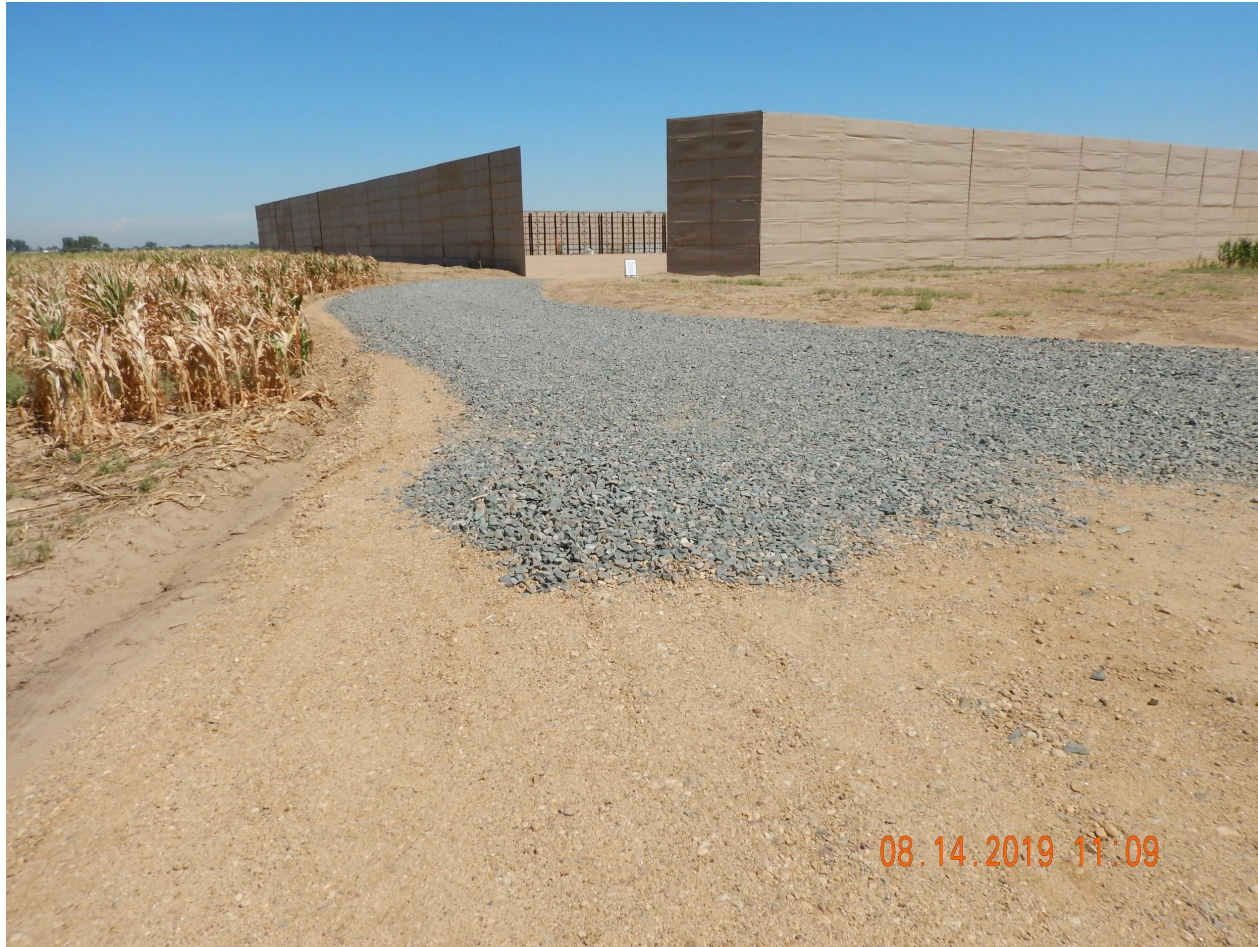
Photo 1. Photo taken from the entrance of Location, facing Northeast. Photo illustrates a vehicle tracking device BMP.

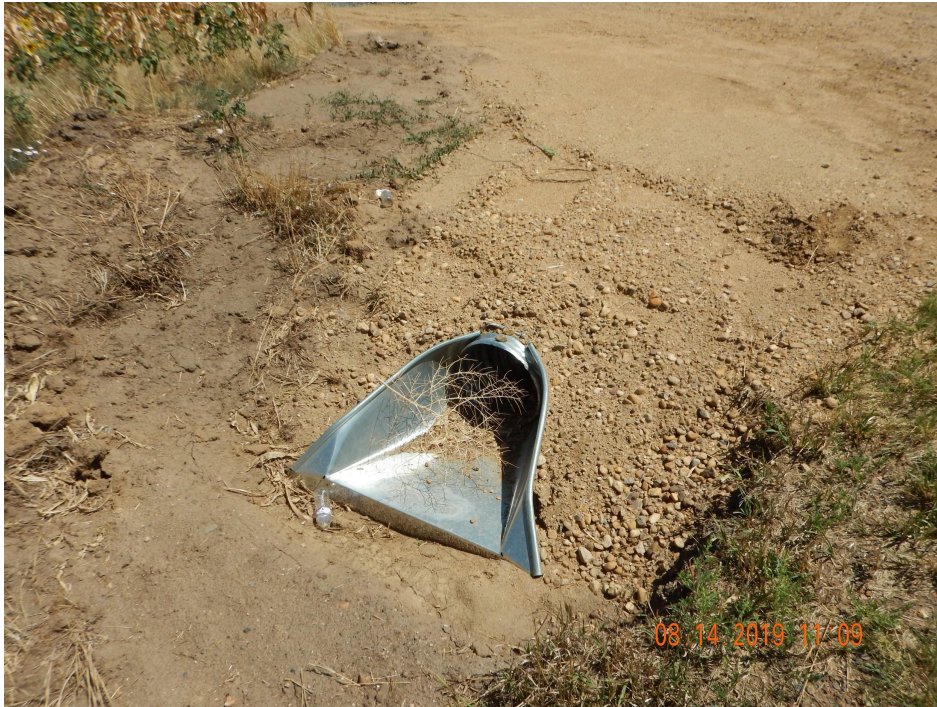
Photo 2. Photo taken from the entrance of Location, facing East. Photo illustrates a culvert installed along the roadside ditch. Operator shall stabilize both the inlet and outlet of the culvert.

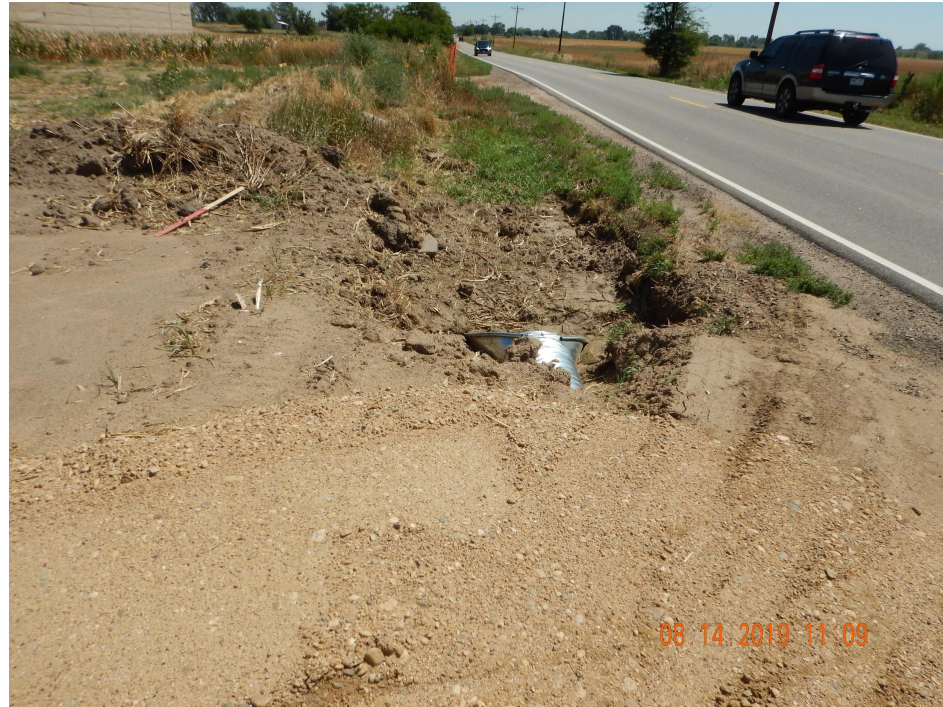
Photo 3. Photo taken from the other end of the culvert (east-side), facing East. See comments under Photo 2.

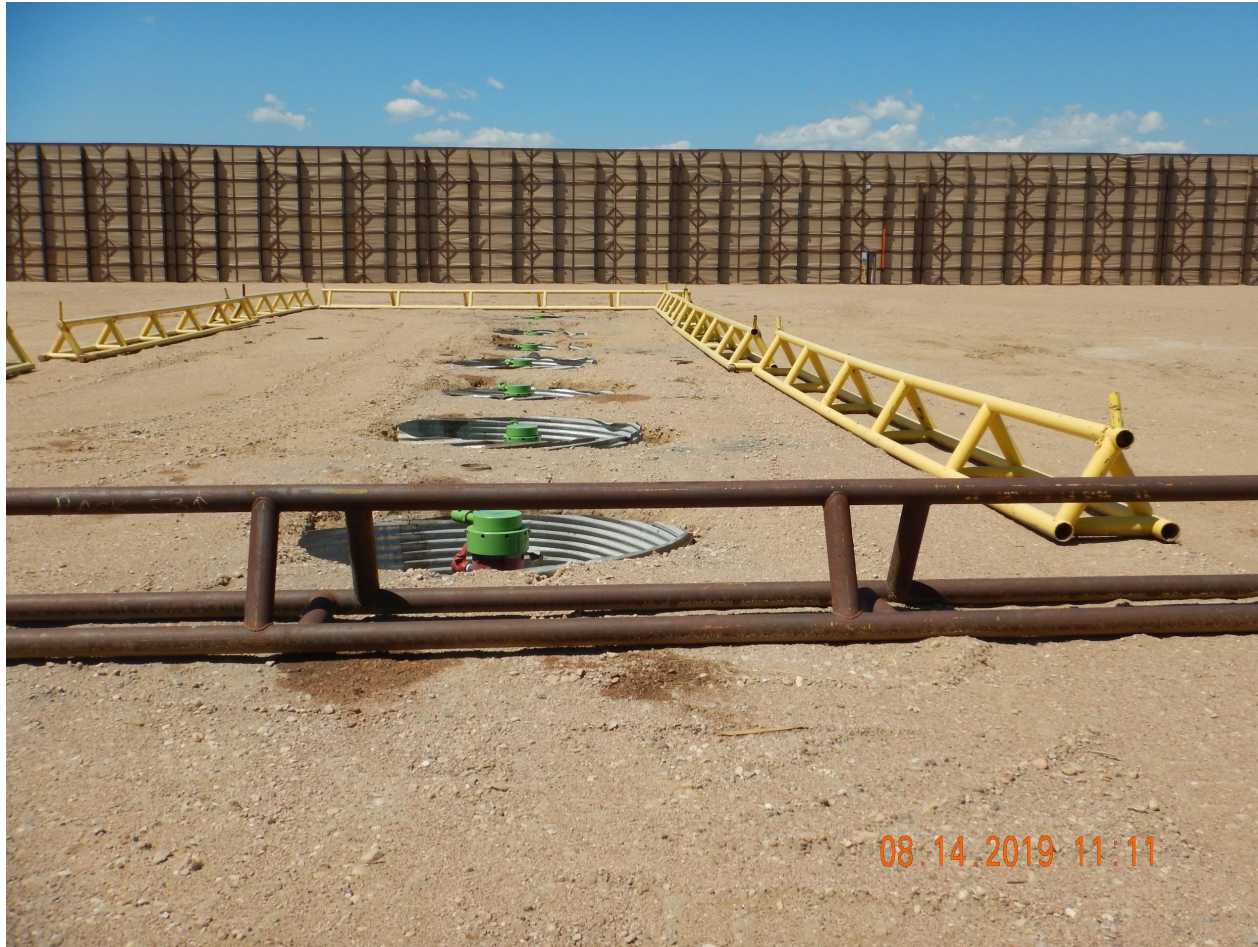
Photo 4. Photo taken from the central Location, facing West. Photo illustrates eight wells have spud the surface hole. Notification to run and cement casing was received in mid-July.

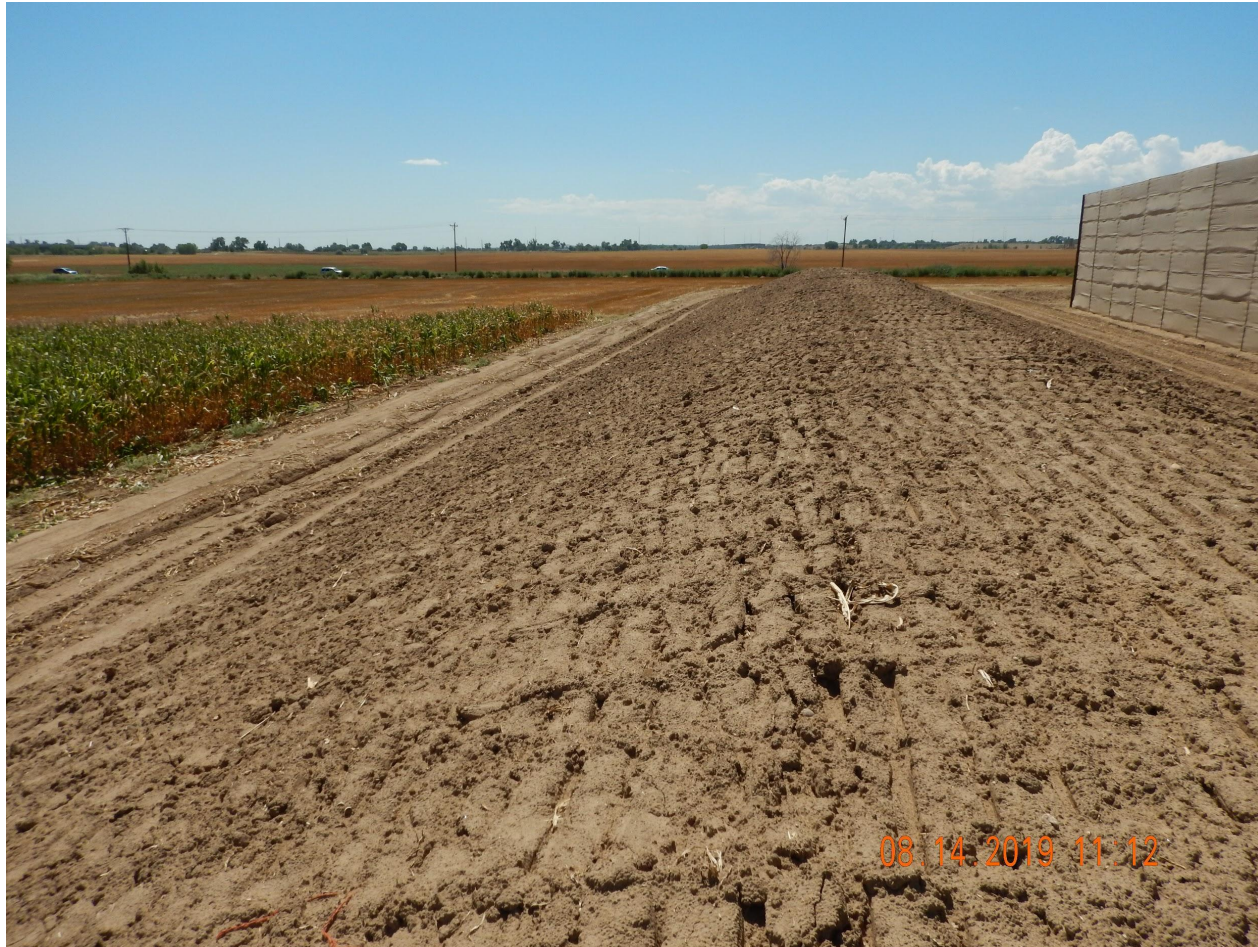
Photo 5. Photo taken from the eastern Location, facing South. Photo illustrates the topsoil stockpile which has been temporarily stabilized with equipment tracking.

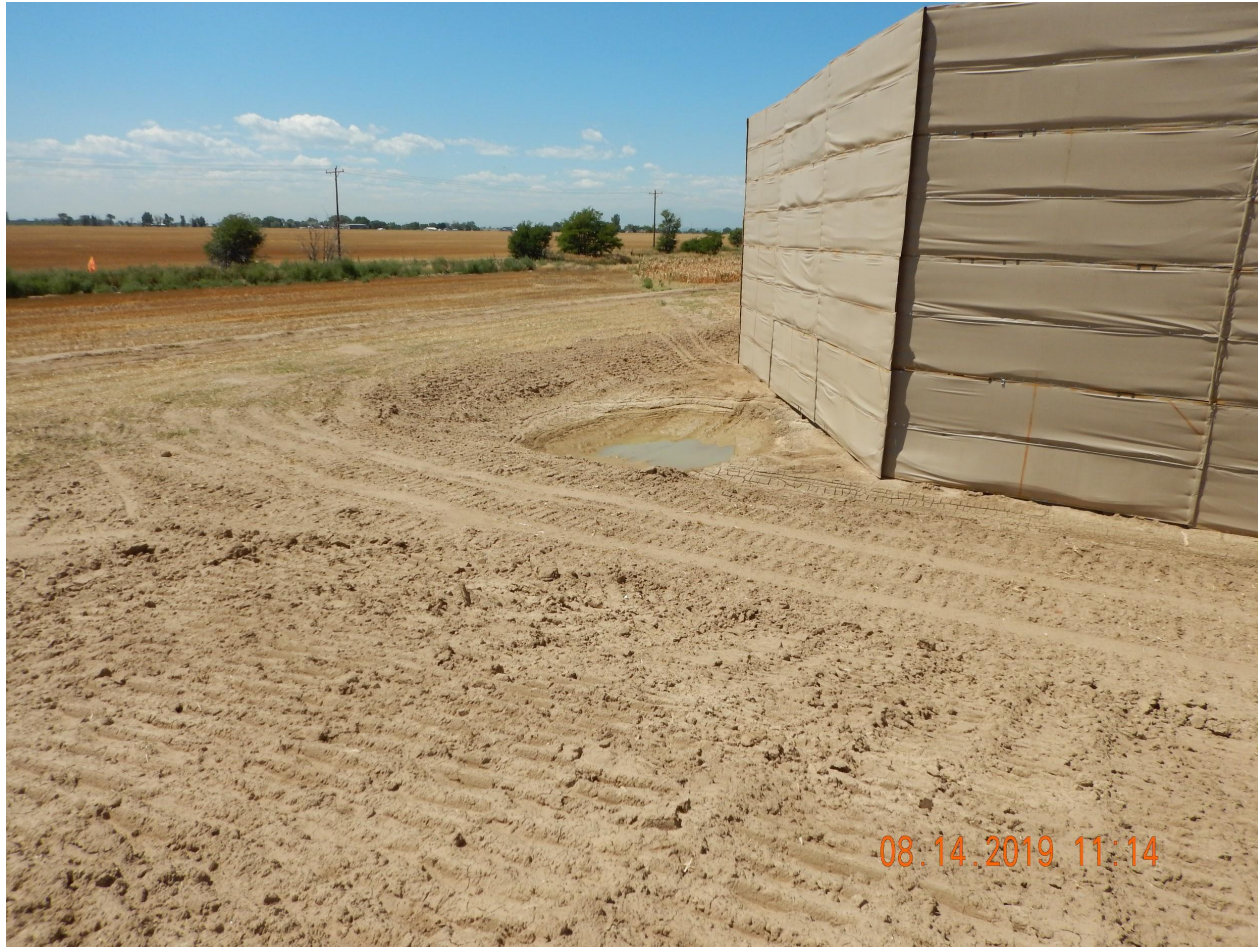
Photo 6. Photo taken from the southeastern Location, facing Southwest. Photo illustrates the well location and retention area which is all within a cut area. A ditch and berm BMP has also been installed along the outer perimeter of the location.
