# Reclamation Inspection

Operator: K P KAUFFMAN COMPANY INC - 46290

Location ID: 332971

Inspection Photos  
Location Name: HLADKY-O'GORMAN #3  
Location ID: 332971

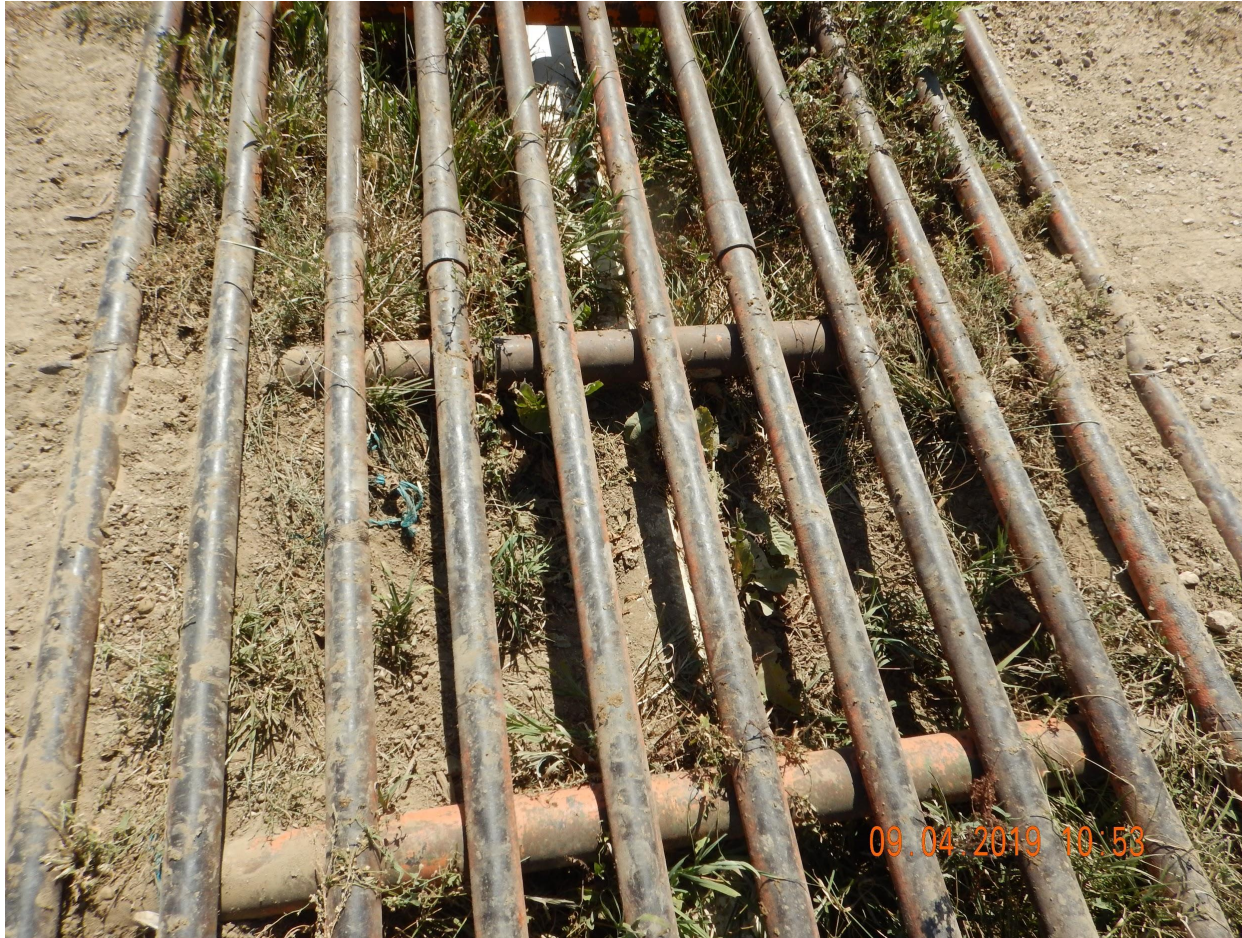
**Photo 1.** Photo taken from the entrance of location. Photo illustrates maintenance needed on cattle guard; this current condition is not keeping cattle out of the oil and gas location.

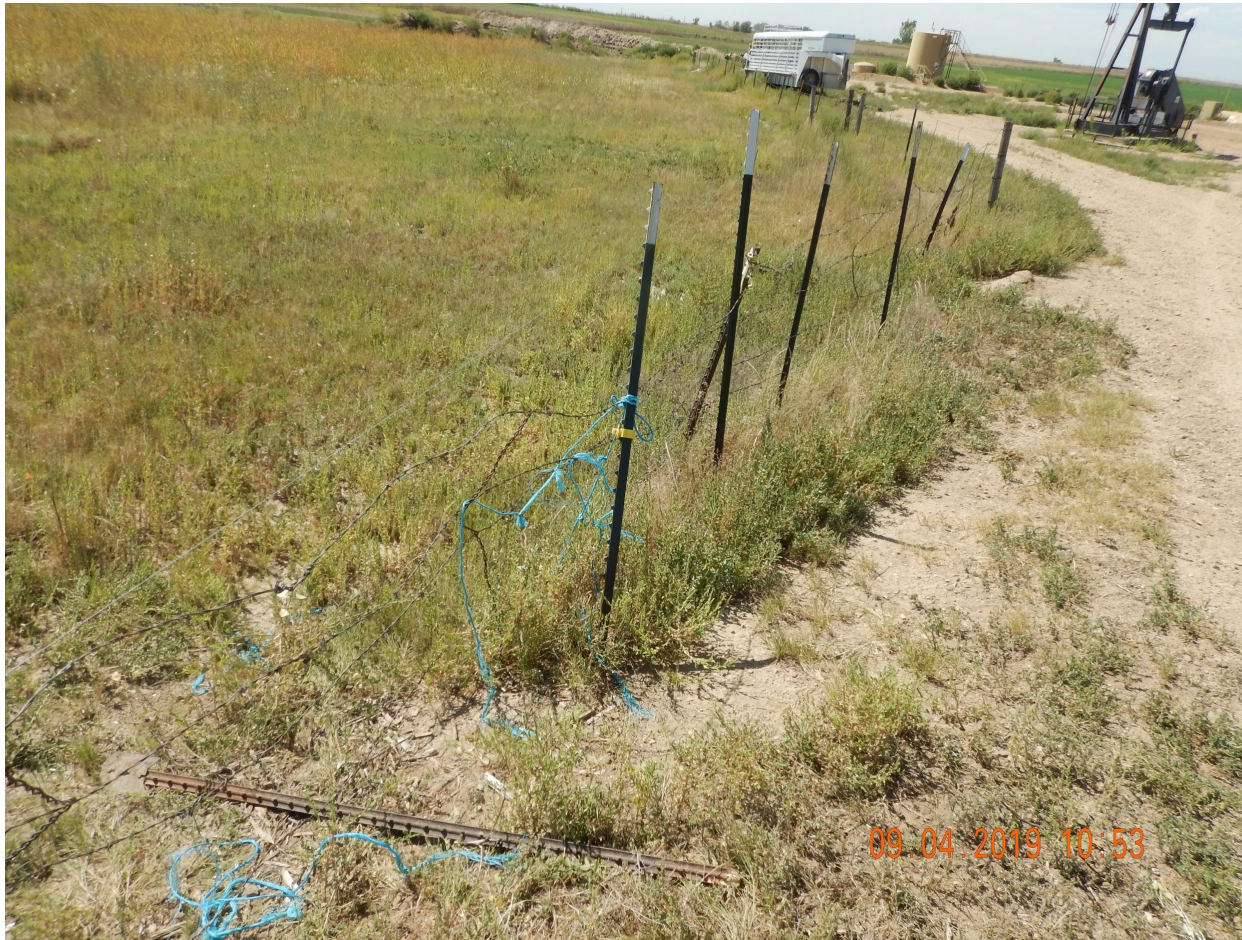
**Photo 2.** Photo taken from the entrance of the location, facing Southwest. Photo illustrates the perimeter fence is in disrepair; this current condition is not keeping cattle out of the oil and gas location. Surface owner currently has a temporary hotwire around the perimeter fence to keep cattle out of the oil and gas location.

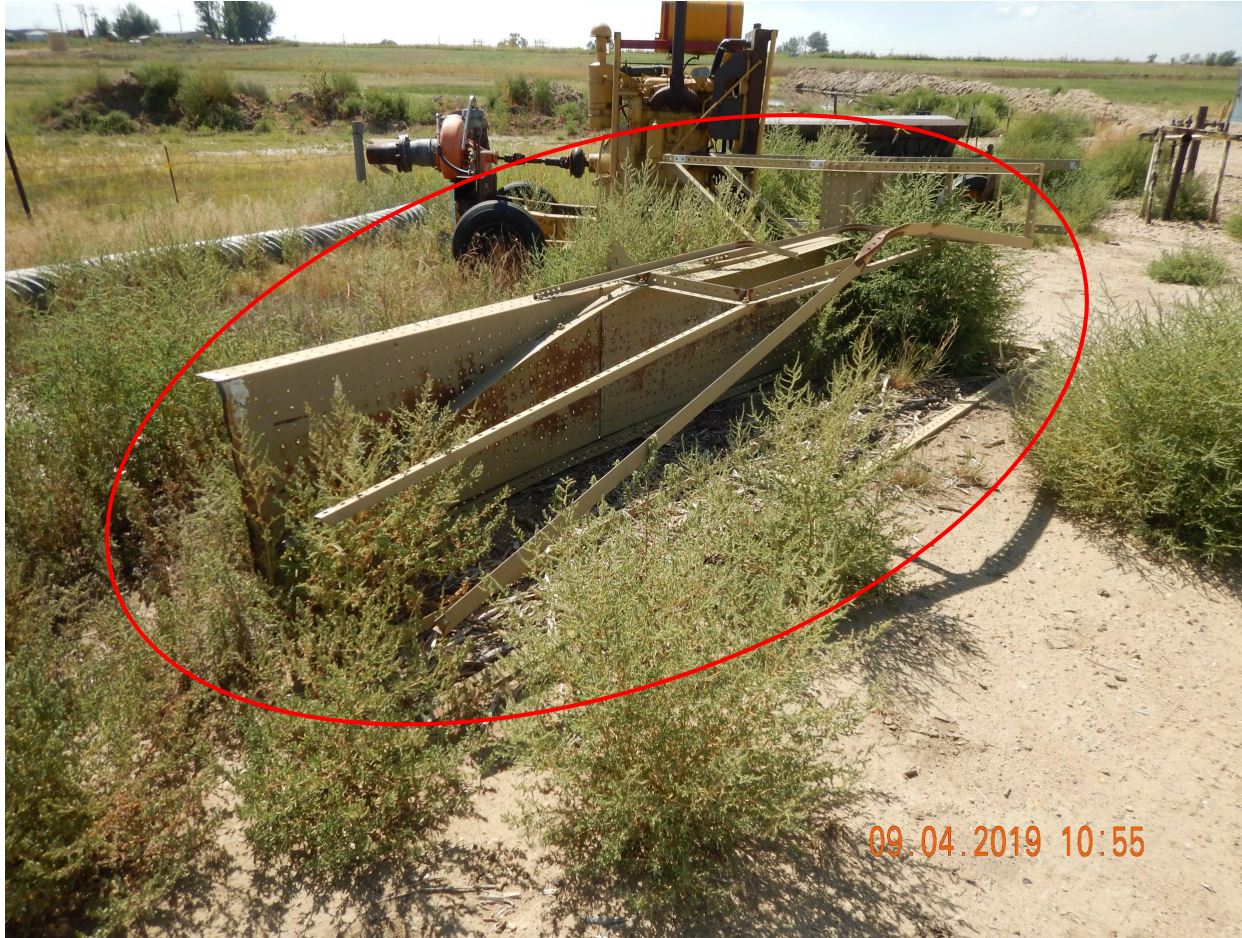
**Photo 3.** Photo taken from the eastern location, facing South. Photo illustrates unused equipment. Operator will have to coordinate with the surface owner to remove surface owner equipment to perform weed maintenance and fence repairs.

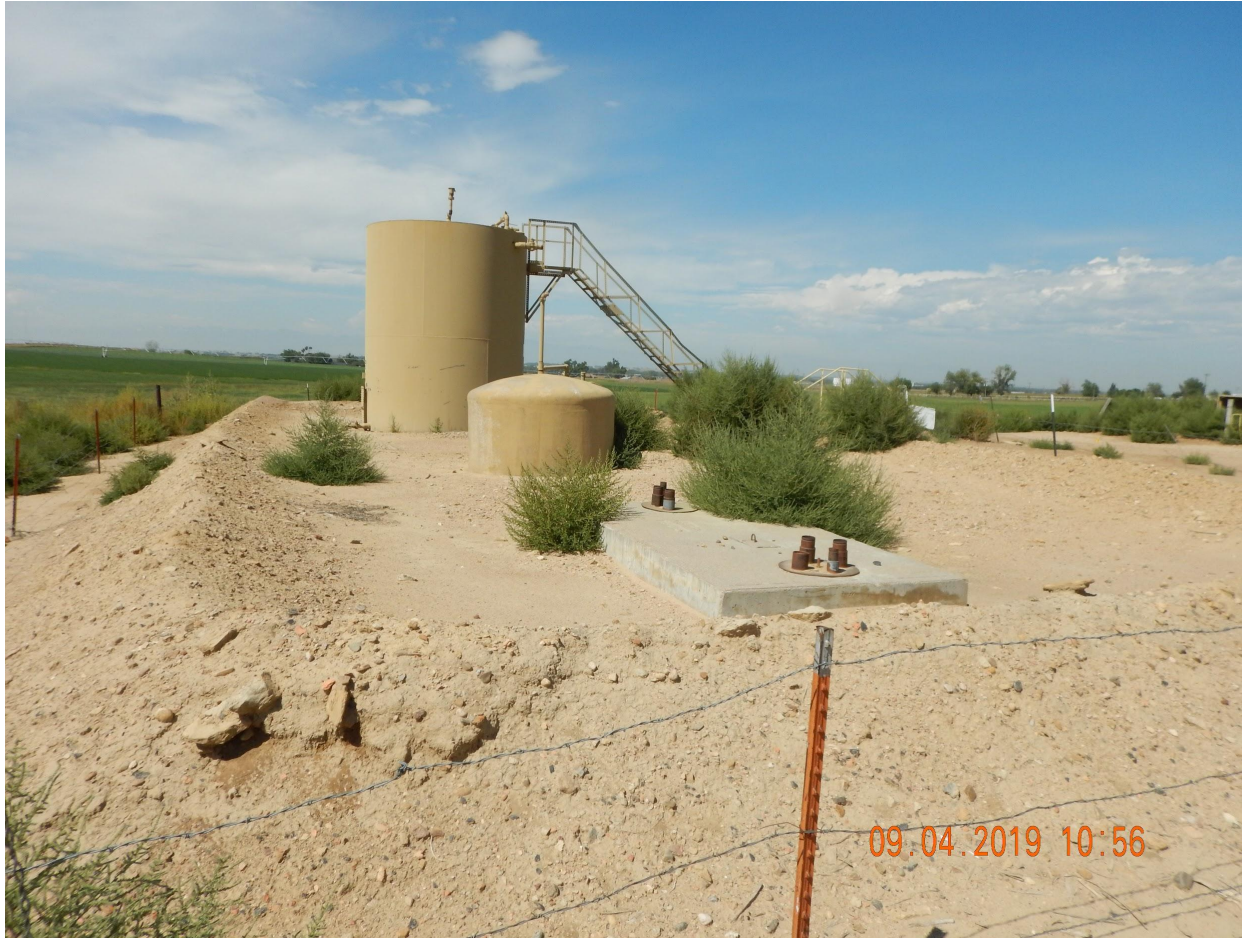
**Photo 4.** Photo taken from the southeastern location, facing West. Photo illustrates unmanaged weeds.

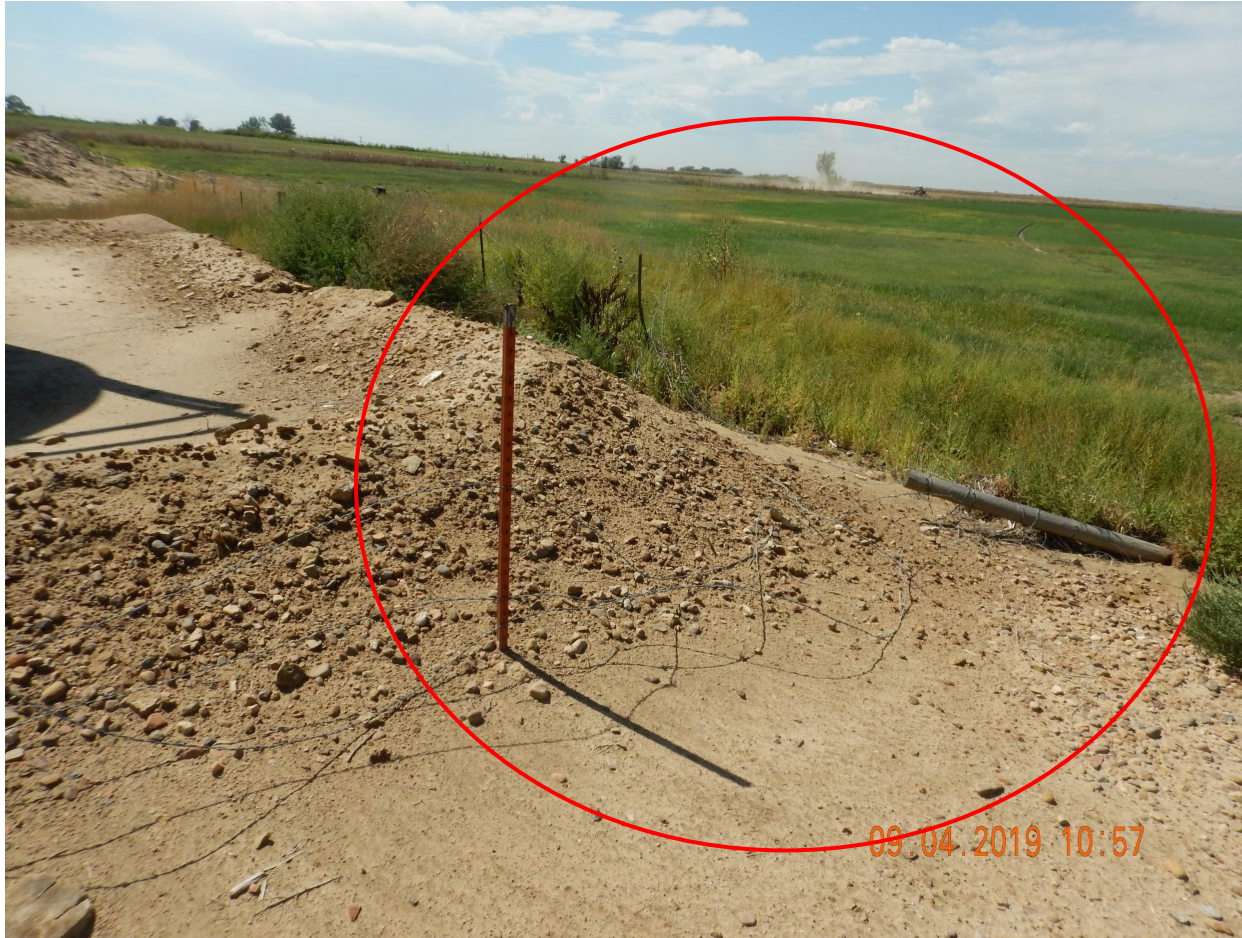
**Photo 5.** Photo taken from the southwestern location, facing Southwest. Photo illustrates fence in disrepair; this current condition is not keeping cattle out of the oil and gas location.

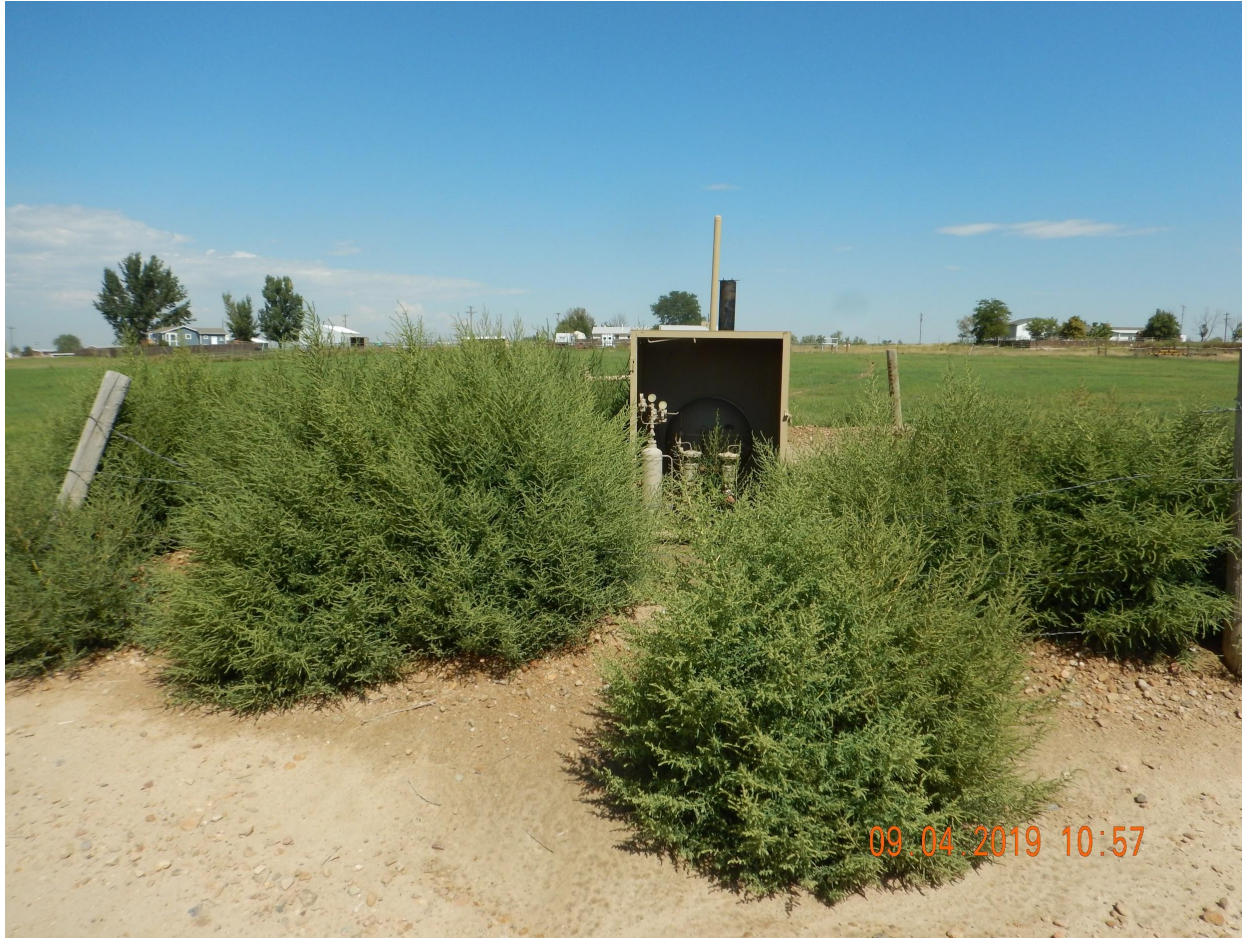
**Photo 6.** Photo taken from the western location, facing North. Photo illustrates unmanaged weeds. Also, fence around the equipment is in disrepair.
