Reclamation Inspection

Operator: K P KAUFFMAN COMPANY INC - 46290

Location ID: 311331

Inspection Photos
Location Name: HLADKY-O'GORMAN #4
Location ID: 332971

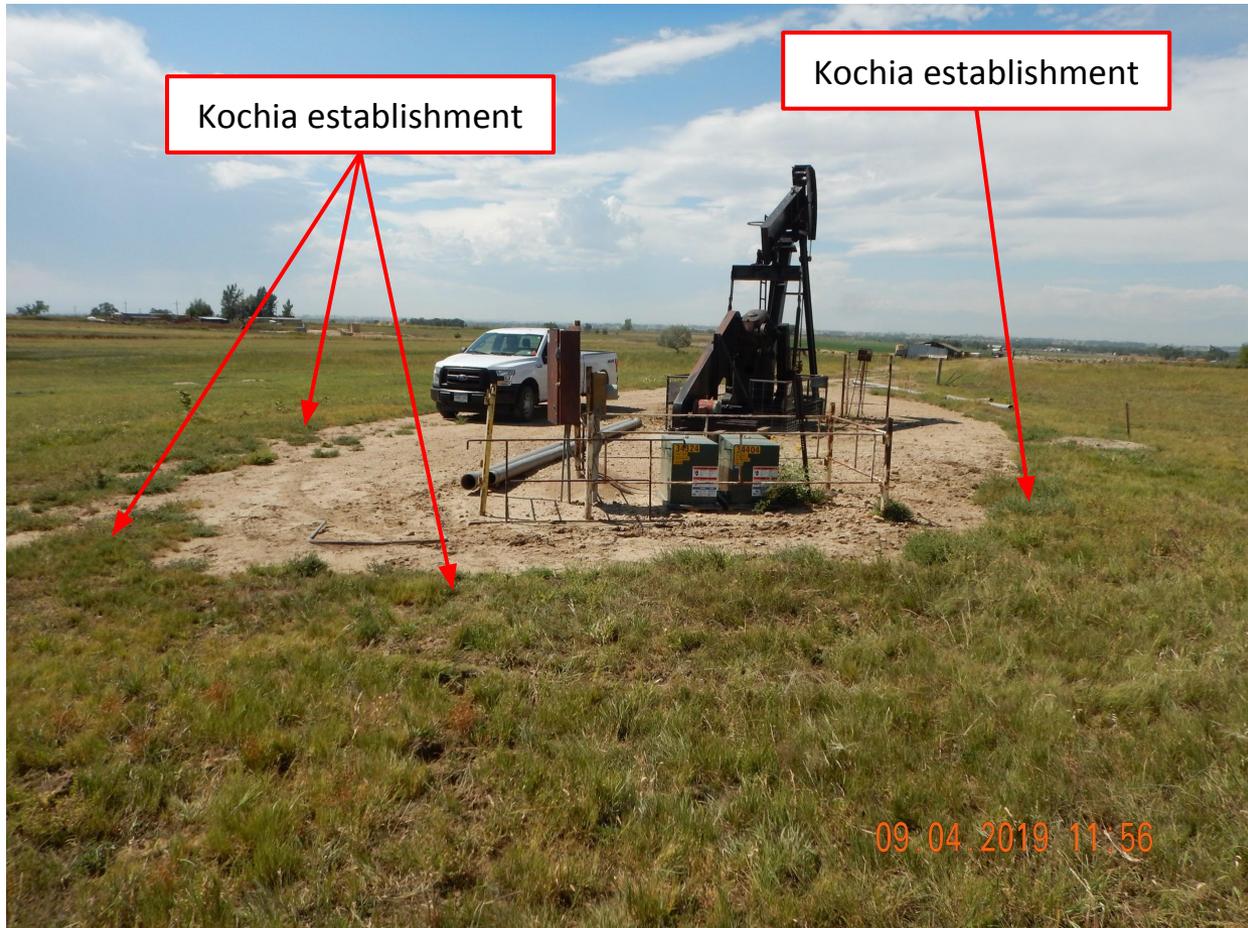
Photo 1. Photo taken from the eastern location, facing West. Photo illustrates Kochia establishment (darker green vegetation) along the perimeter of the location. Operator shall perform revegetation activities to comply with Rule 1003 standards.

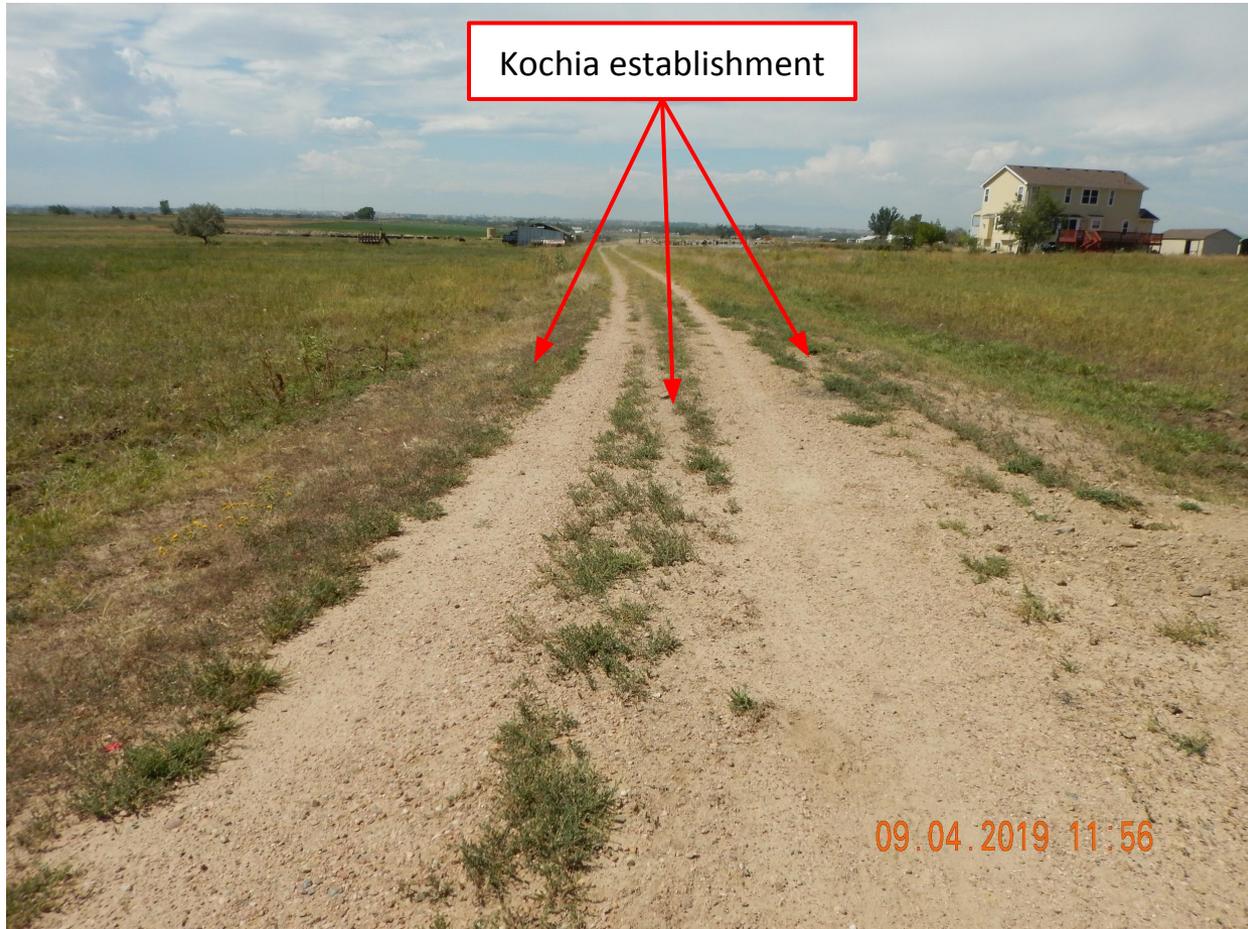
Photo 2. Photo taken from the location, facing West along the access road. Photo illustrates Kochia establishment (darker green vegetation) along the access road. Operator shall perform revegetation activities to comply with Rule 1003 standards.

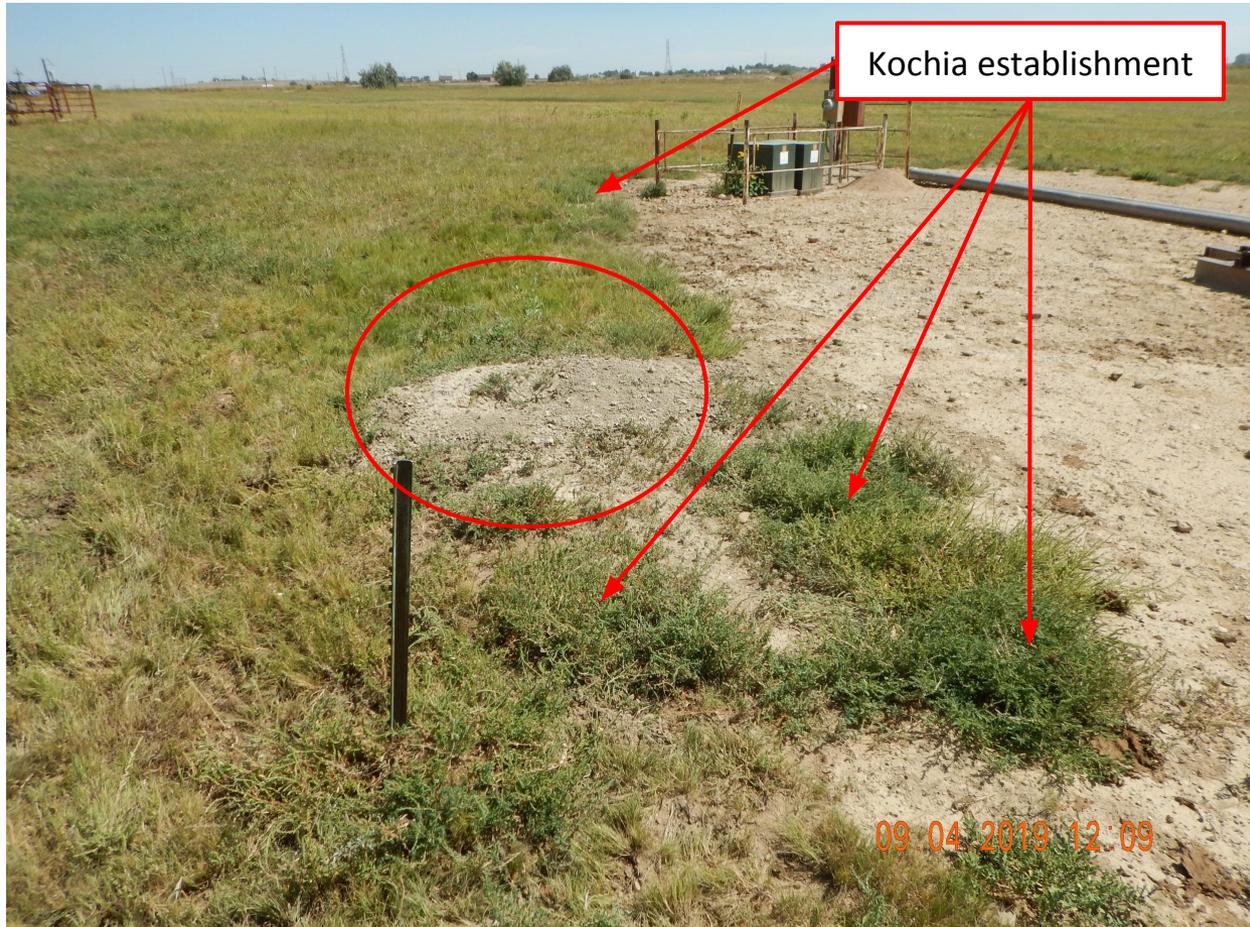
Photo 3. Photo taken from the northern location, facing East. Photo illustrates Prairie dog establishment. Operator shall control Prairie dog establishment to ensure vegetation is not impacted and meets Rule 1003 vegetation standards. Operator shall perform revegetation activities to comply with Rule 1003 standards. Photo also illustrates Kochia establishment (darker green vegetation).

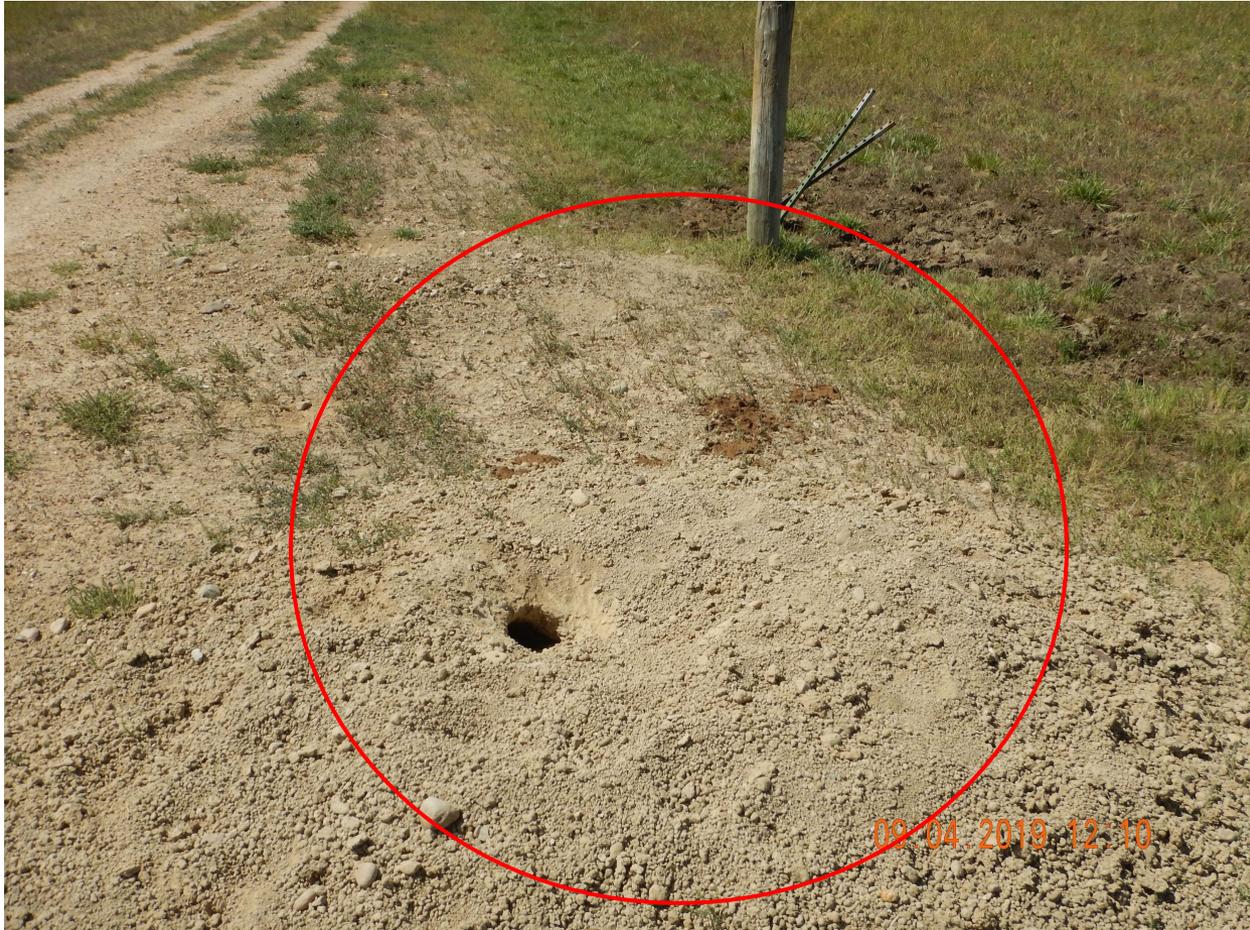
Photo 4. Photo taken from the northern location, facing West. Photo illustrates Prairie dog establishment. See comments under Photo 3.
