Inspection Photos

Operator: FOUNDATION ENERGY
MANAGEMENT LLC # 10112

Location ID: 455471
Weld County, CO

Aaron Trujillo
NE Reclamation Specialist
COGCC

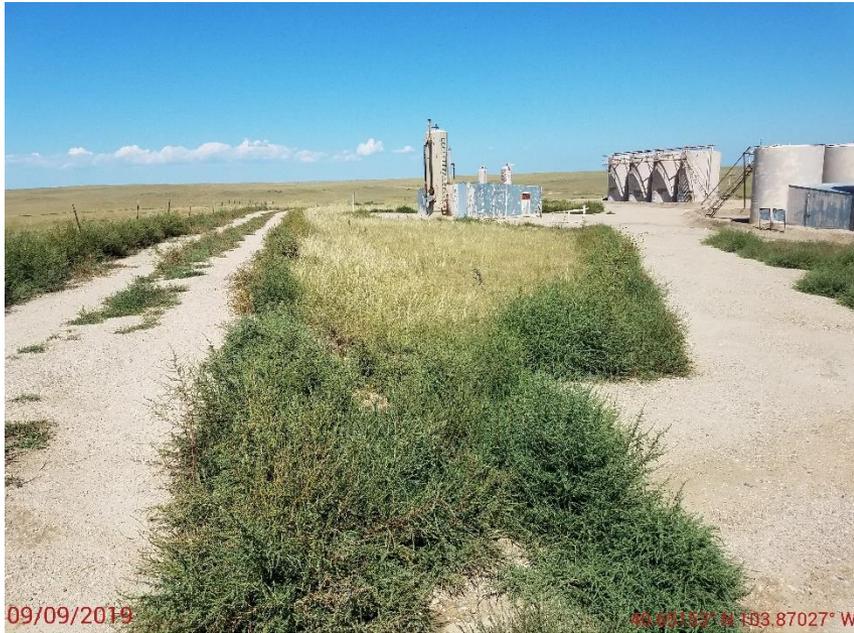
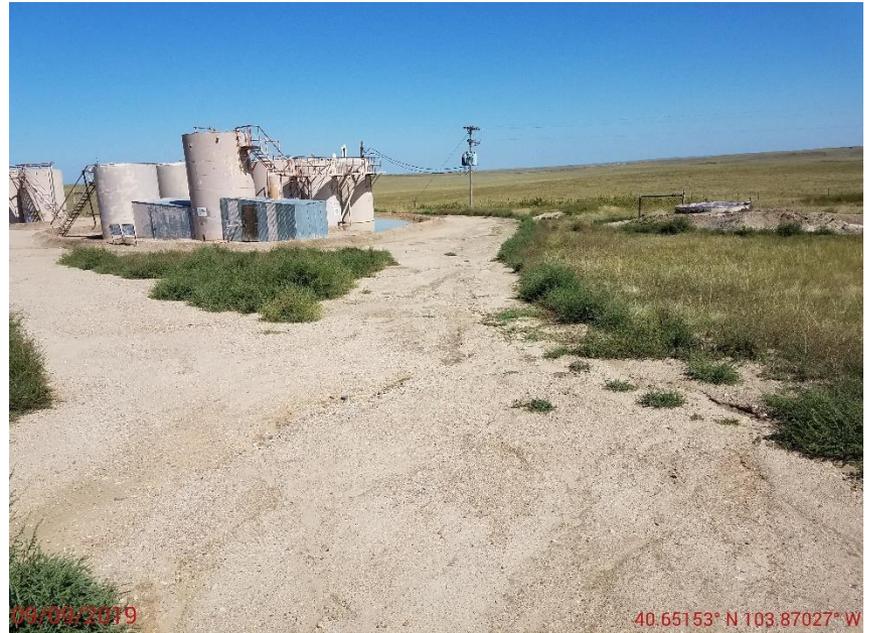
Photo 1: Photo taken from the southwest end of the location, facing north. Photo 1-2 provide an overview of the location.

Photo 2: See comments under photo 1

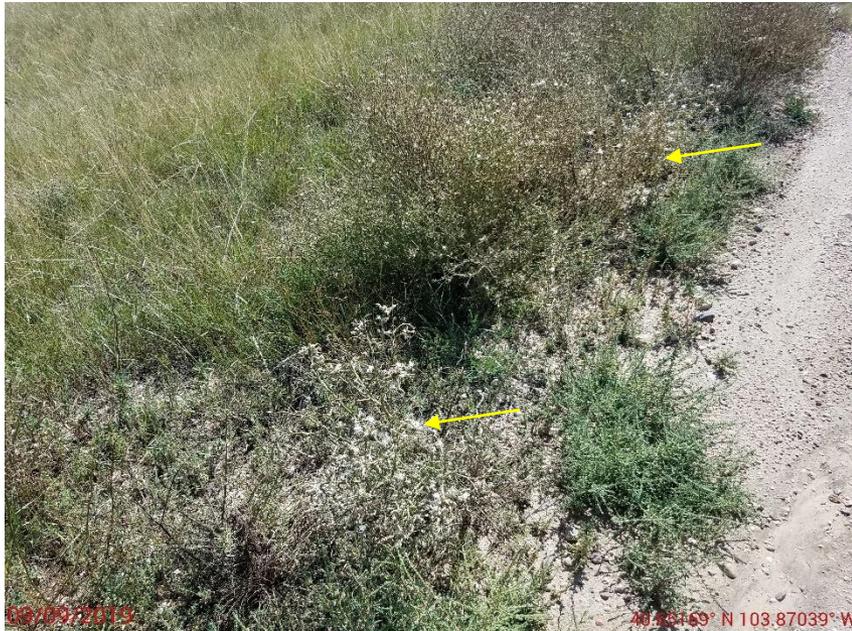
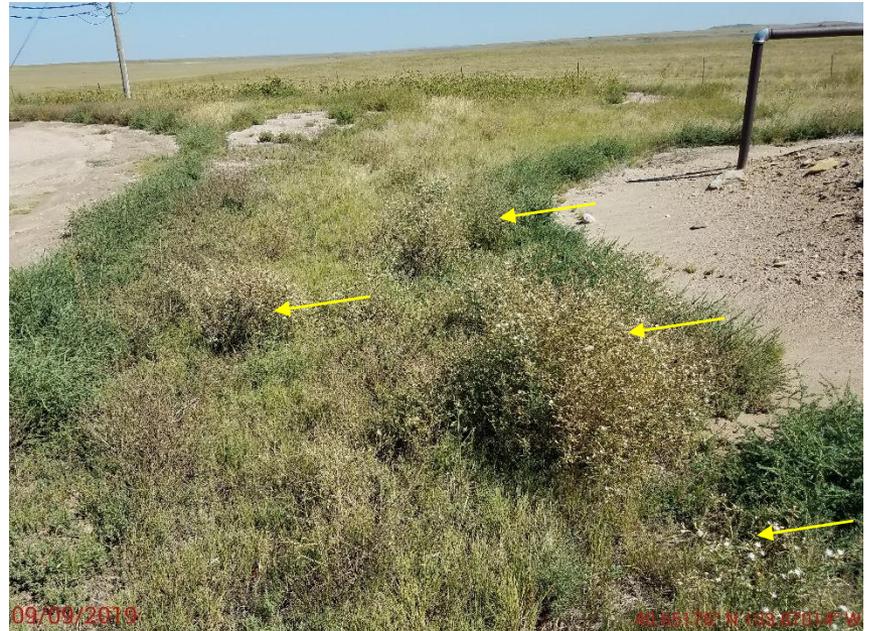
Photo 3: Photo shows noxious weeds (Diffuse Knapweed) remaining on location.

Photo 4: See comments under photo 3

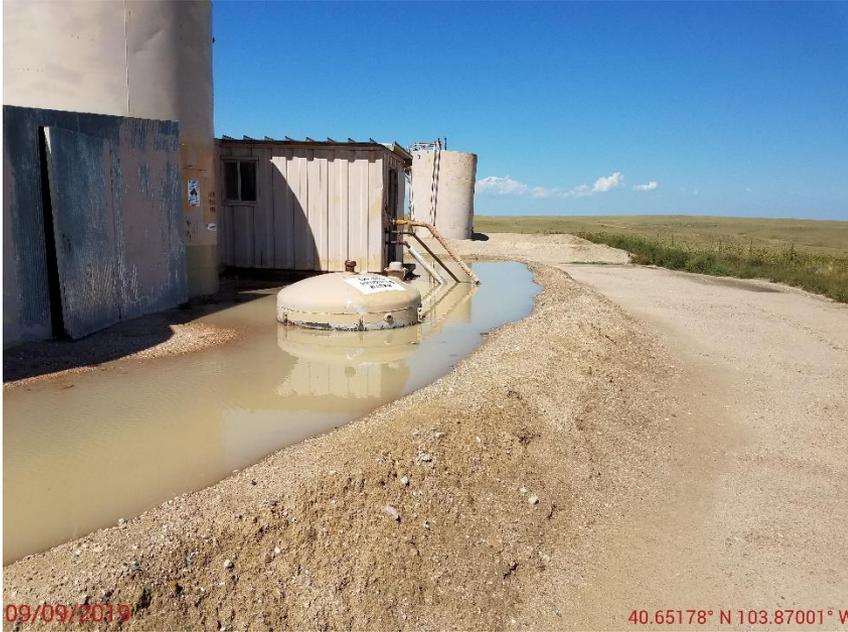
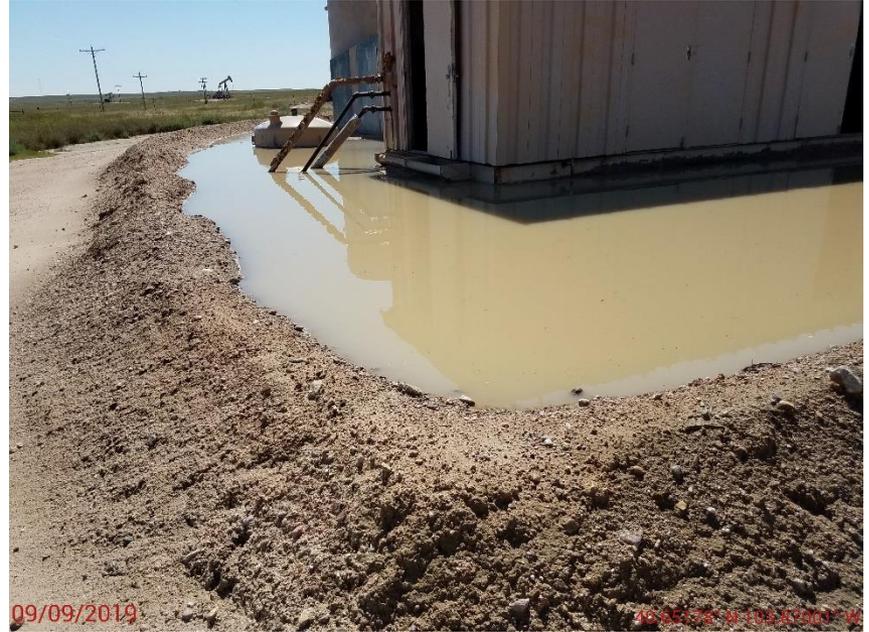
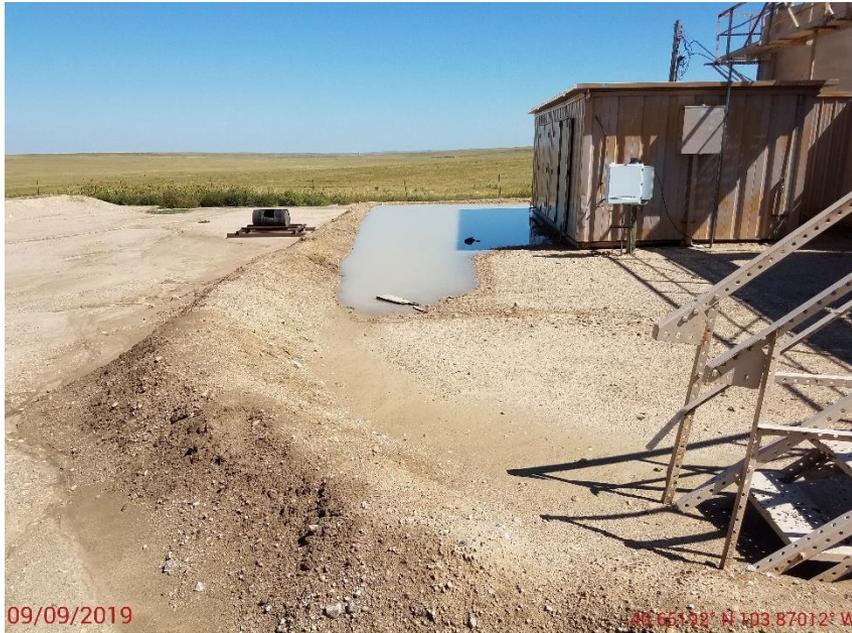
Photo 5: Photo taken from the east end of the tanks on the southeast end of the location. Photo shows secondary containment does not appear to be sufficient to contain the contents of the largest single tank and sufficient freeboard to contain precipitation.

Photo 6: See comments under photo 5.

Photo 7: See comments under photo 5.

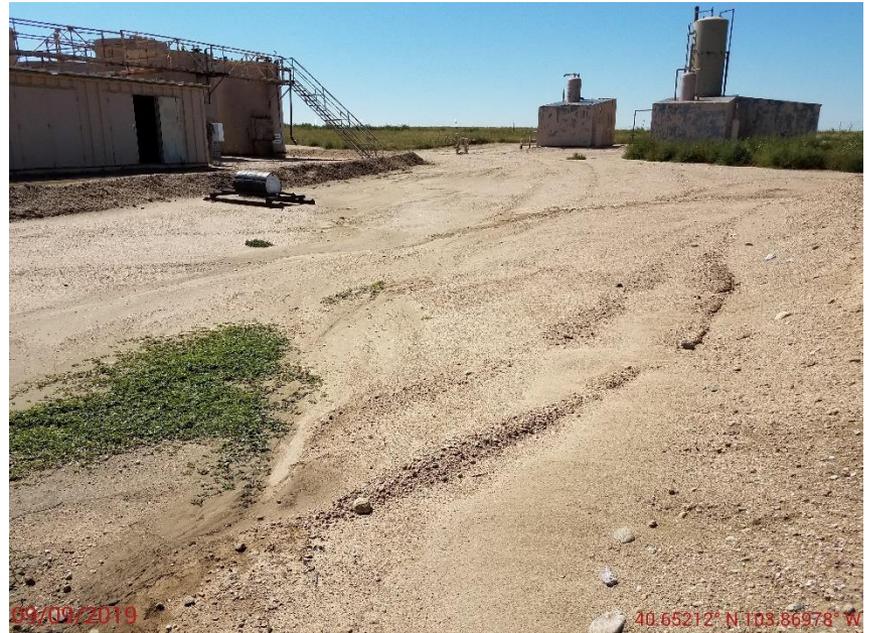
Photo 8: Photo taken from the east central area of the location, facing southwest. Photo shows stormwater erosion degradation on location.

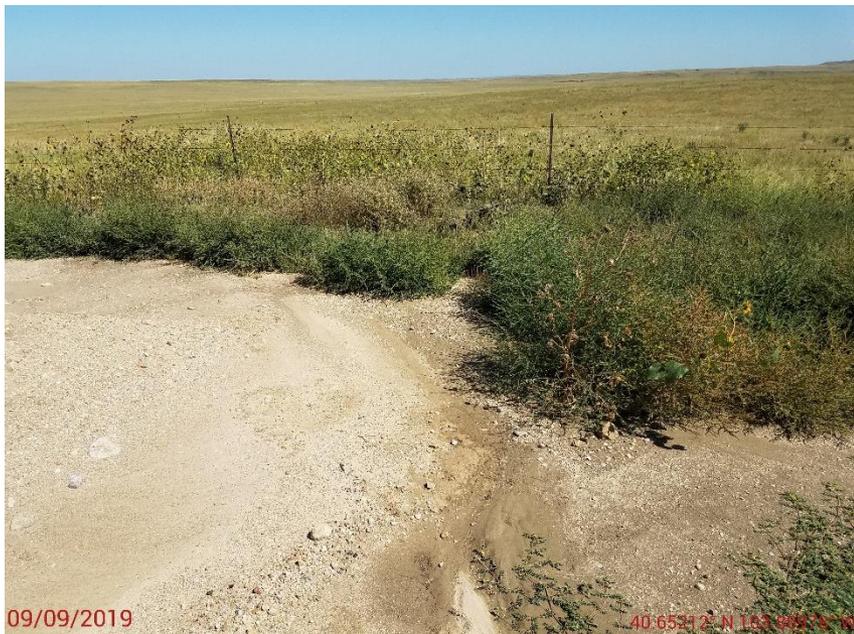
Photo 9: Photo taken from the east end of the location. Photo shows area where stormwater from the location runs off onto the adjacent lands

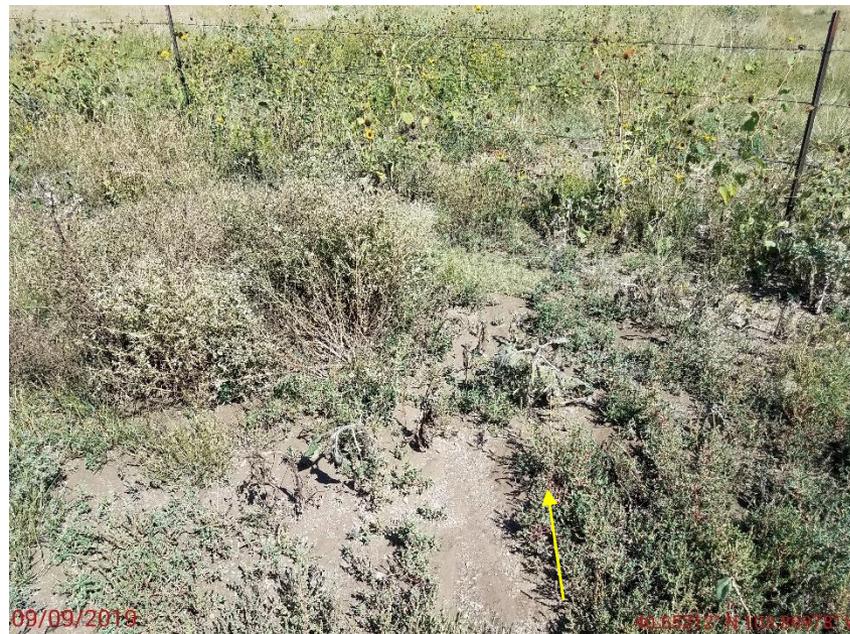
Photo 10: Continued from photo 9. Photo shows sediment deposition from stormwater runoff on adjacent lands.

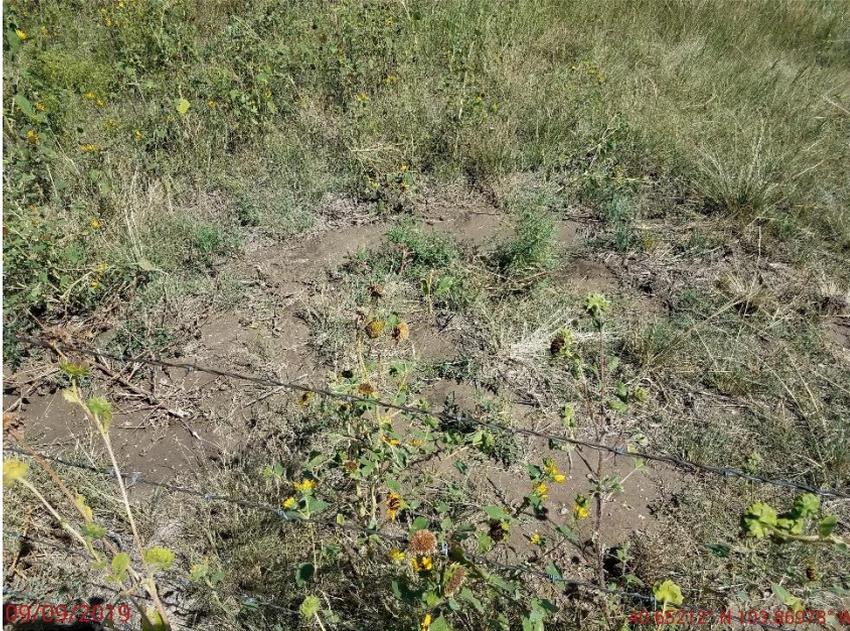
Photo 11: Continued from photo 9. Photo shows sediment deposition from stormwater runoff on adjacent lands.

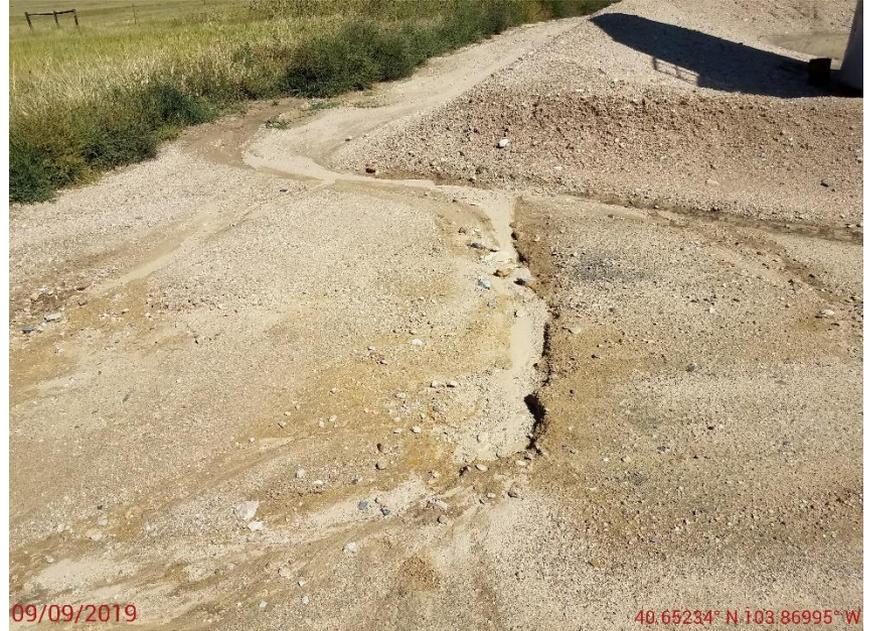
Photo 12: Photo of stormwater erosion degradation on the north end of the location.

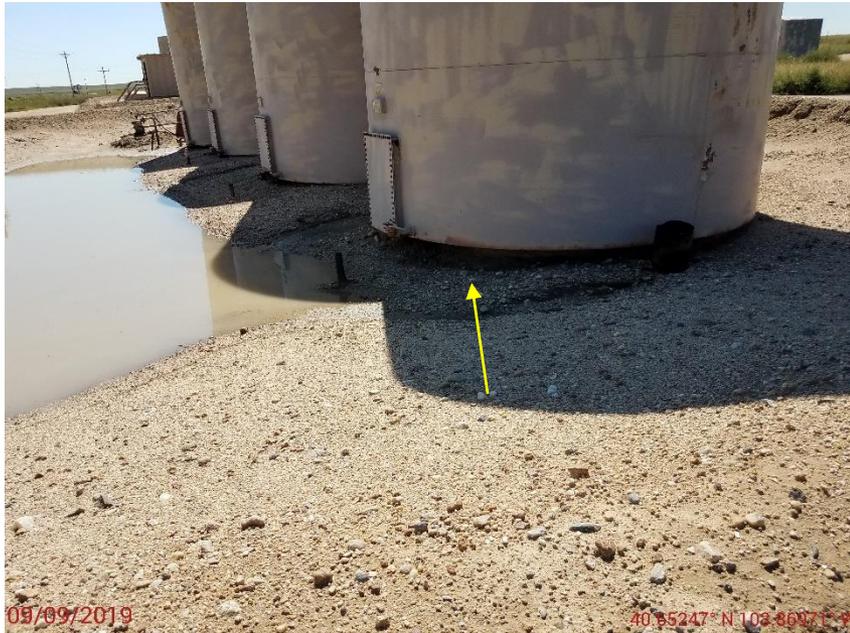
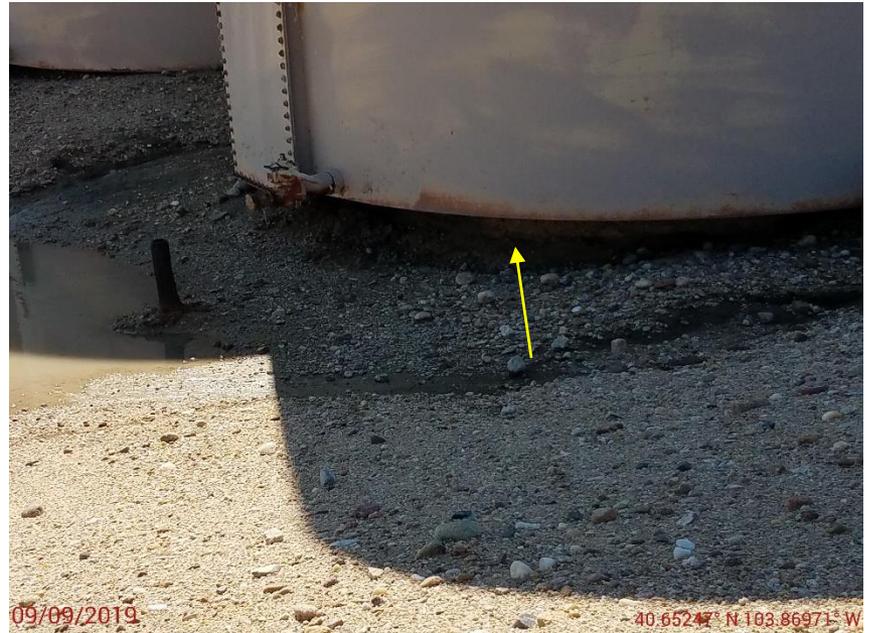
Photo 13: Photo taken from the tanks on the north end of the location. Photo shows stormwater erosion appears to be undermining the tanks.

Photo 14: Continued from photo 14.
