Inspection Photos
Operator: BP America
Location/API #: 067-09601
Date: 9-6-2019

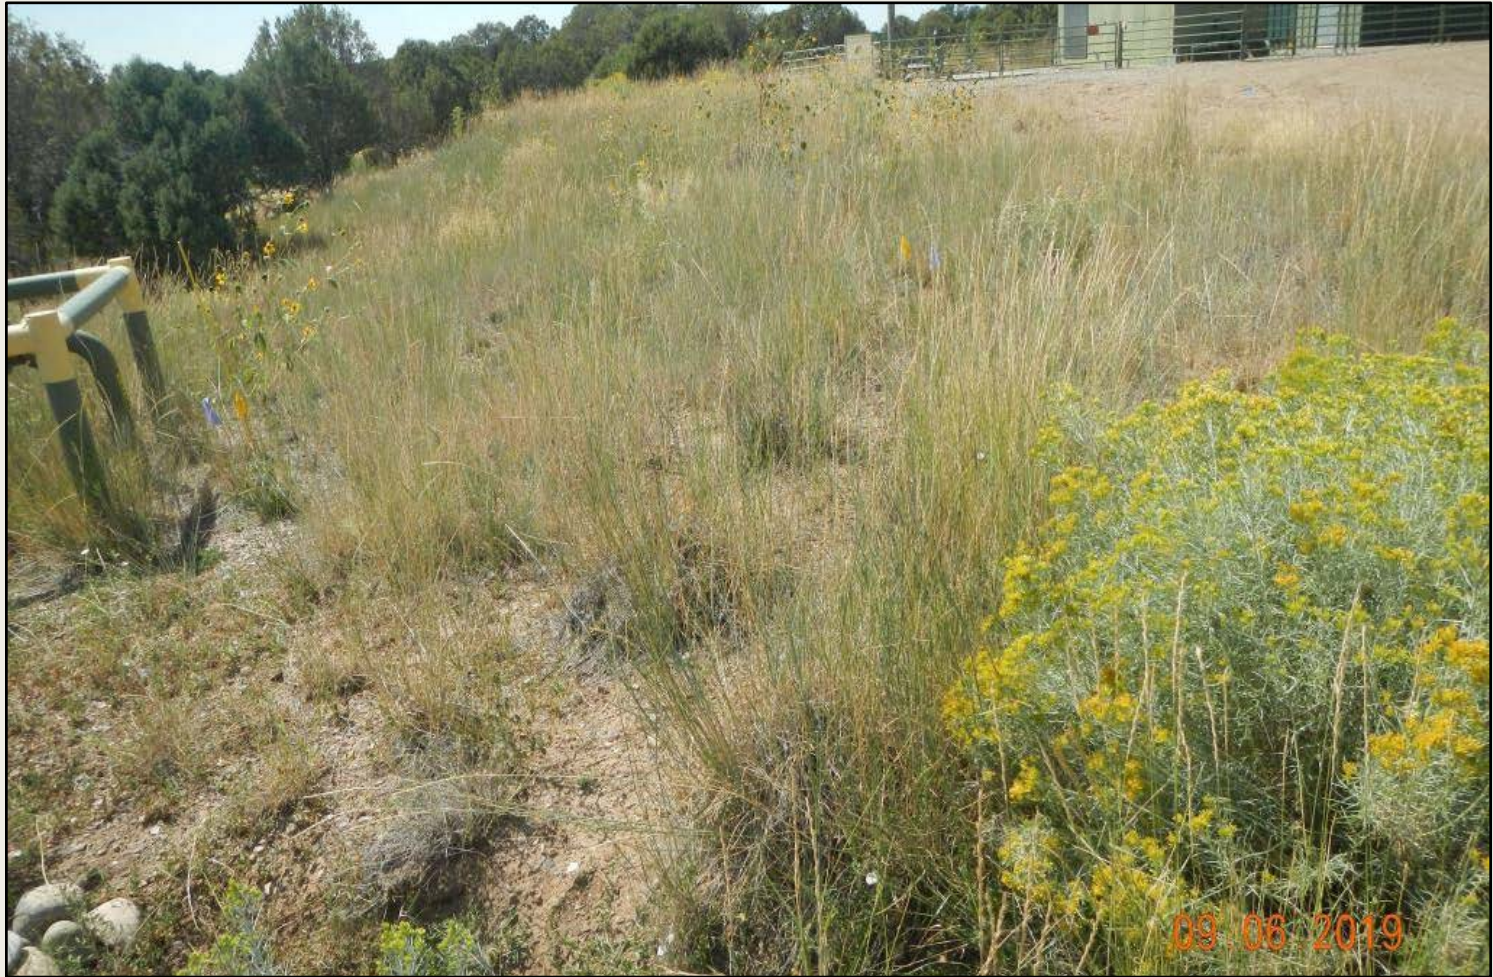
Photo 1. View of southern portion of project area from the southeastern edge facing westward. Revegetation is progressing with western wheatgrass and crested wheatgrass.

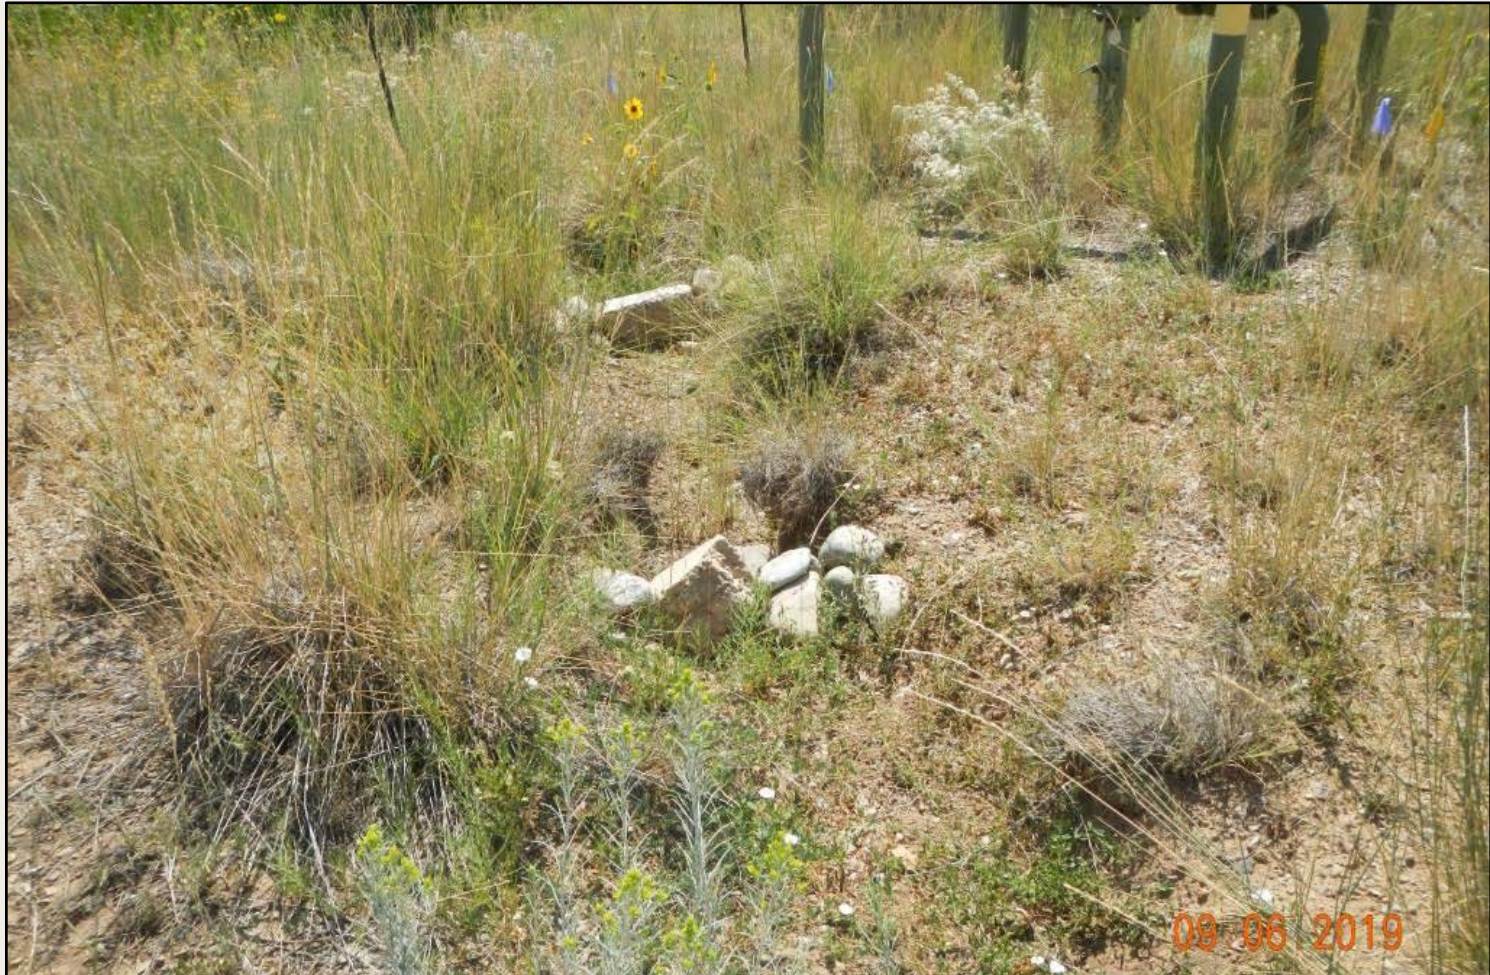
Photo 2. View of rock checks in the southern project area. These are not a sufficient stormwater BMP for this area.

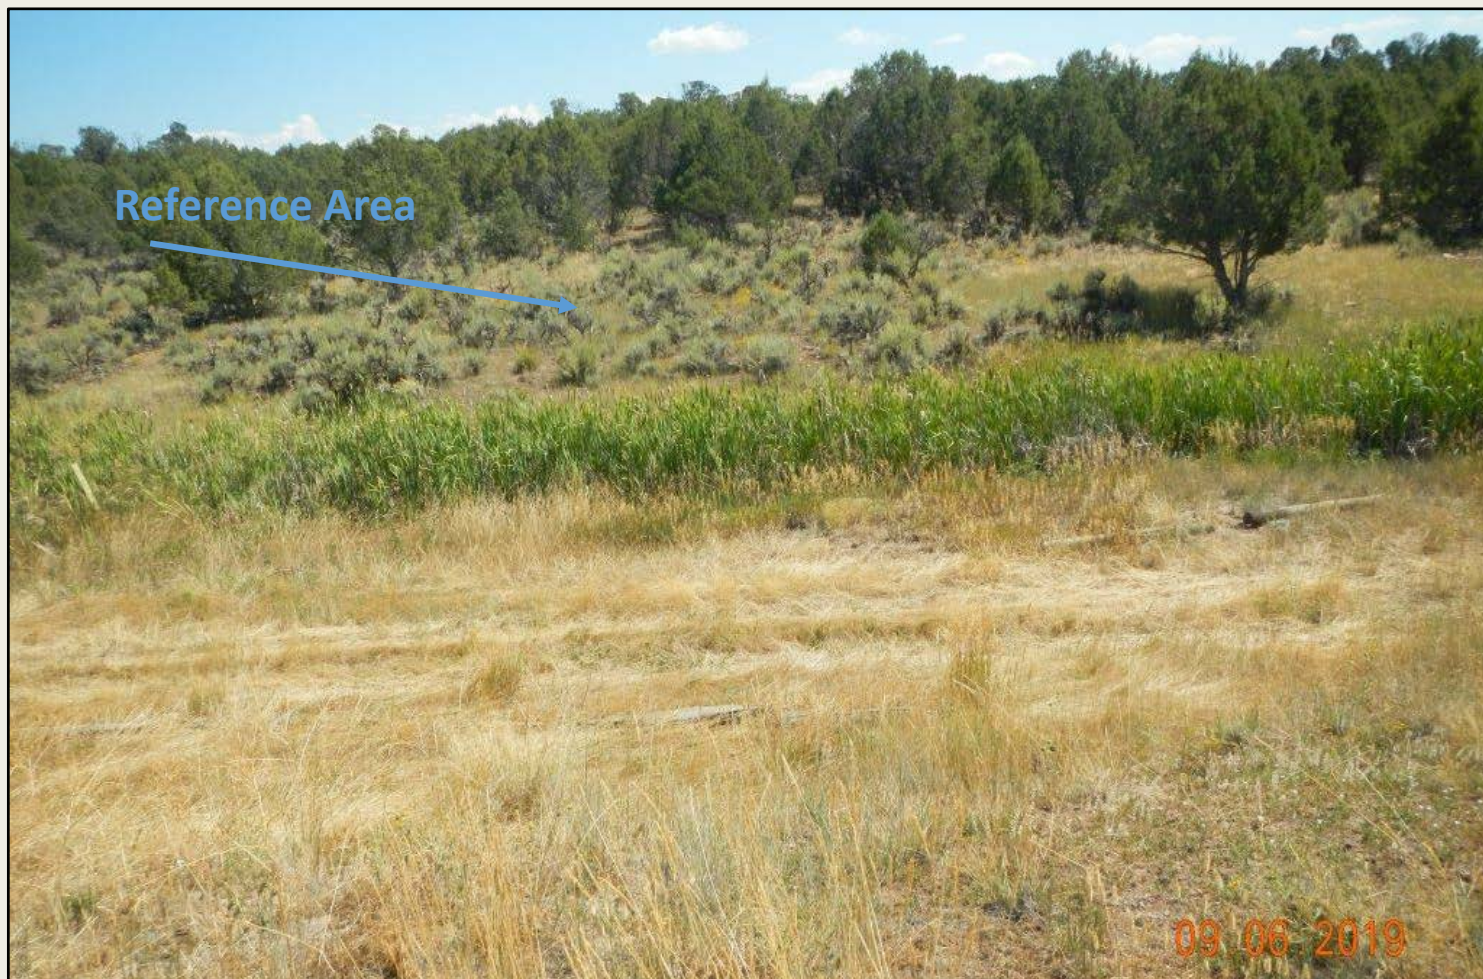
Photo 3. View of reference area (in background, past wetland vegetation. Reference area vegetation is comprised of open pinyon juniper woodland and sagebrush shrubland.
