Inspection Photos
Operator: BP America
Location/API #: 067-07741
Date: 9-10-2019

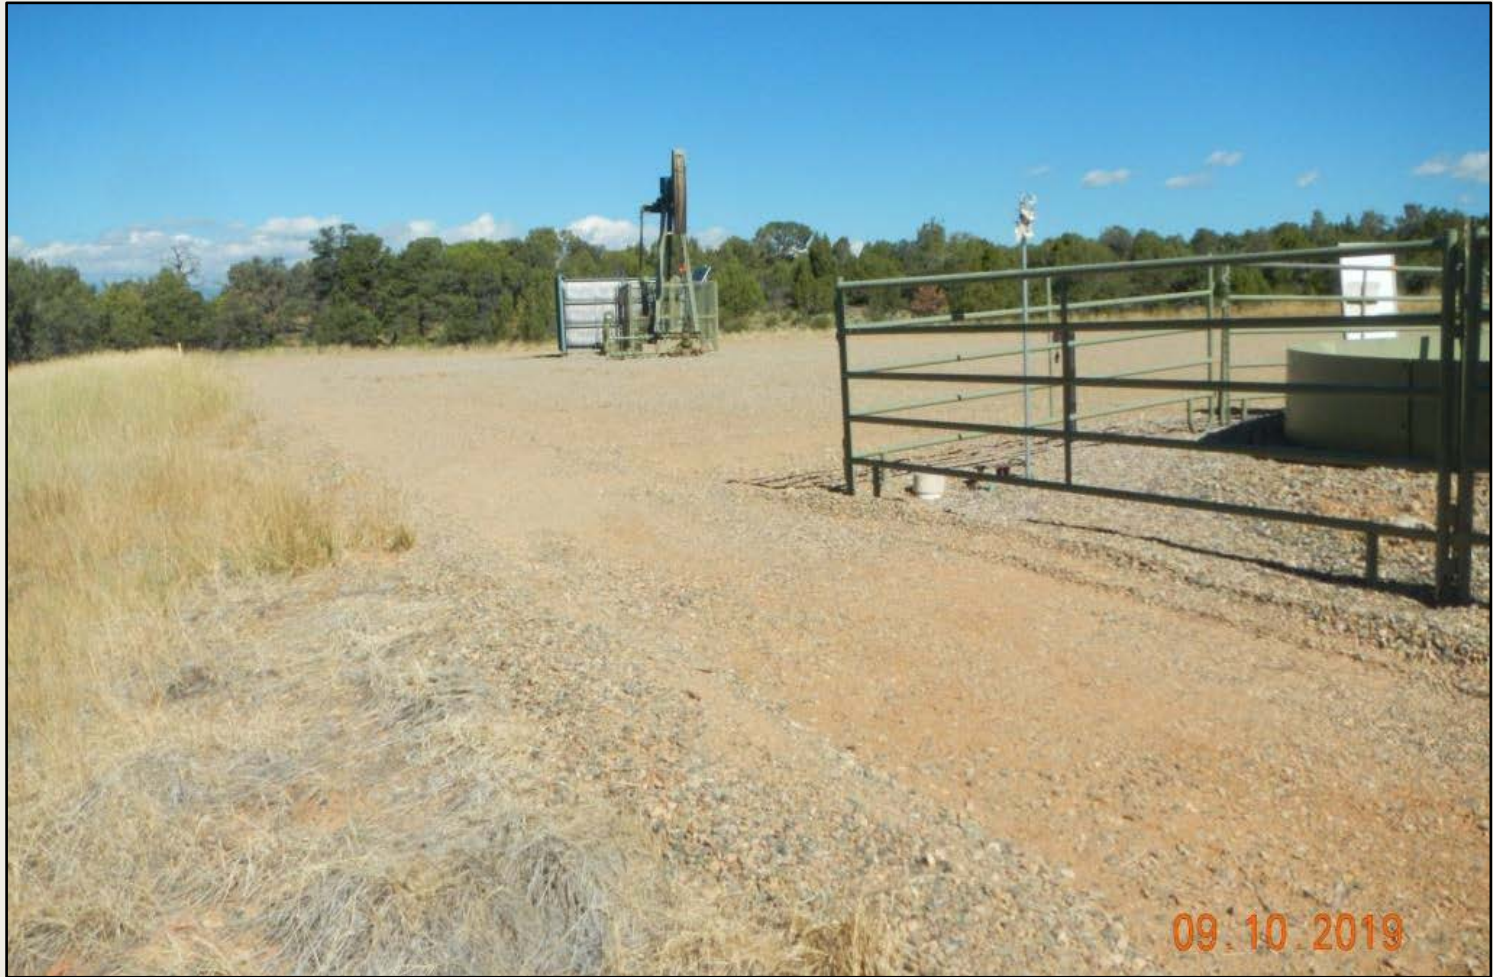
Photo 1. View of the project area from the southeastern edge facing center.

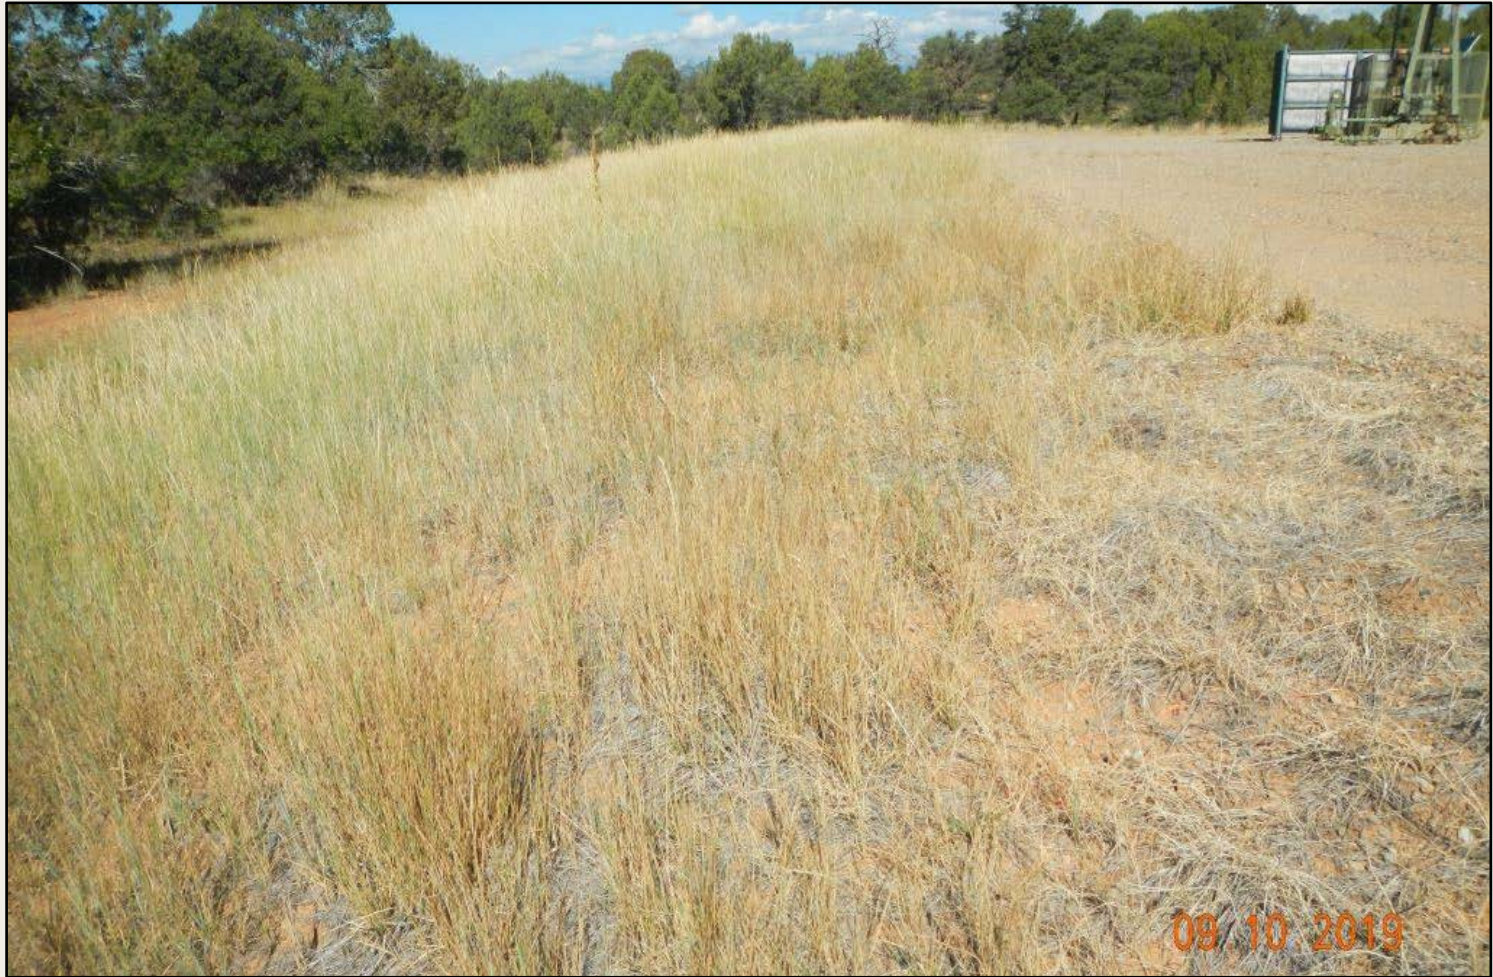
Photo 2. View of the southern fill slope from the southeastern edge facing westward. Revegetation is progressing with western wheatgrass and intermediate wheatgrass.

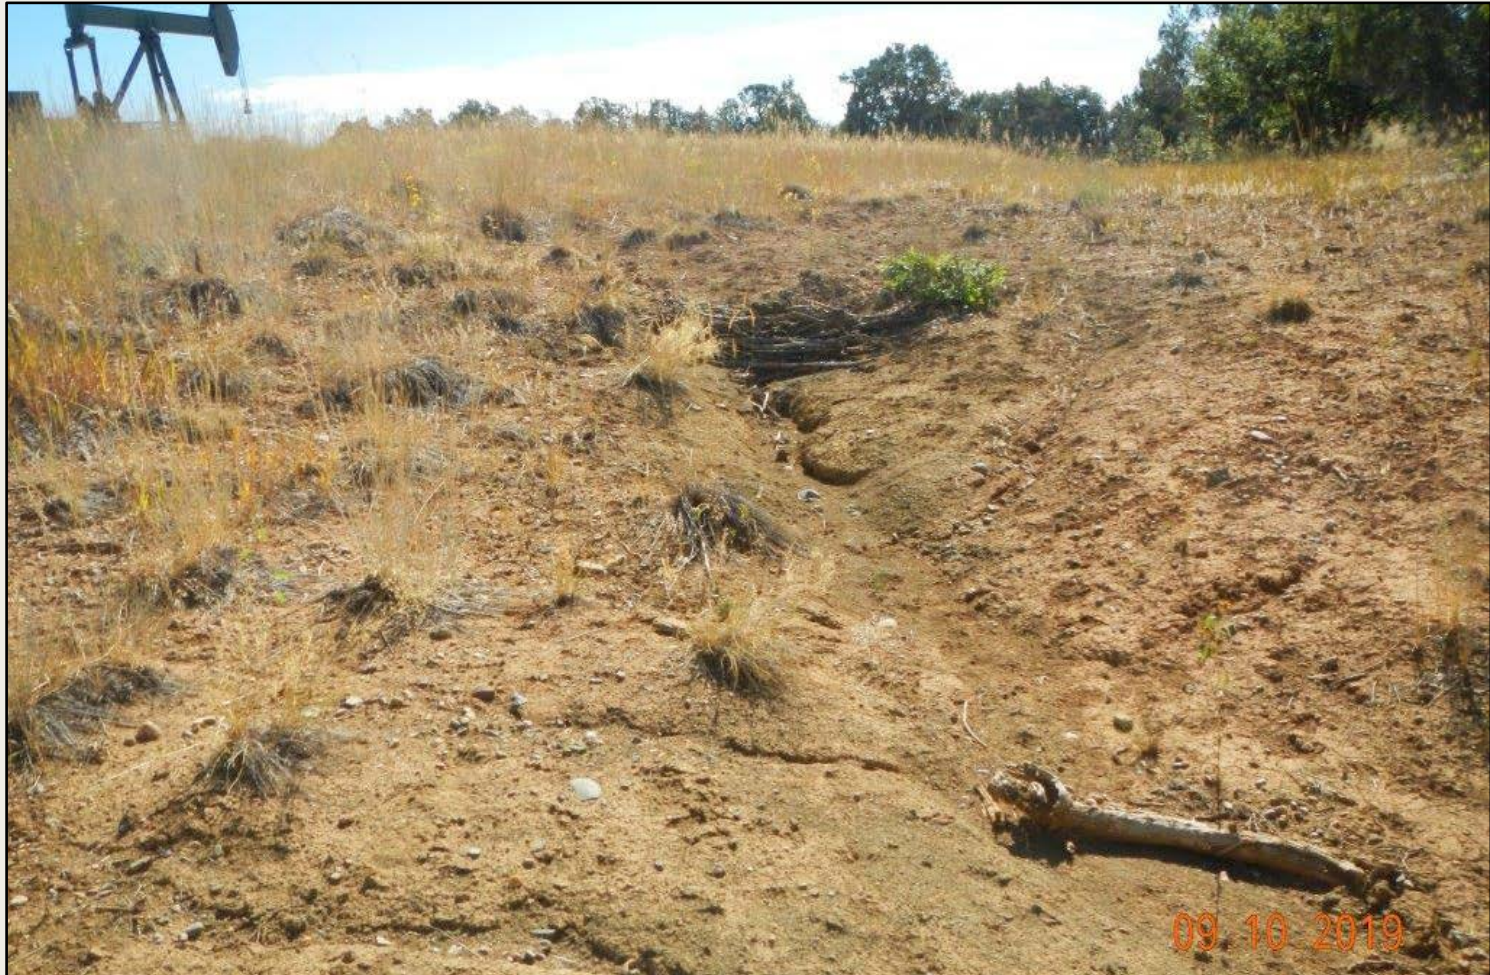
Photo 3. View of erosional channel approximately 1 foot wide and deep within the southwestern project area (facing upslope).

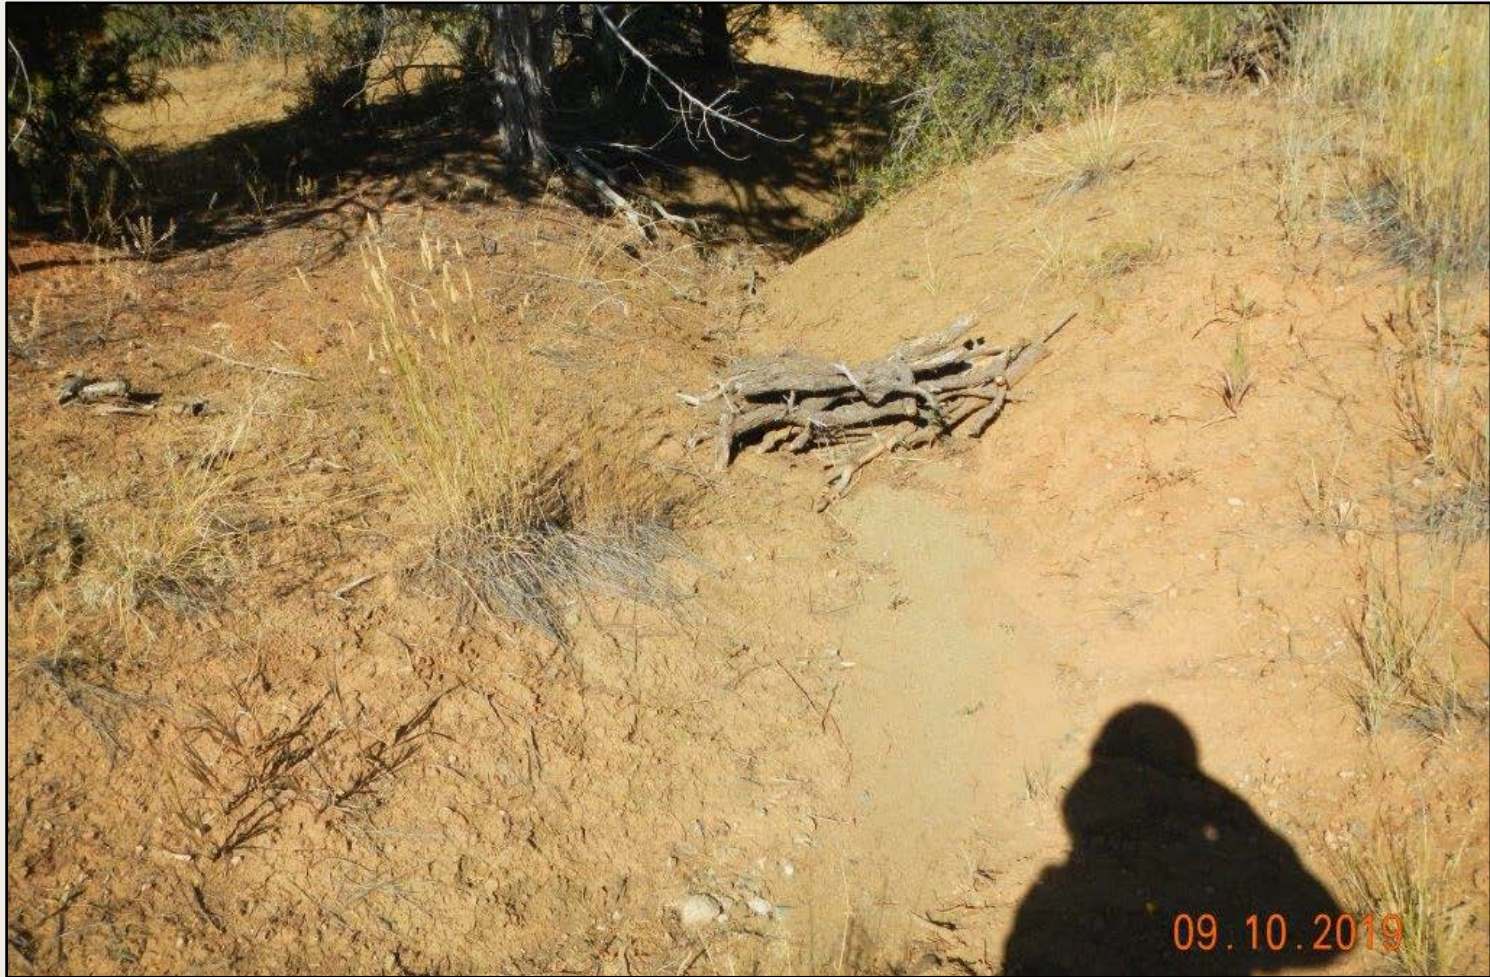
Photo 4. View of erosional channel approximately 2 feet wide and deep within the southwestern project area (facing downslope).
