Final Reclamation Inspection

Operator: PDC ENERGY INC - 69175

API: 05-123-27373

Inspection Photos
Location Name: ROTHARMEL #11-32
API: 05-123-27373

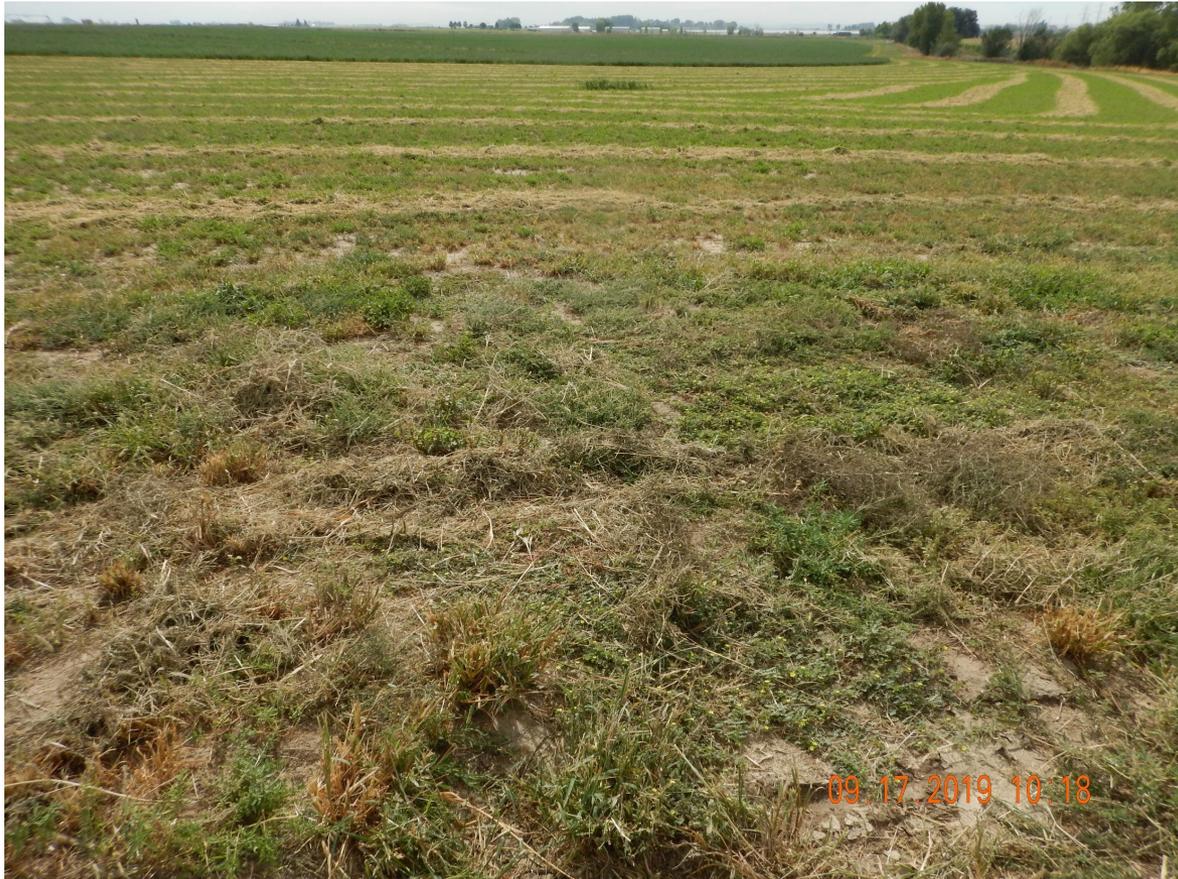
Photo 1. Photo taken from the well location, facing South. Photo illustrates the area around the well location has been recently mowed. There was a high establishment of weeds around the wellhead area.

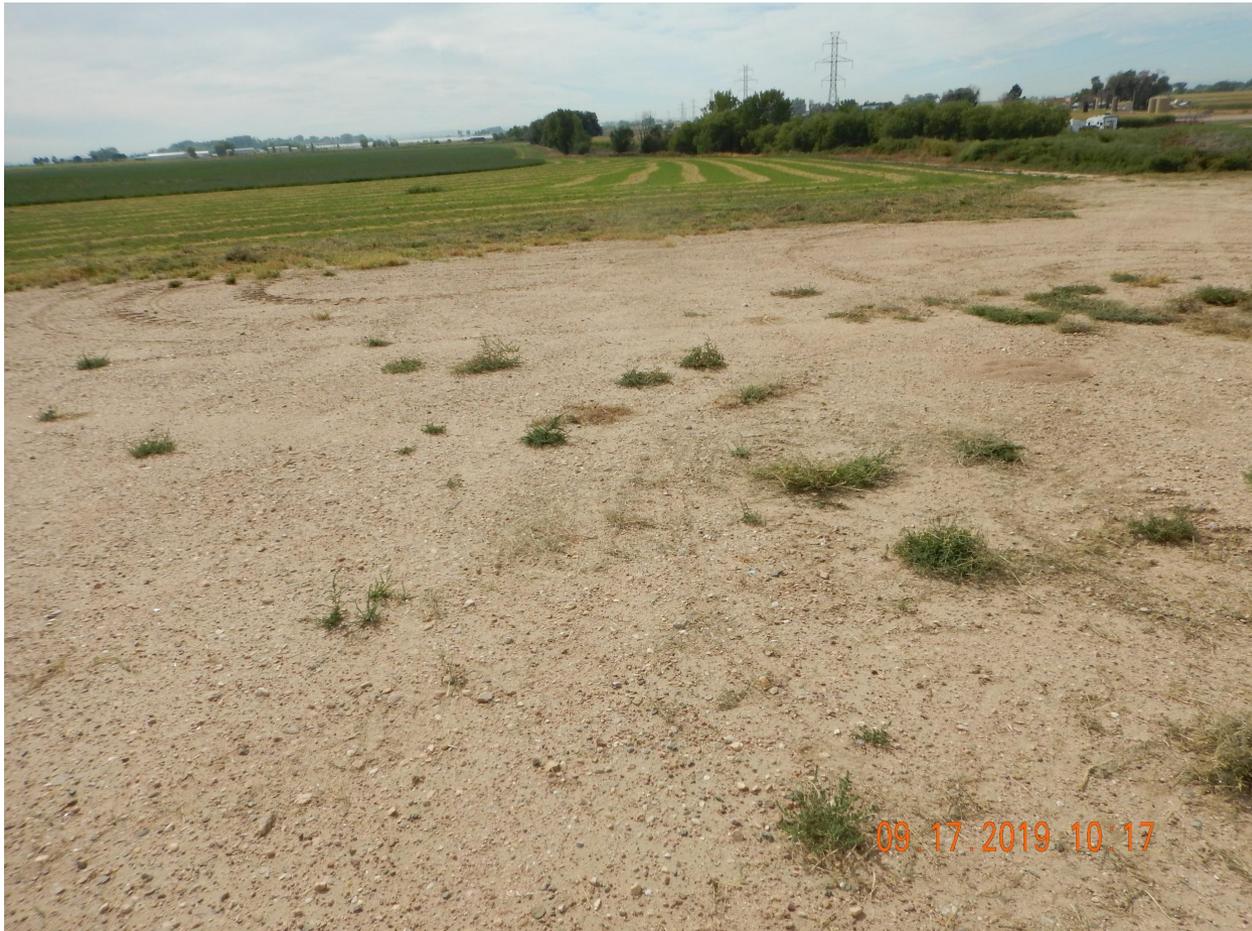
Photo 2. Photo taken from the battery location, facing South. Photo illustrates the Operator has failed to complete final reclamation activities. Note: Surface owner was at the tank battery location and indicated the desire to leave the gravel in-place for hay and equipment storage.

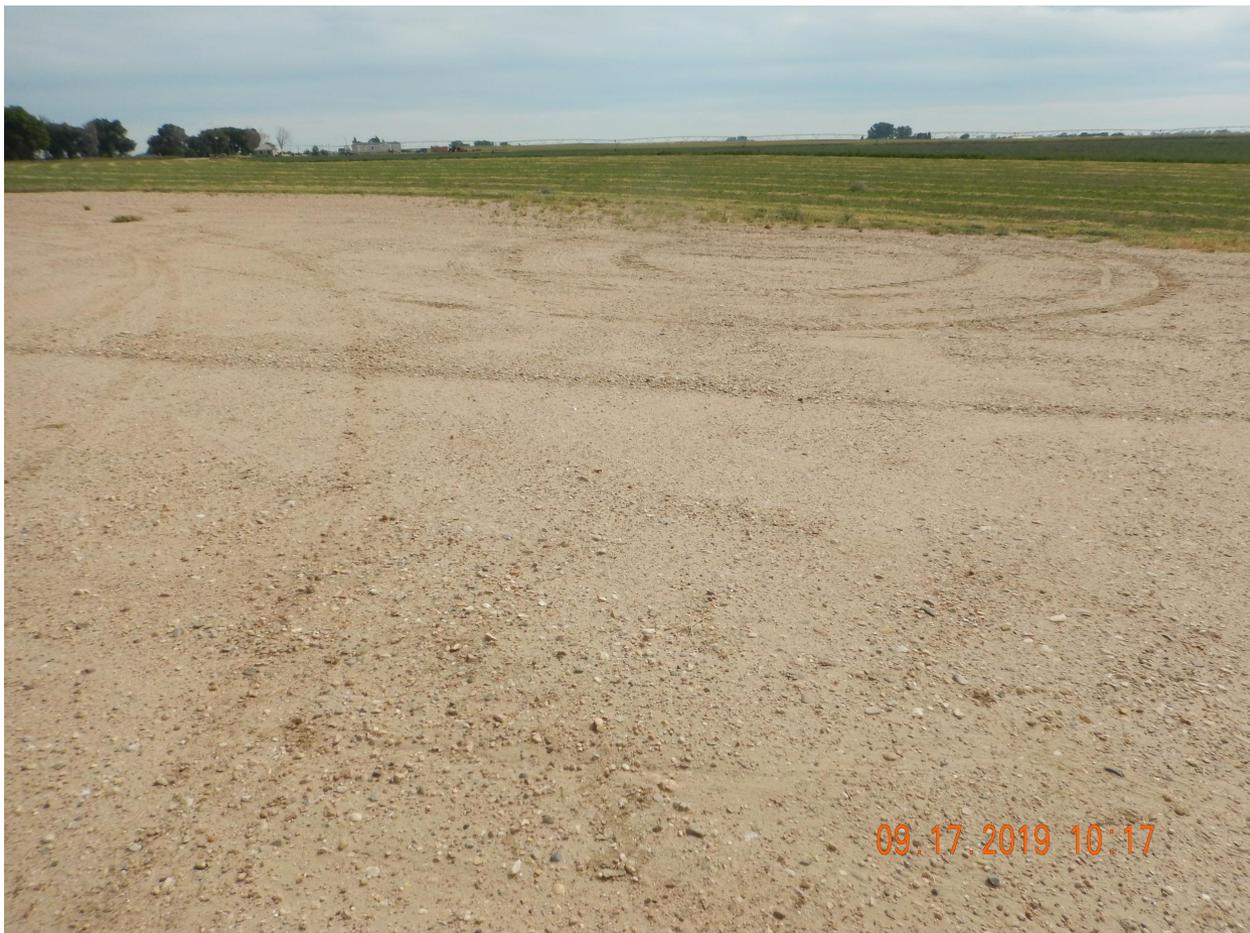
Photo 3. Photo taken from the battery location, facing East. See comments under Photo 2.

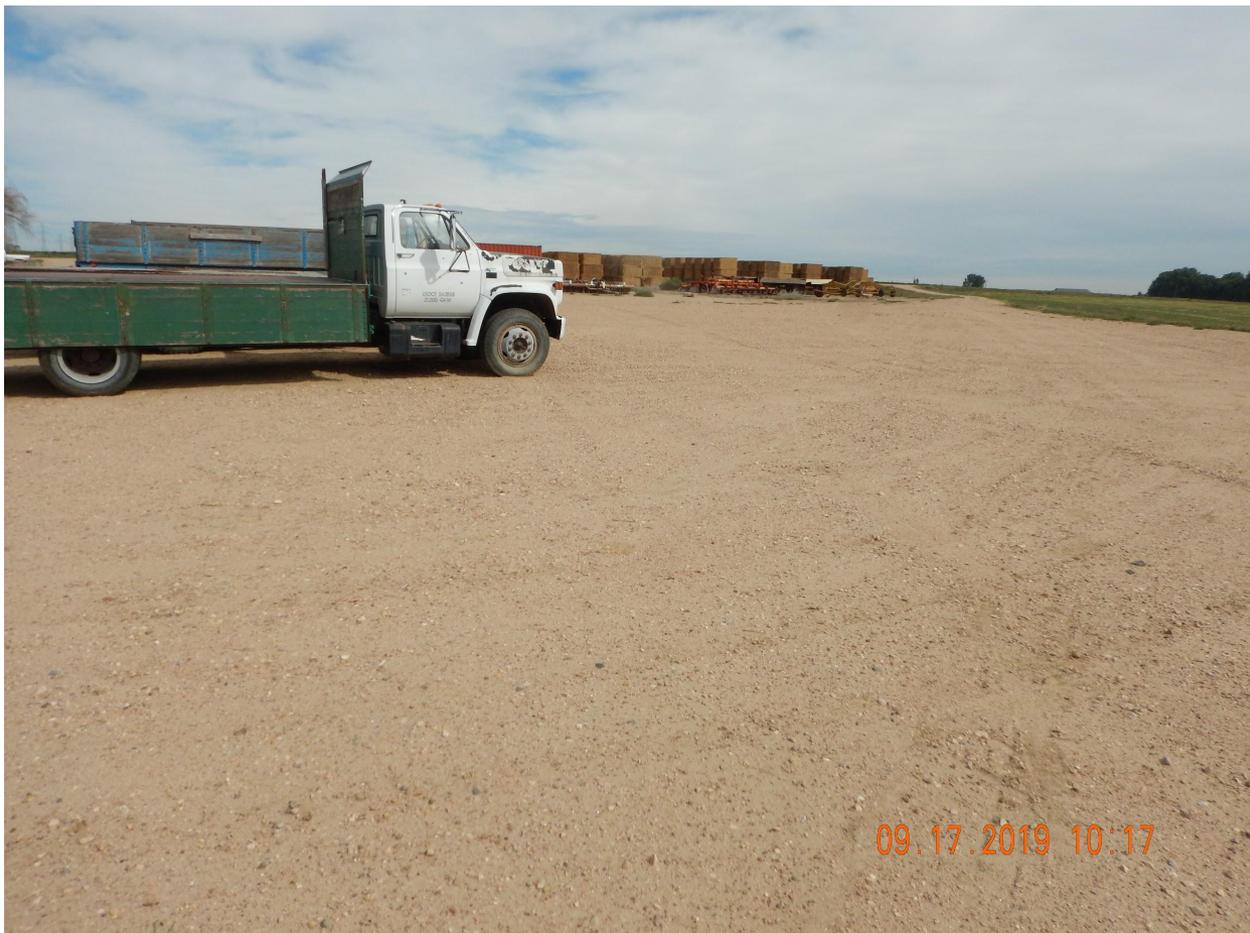
Photo 4. Photo taken from the battery location, facing North. See comments under Photo 2.
