Construction and Stormwater Inspection

Operator: SRC ENERGY INC- #10311

Location ID: 458940

Inspection Photos
Location Name: Chalk-Seeley Federal /7-26
Pad
Location ID: 458940

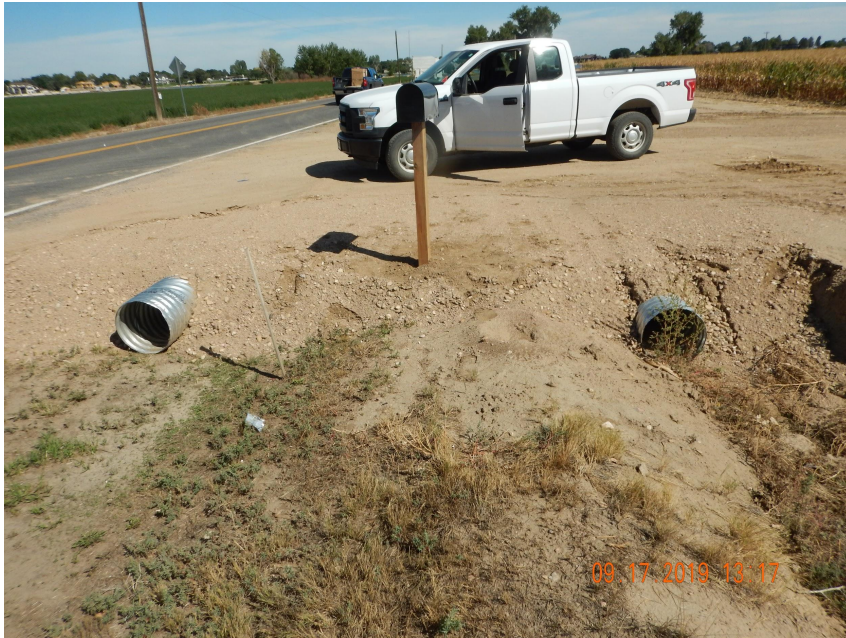
Photo 1. Photo taken from the entrance of the location, facing East. Photo illustrates culverts have been installed. The required permits were inside the mailbox. Operator shall install vehicle tracking device BMPs to ensure compliance with potential sediment discharges from operations, as a new access road has been constructed.

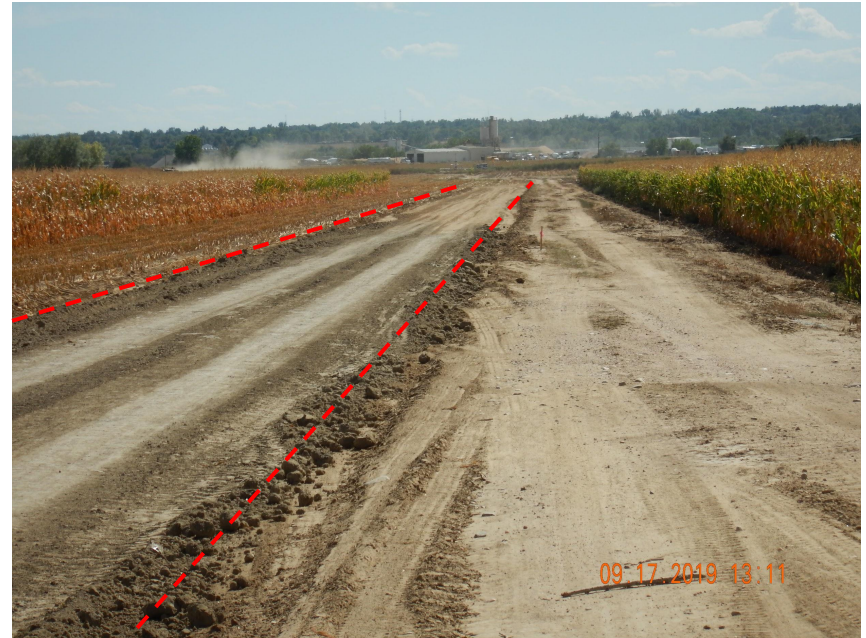
Photo 2. Photo taken from the entrance of the location, facing South. Photo illustrates the Operator has constructed a new access road (red-dashed lines) adjacent to an existing oil and gas access road. Operator indicated that the existing oil and gas access road would be reclaimed. Operator indicated the new access road was a County requirement.

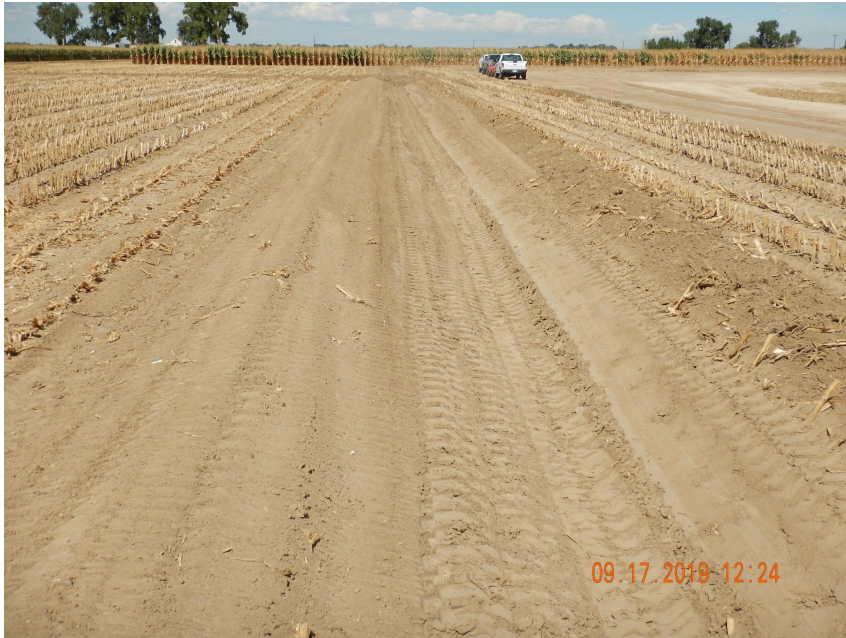
Photo 3. Photo taken from the western well pad location, facing North. Photo illustrates a ditch and berm BMP installed around the perimeter of location. Operator has only constructed the eastern portion of the location.

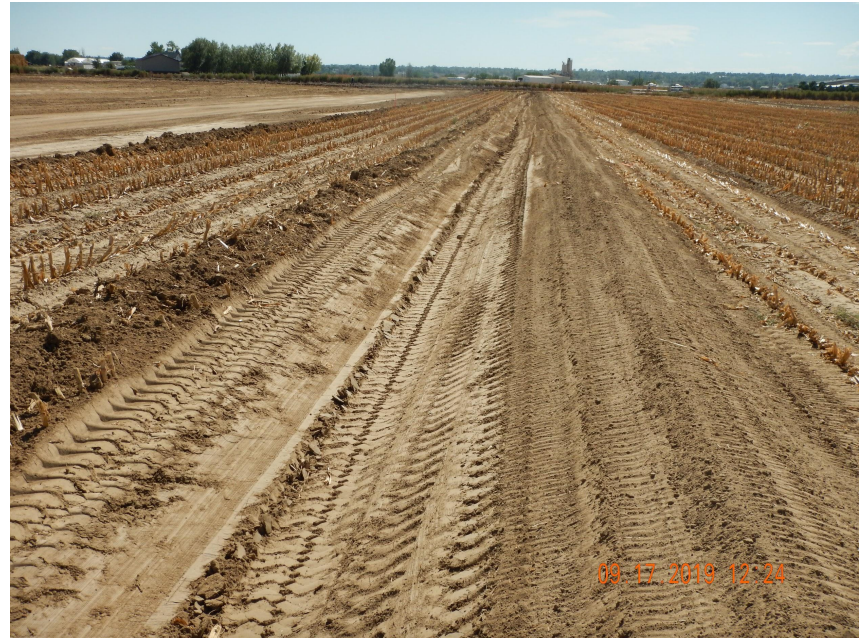
Photo 4. Photo taken from the western well pad location, facing South. See comments under Photo 3.

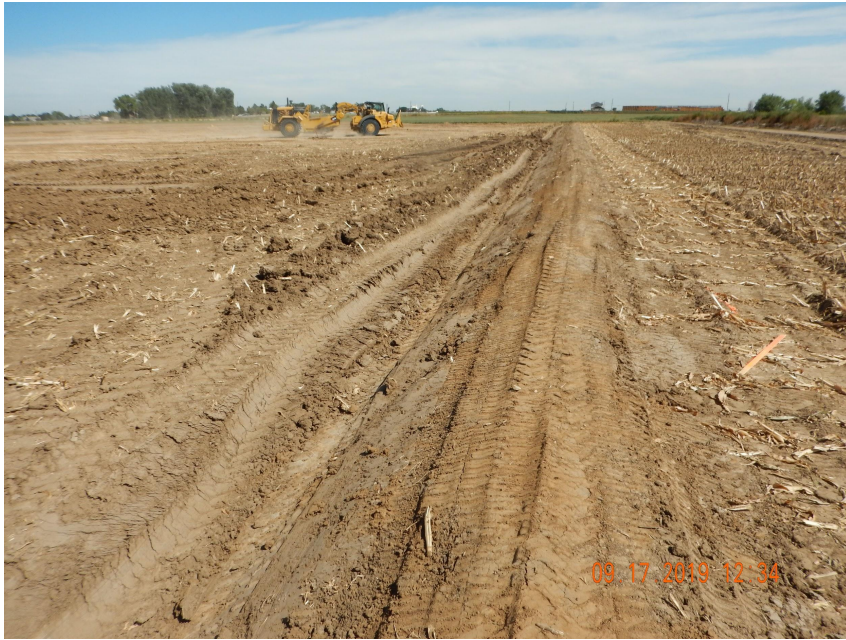
Photo 5. Photo taken from the southwestern well pad location, facing East. See comments under Photo 3.

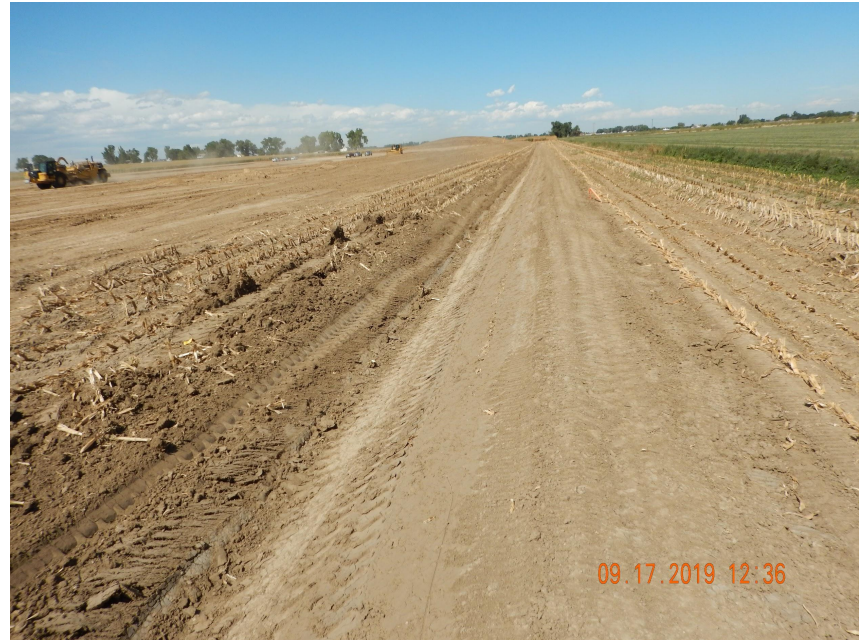
Photo 6. Photo taken from the southeastern well pad location, facing North. See comments under Photo 3.

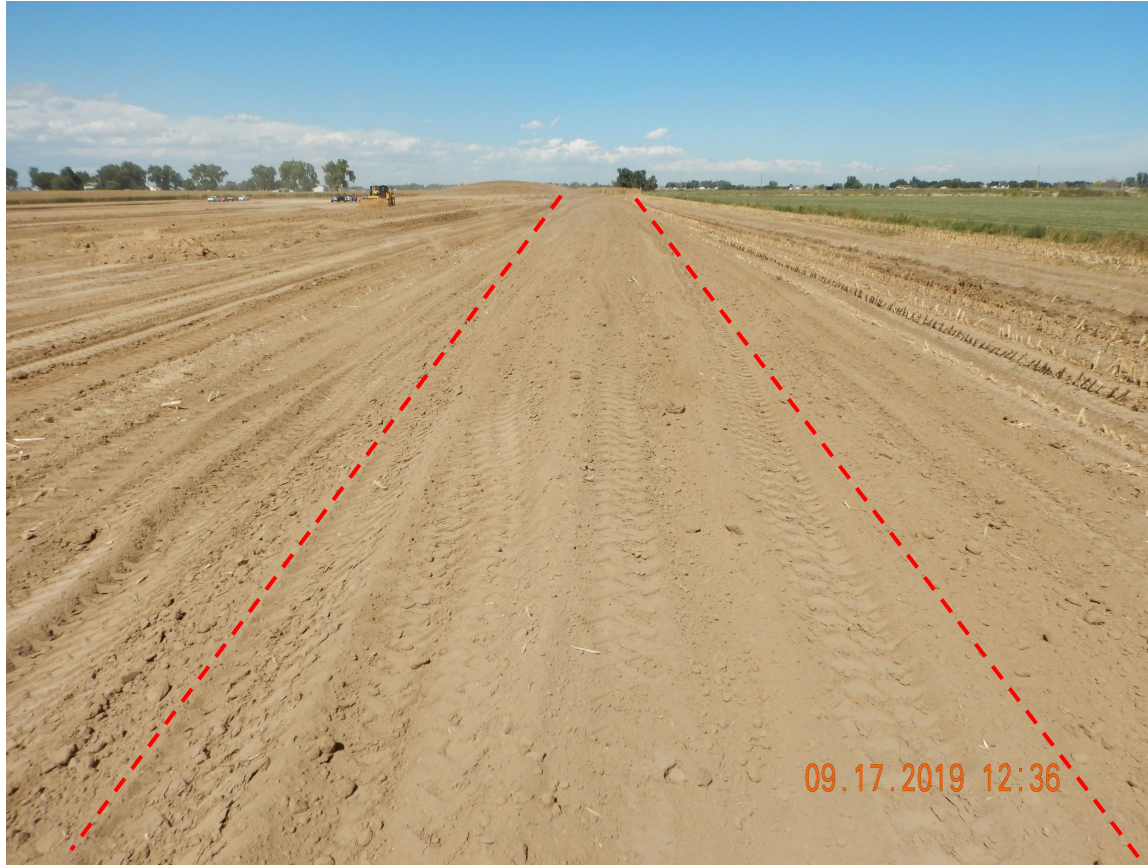
Photo 7. Photo taken from the eastern well pad location, facing North. Photo illustrates a topsoil stockpile (red-dashed lines) stored along the eastern perimeter.

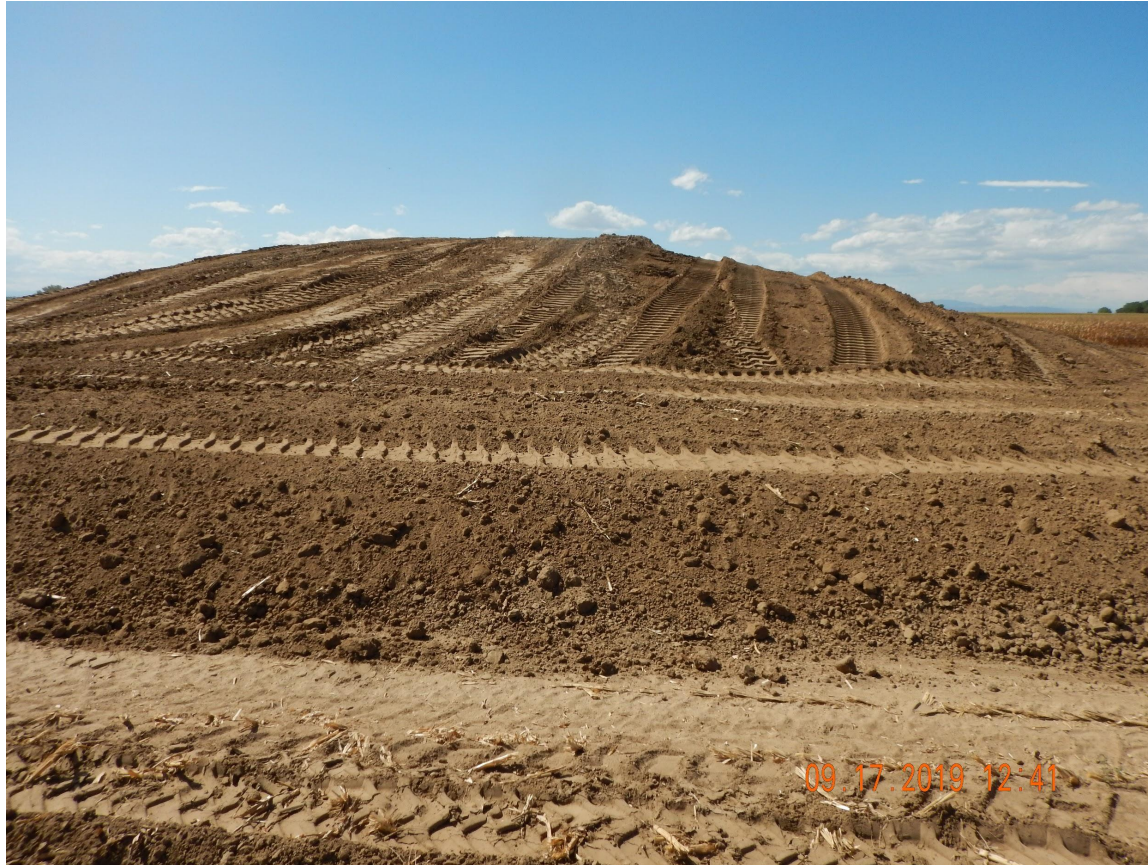
Photo 8. Photo taken from the northeastern well pad location, facing West. Photo illustrates a second topsoil stockpile stored along the northern well pad location.
