# Final Reclamation Inspection

Operator: SRC ENERGY INC- #10311

Location ID: 305727

Inspection Photos  
Location Name: BUXMAN I #26-6  
Location ID: 305727

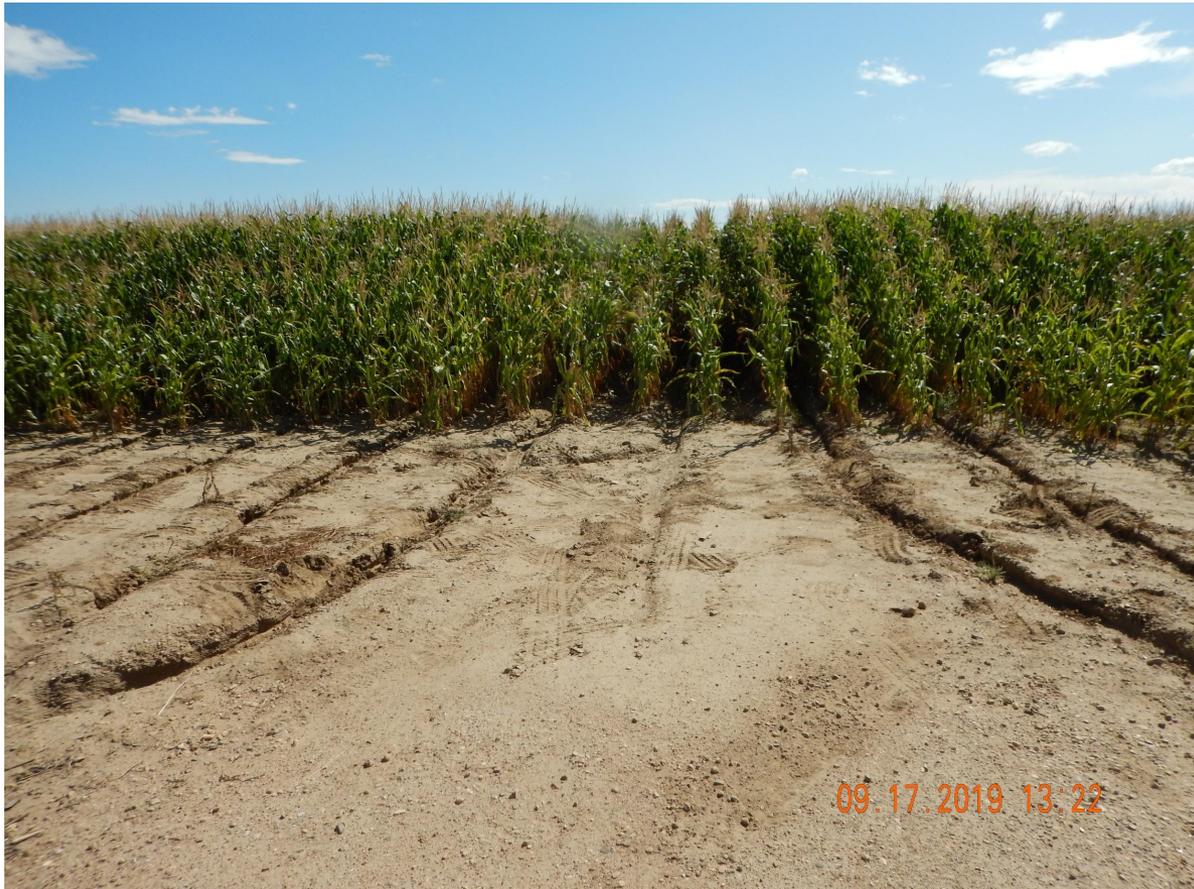
**Photo 1.** Photo taken from the well location entrance point, facing South. COGCC staff could not make a full assessment due to crop height and density, as the location was ~500' further south.

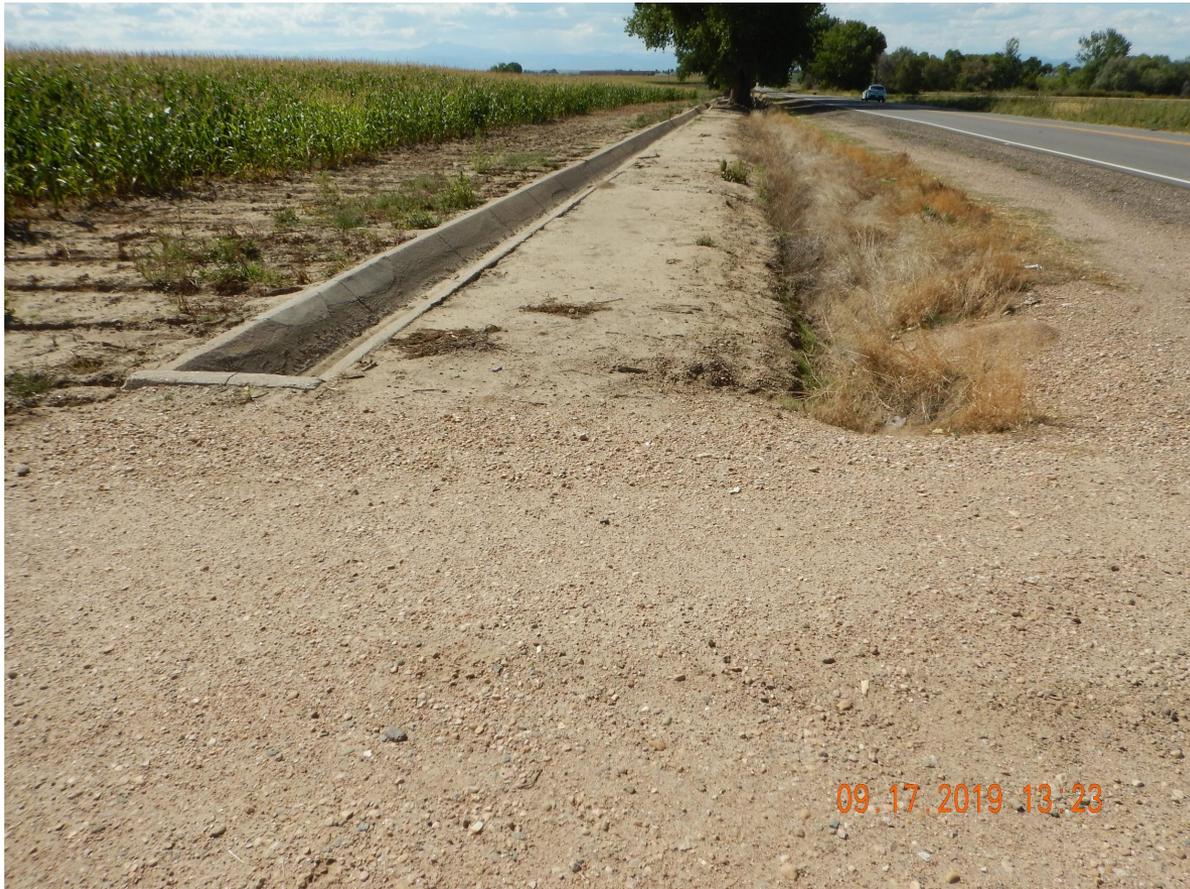
**Photo 2.** Photo taken from the well location entrance point, facing West. Photo illustrates the Operator has failed to remove the culvert. There is an access point for this crop field ~600 feet to the west of this point. This access point is no longer in use and was used for oil and gas operations. See Field Inspection Report Doc. #697500616 regarding the corrective action to remove the culvert.
