Inspection Photos
Location Name: BEARLY 24-29
API#: 05-071-08177
INSP. #: 695101400

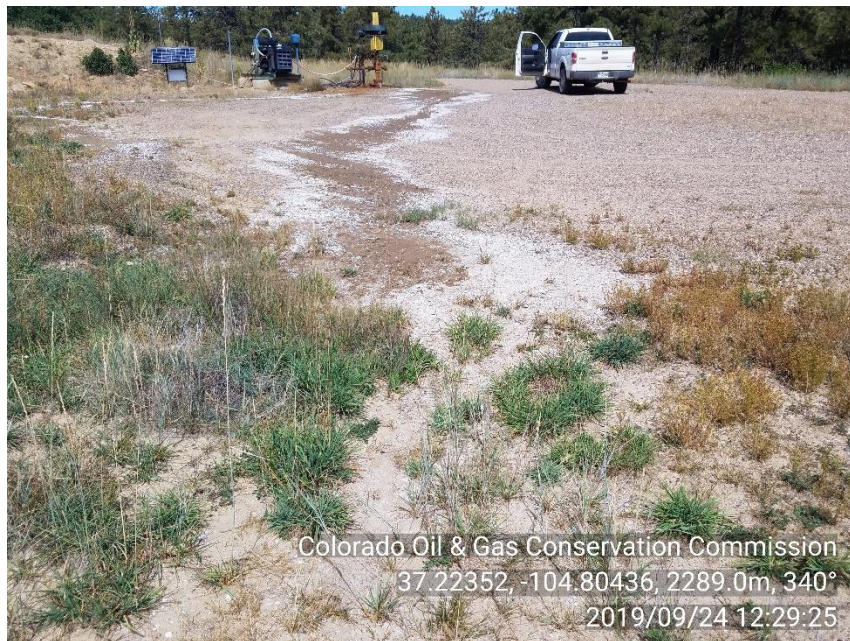
PHOTO 3: APPEARS THAT PACKING WAS LEAKING ON WELLHEAD (NOT THERE IS NO LEAK AT TIME OF INSPECTION). IMPACTED AREA EXTENDS FROM WELLHEAD TO SOUTHWEST APP. 123'. Control and contain spills/releases and clean up per Rule 906.a. Contact COGCC EPS staff. CA DATE 9-25-19.

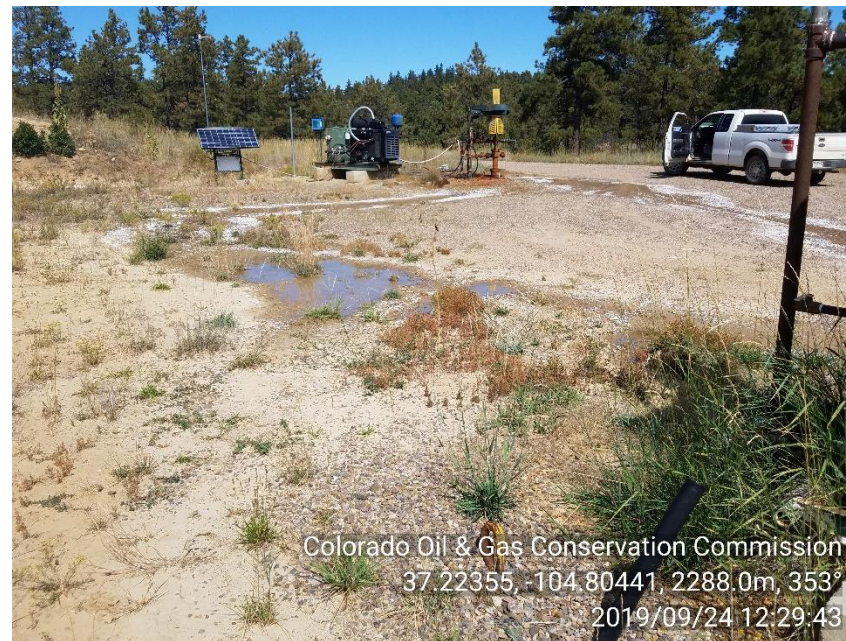
PHOTO 4: ANOTHER PATH EXTENDING FROM WELLHEAD WEST AND THEN SOUTH FOR APP. 93'.

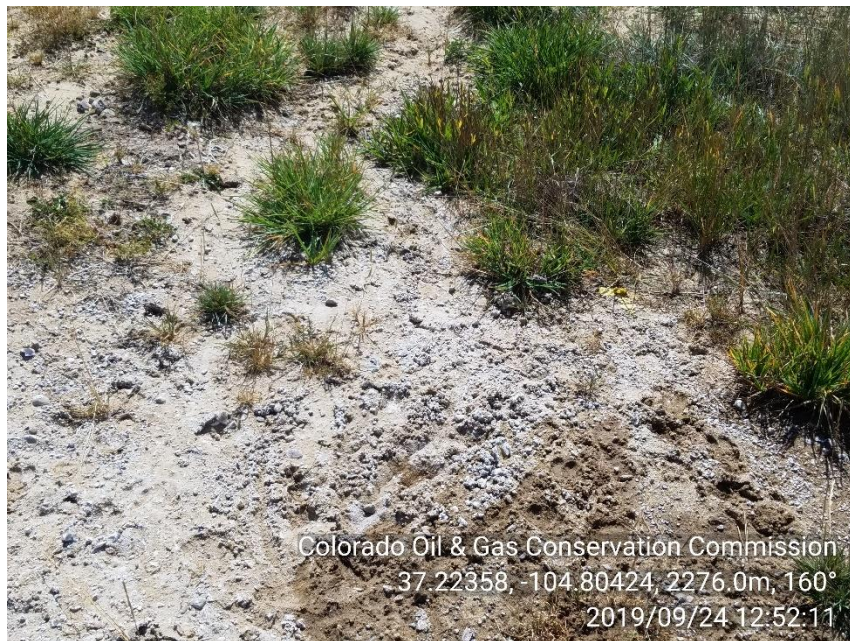
PHOTO 5: PHOTO SHOWING THAT THERE HAS BEEN OTHER EVENTS AS YOU CAN SEE THE WHITE CHALKY STAINING BEYOND THE CURRENT WET SOIL. WHITE CHALKY STAINING EXTENDS PAST CURRENT WET SOIL APP. 18'.
