Inspection Photos
Operator Name: Caerus Piceance LLC
Location ID: 334069

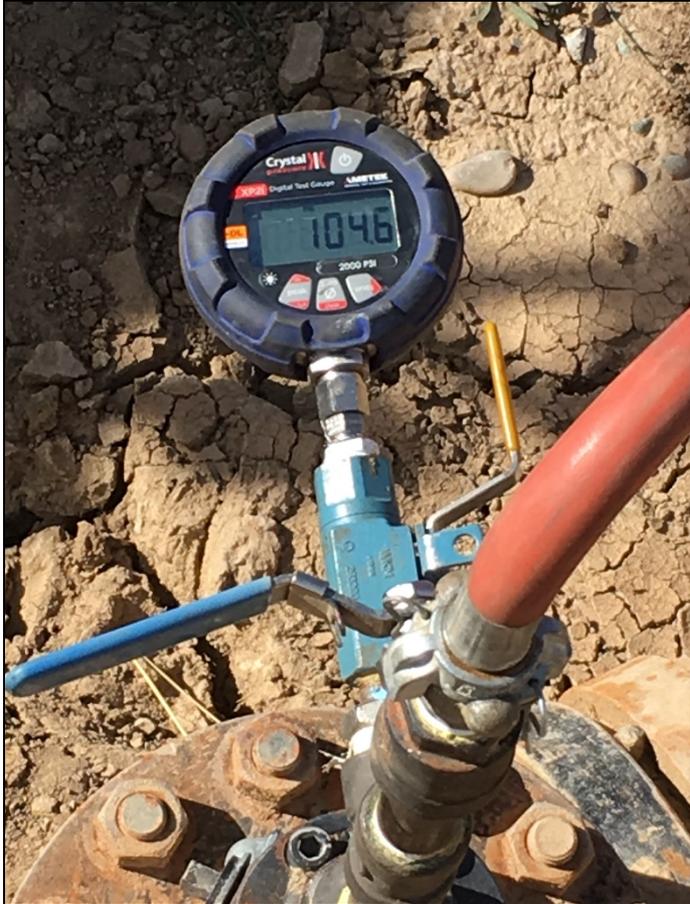
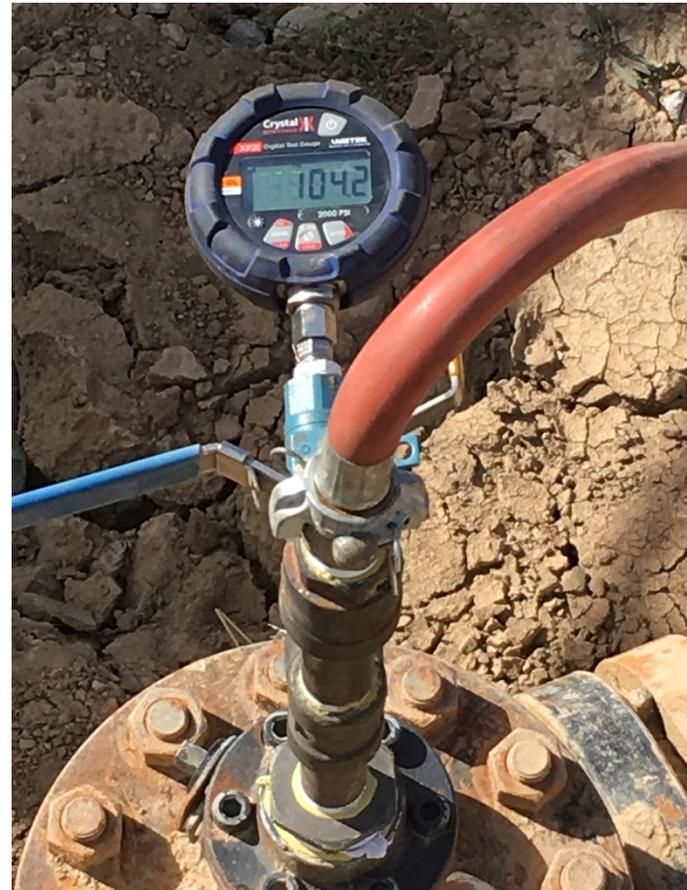
6" Flexsteel produced water flowline. 30 Minute pressure test. Start and Finish. Test performed with Air. Flexsteel flowline runs approximately 1-1/2 miles. From G1SW location to the H2SW location

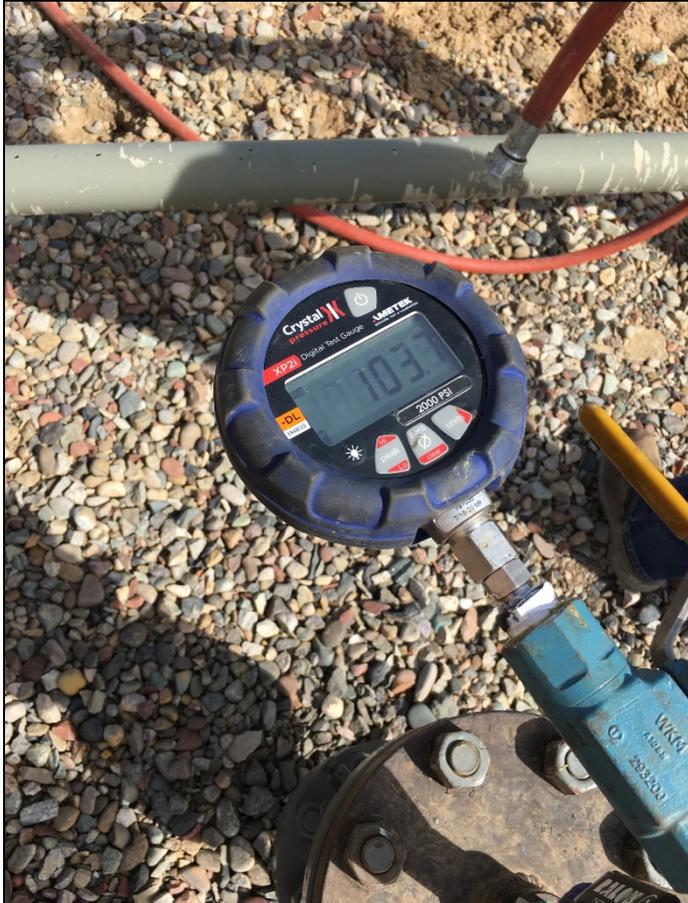
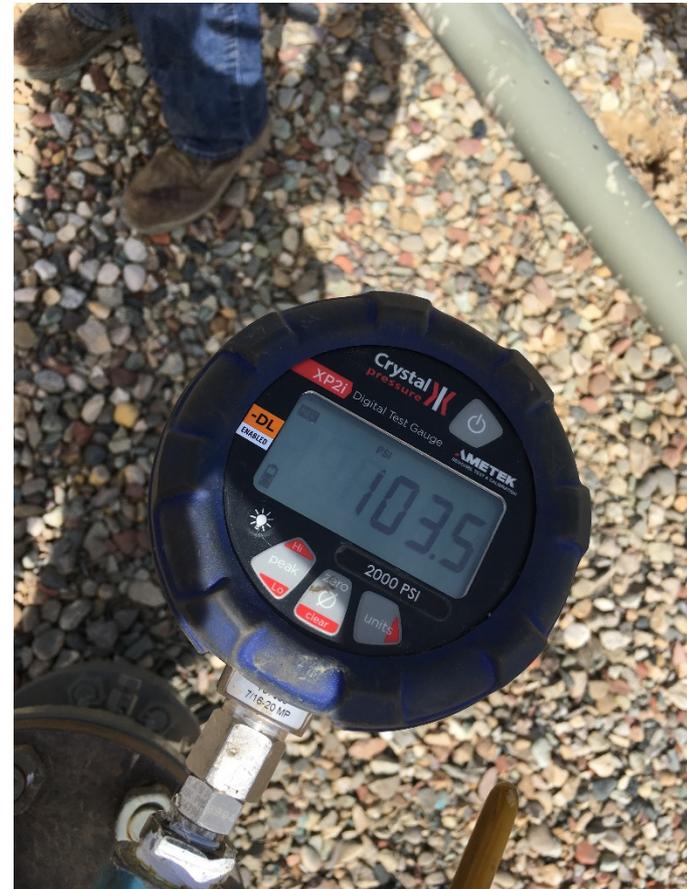
4" Flexsteel produced water flowline. 30 Minute pressure test. Start and Finish. Test performed with Air. Flexsteel flowline runs approximately 1-1/2 miles. From G1SW location to the H2SW location
