Inspection Photos
Operator: BP America
Location/API #: 067-08629
Date: 9-30-2019

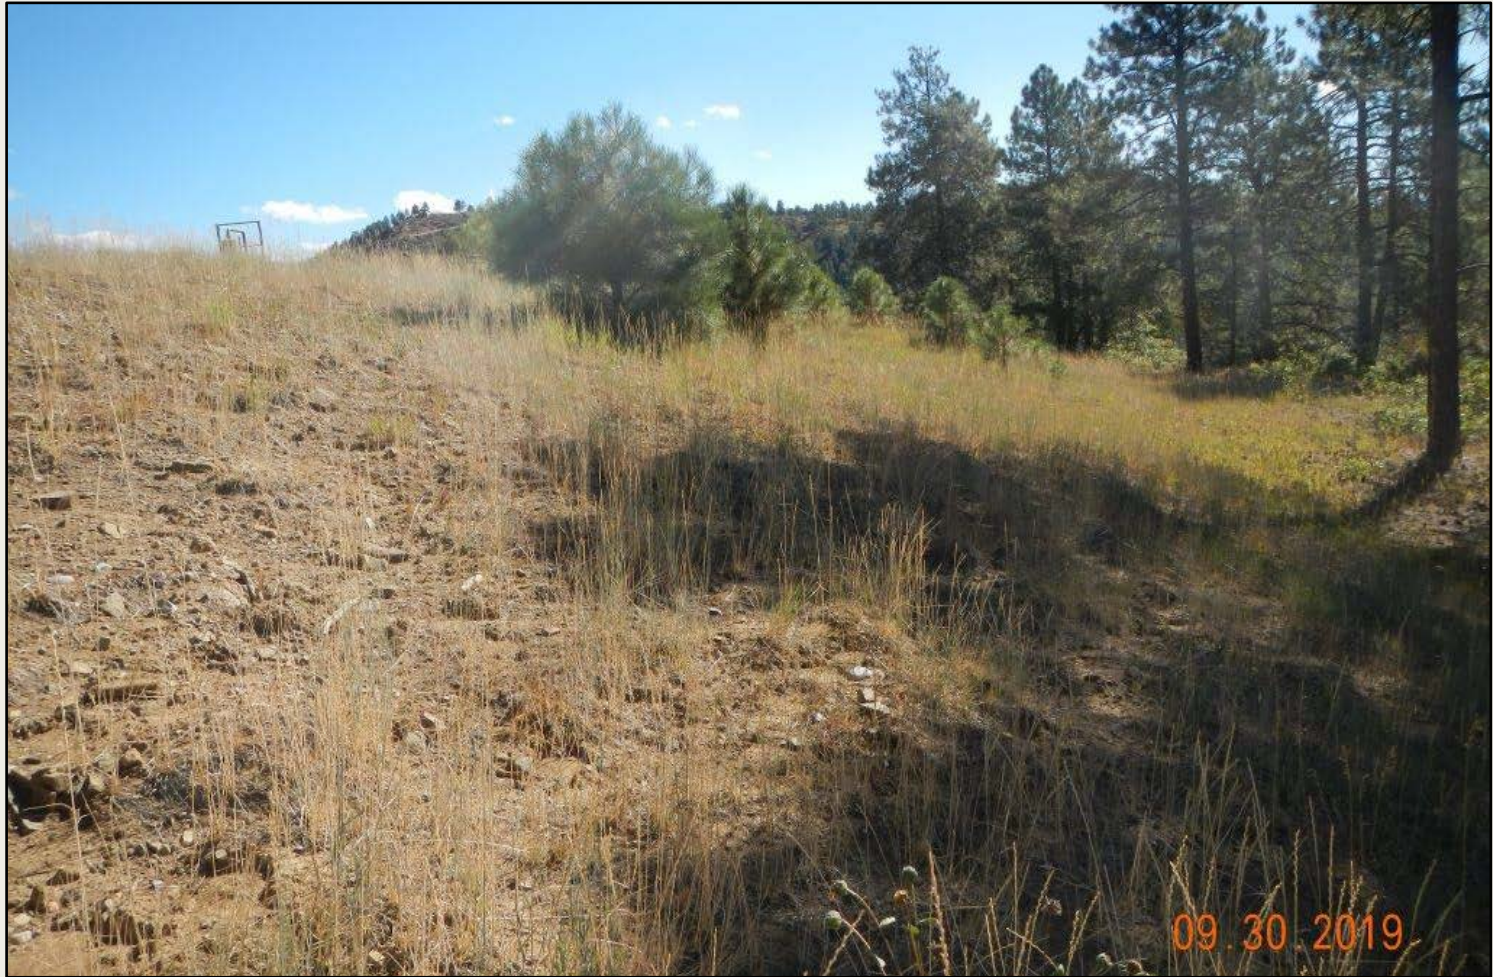
Photo 1 View of the southern project area from the southwestern edge facing eastward. Revegetation is progressing with grasses such as western wheatgrass and smooth brome, as well as young ponderosa pine trees.

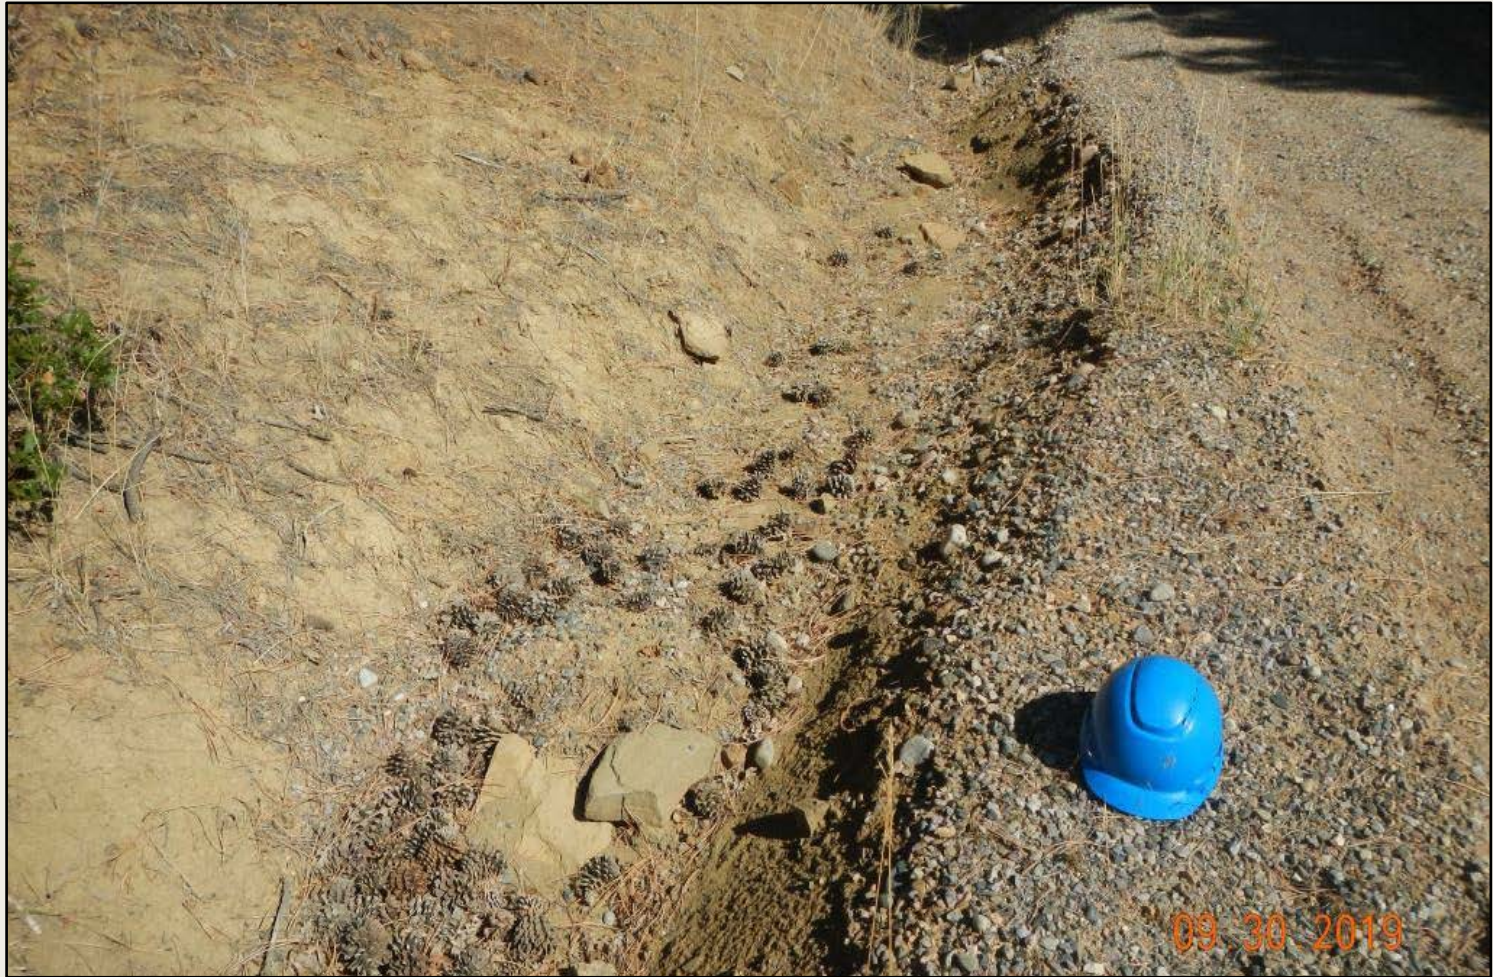
Photo 2. View of erosional downcutting (approx. 2 feet wide and deep) occurring along the access road where stormwater controls are needed.

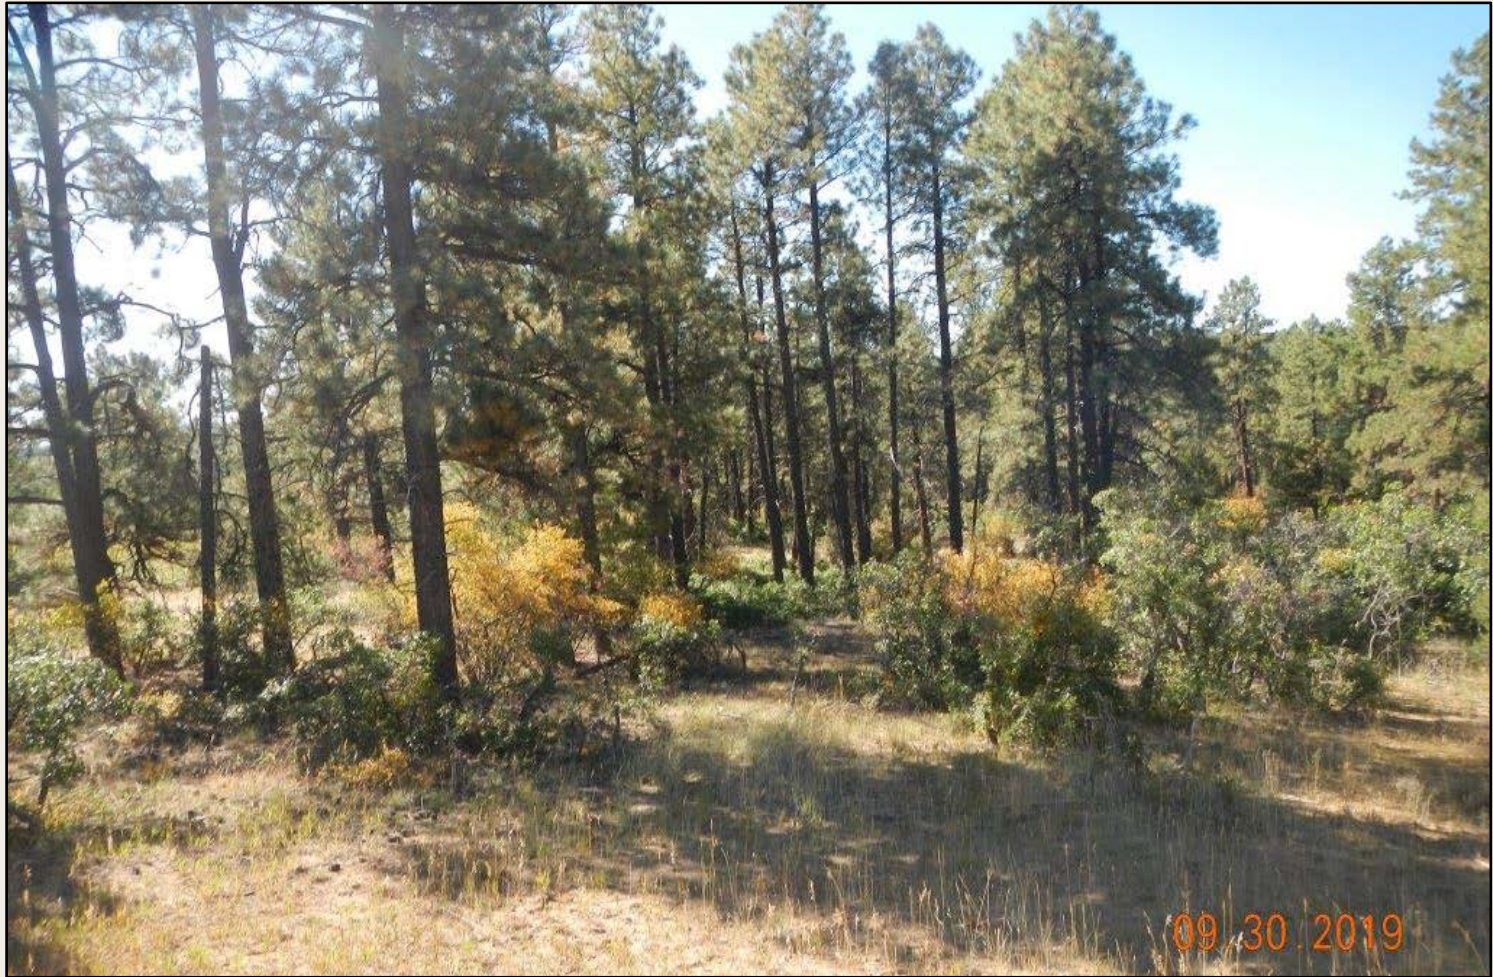
Photo 3. View of reference area vegetation, comprised of open ponderosa pine woodland and shrub/grass understory dominated by gambel oak.
