Final Reclamation Inspection

Operator: ANADARKO E&P ONSHORE LLC - #2800

API: 05-123-31795

Inspection Photos
Location Name: HOBART #8-67-1-4H
API: 05-123-31795

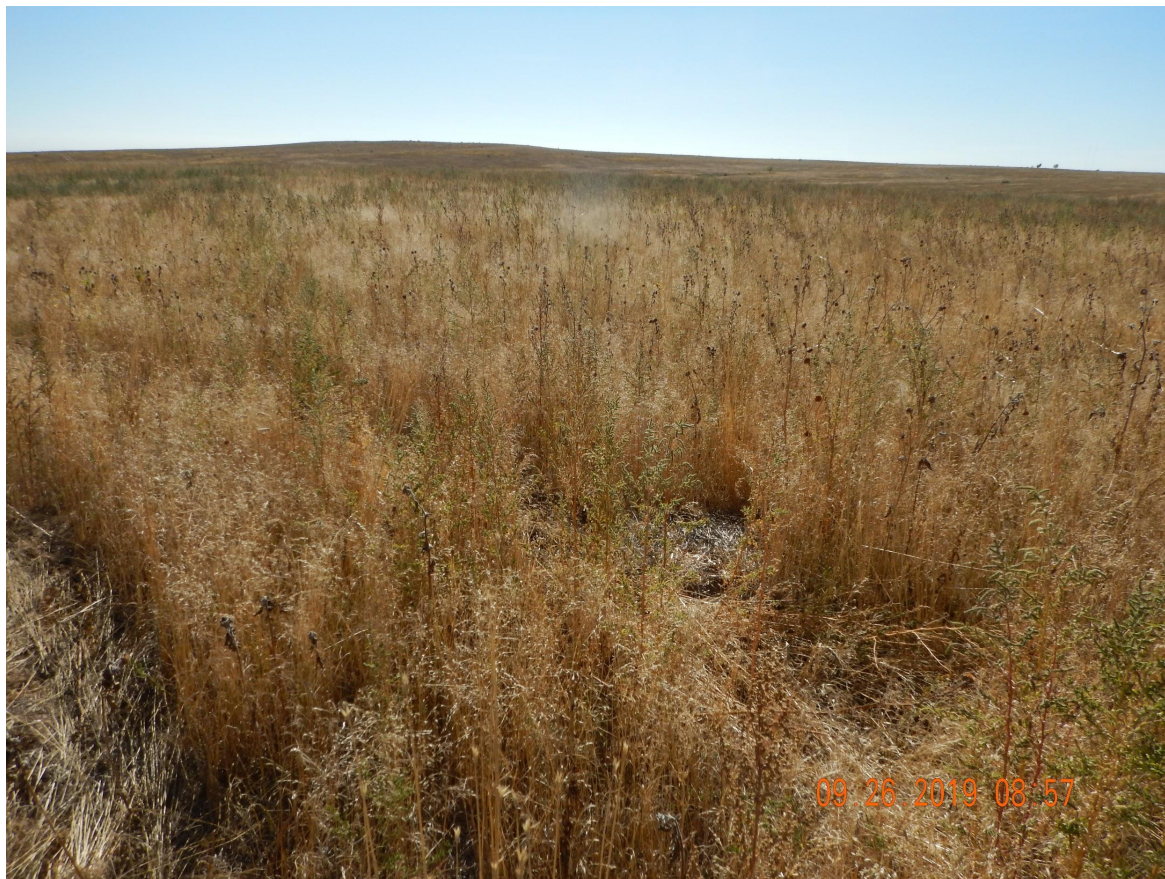
Photo 1. Photo taken from the approximate central location, facing East. Photo illustrates weed maintenance is needed, as Kochia and a high abundance of cheatgrass were observed. The presence of desirable species was observed underneath the weeds.

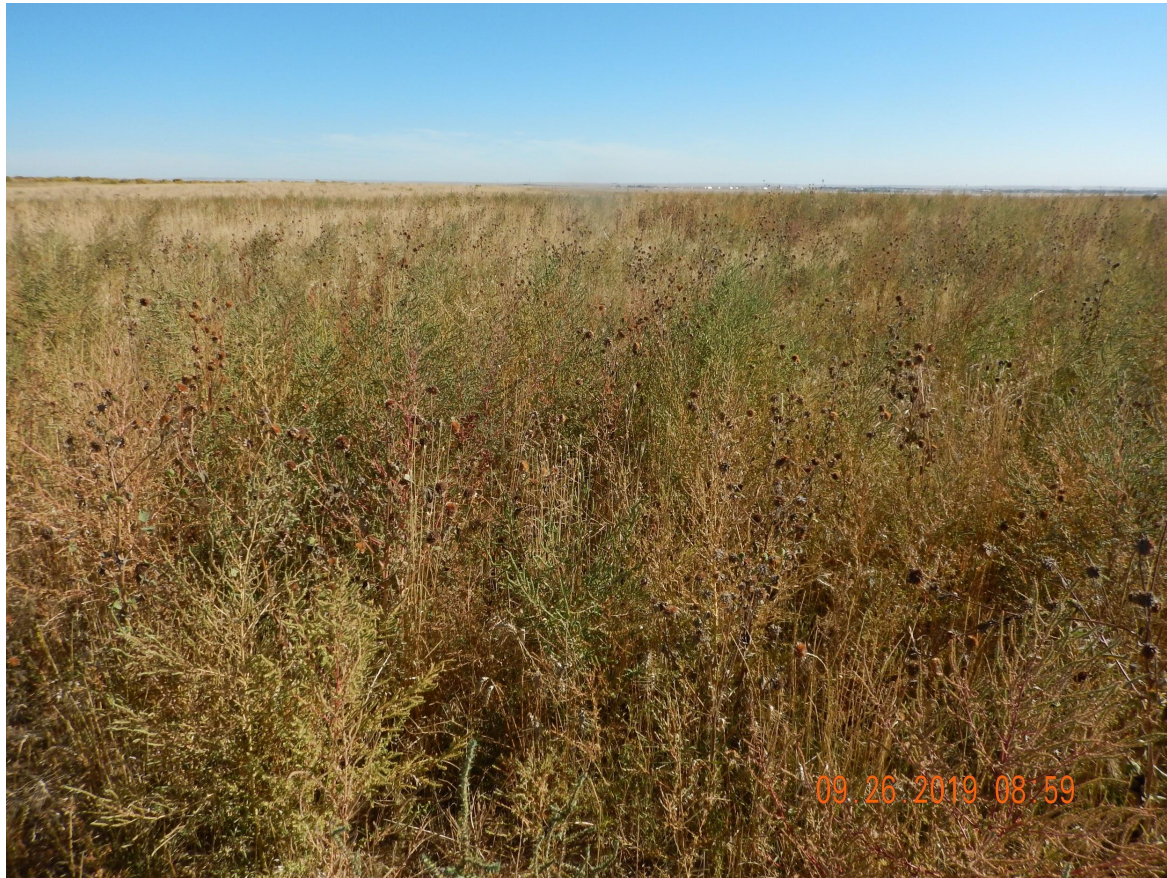
Photo 2. Photo taken along the southern location, facing North. See comments under Photo 1.

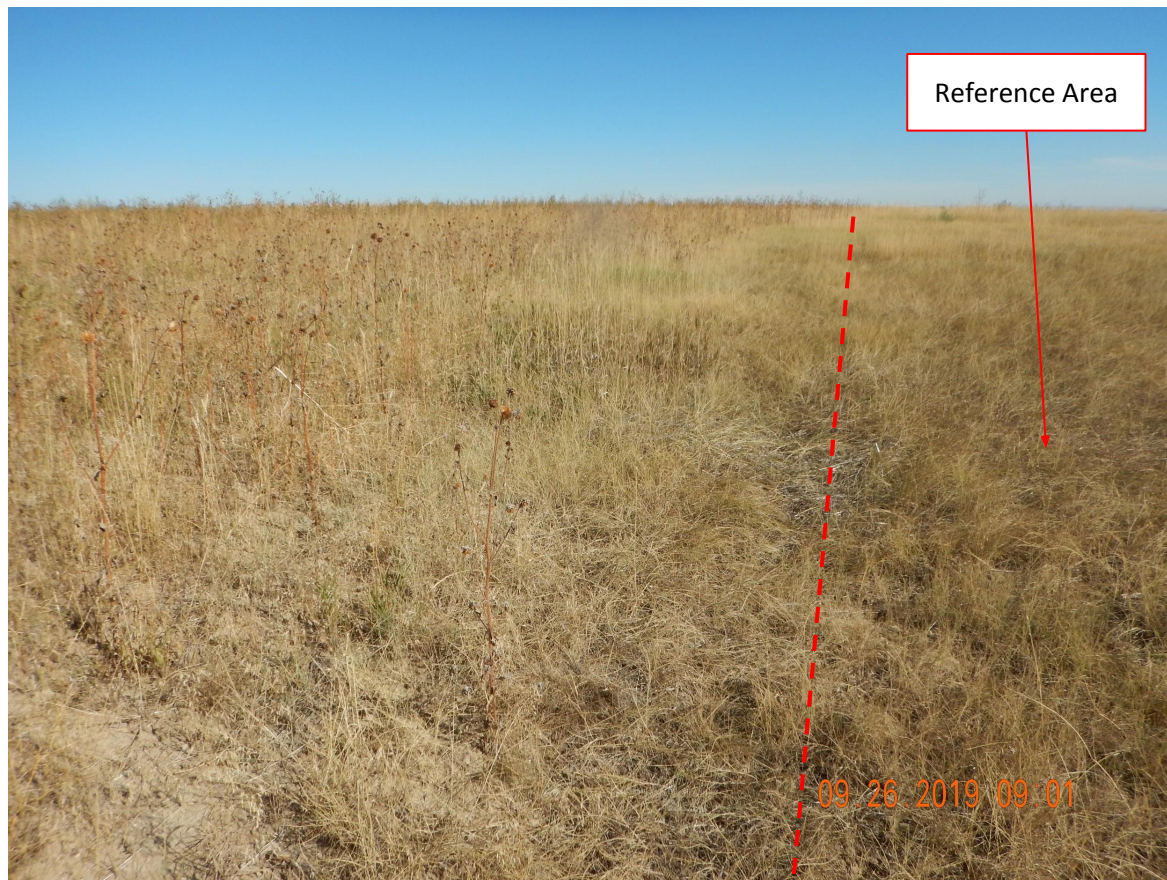
Photo 3. Photo taken along the eastern location, facing North. Photo illustrates the reference area vegetation to the right of the red-dashed line and the disturbance area to the left of the red-dashed line.

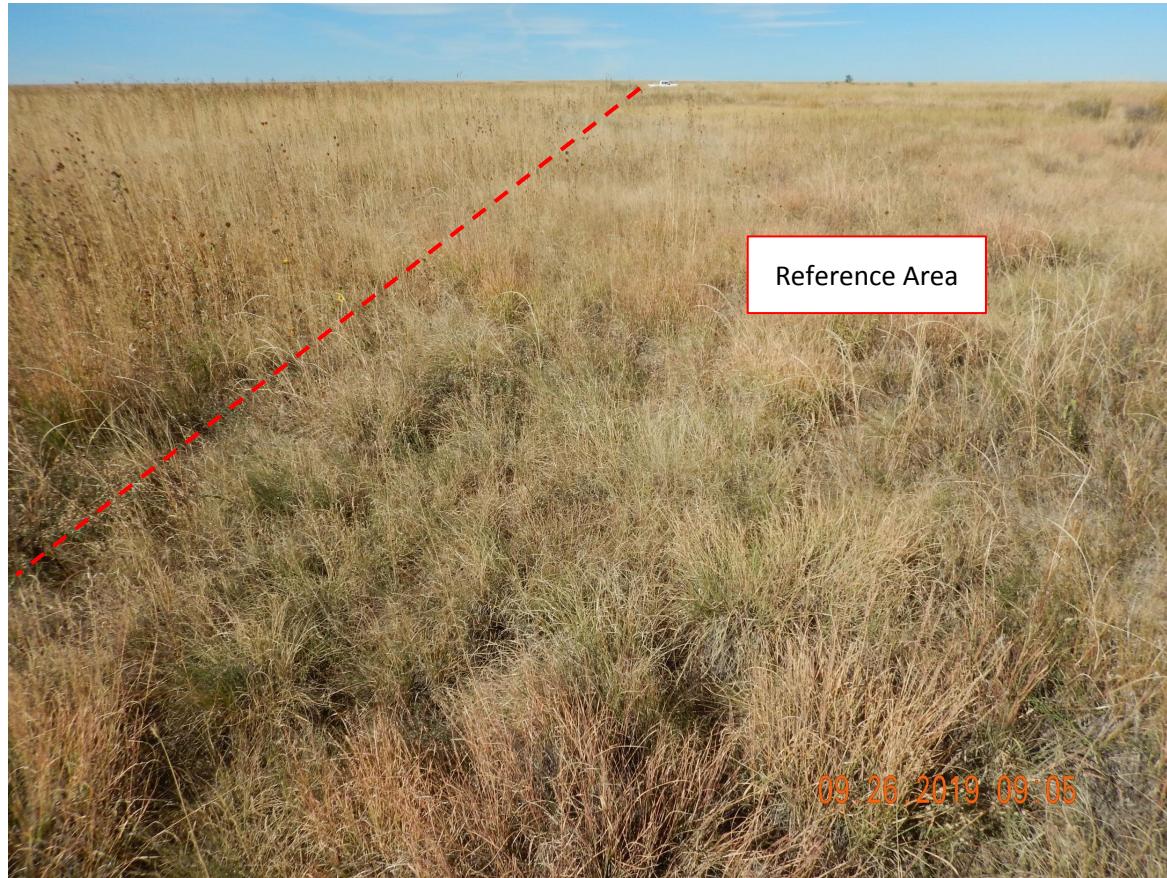
Photo 4. Photo taken along the northern location, facing West. See comments under Photo 3.
