Inspection Photos
Location Name: Huck /41-28 Pad
Location #: 456482

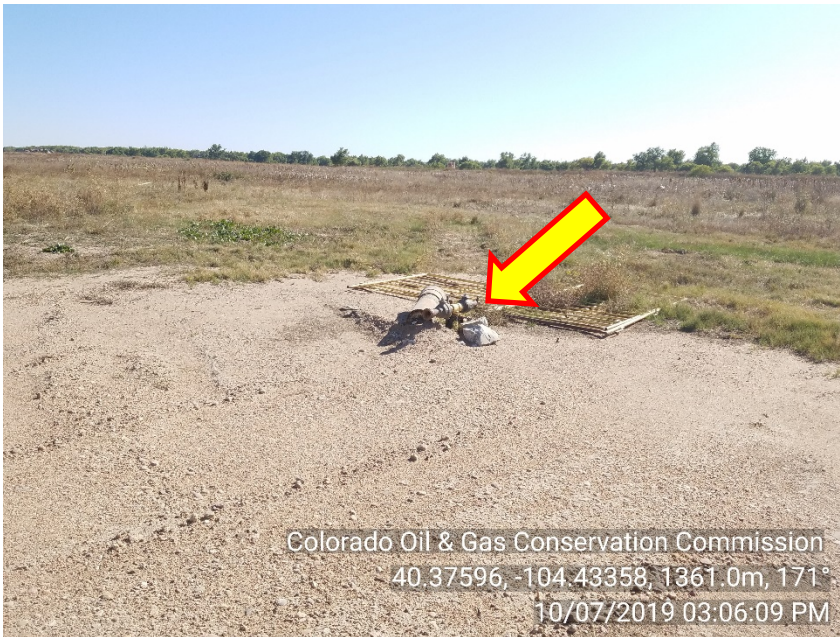
Photo #1
Huck 41-28 (05-123-21882) Wellsite
Plugged & Abandoned | PA
Appears to be cut & capped
Unused Equipment
Unused flow line riser NOT marked & LO/TO

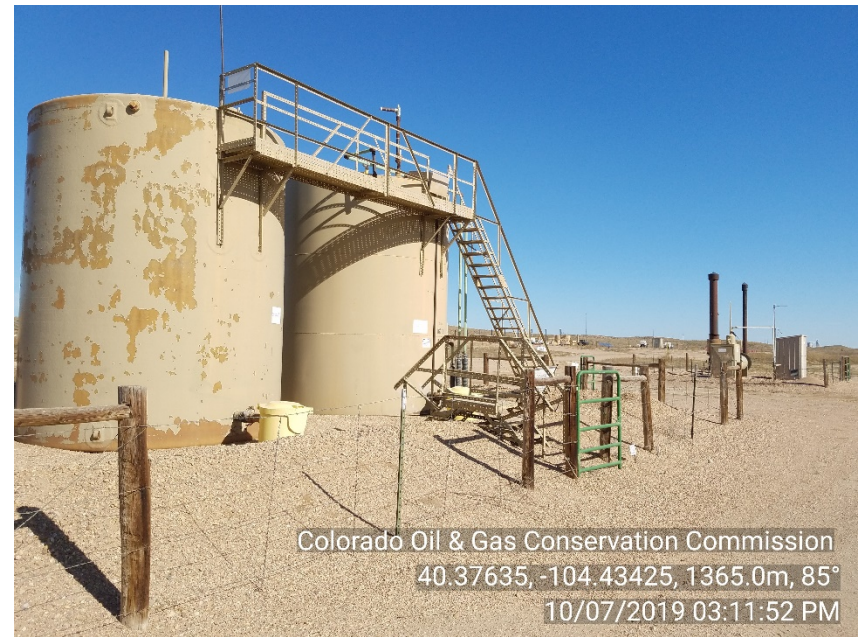
Photo #2
Huck 41-28 Battery
Shut-down | Inactive
Well: Plugged & Abandoned | PA
Unused Equipment
