Inspection Photos

Location Name: BLADE RUNNER 23-21

API#: 05-071-07241

INSP. #: 695101507

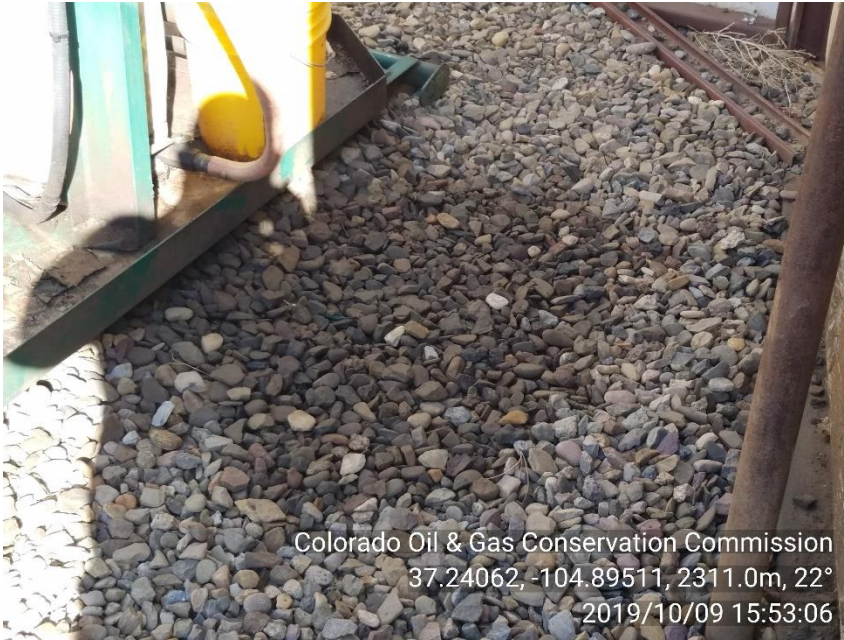
PHOTO 3: AREA OF IMPACTED GRAVEL/SOIL NEAR COMPRESSOR. Properly treat or dispose of oily waste in accordance with 907.e. CA DATE 11-9-19
