**Inspection Photos**  
**Location Name: BIG MEADOW 34-4**  
**API#: 05-071-07879**  
**INSP. #: 695101516**

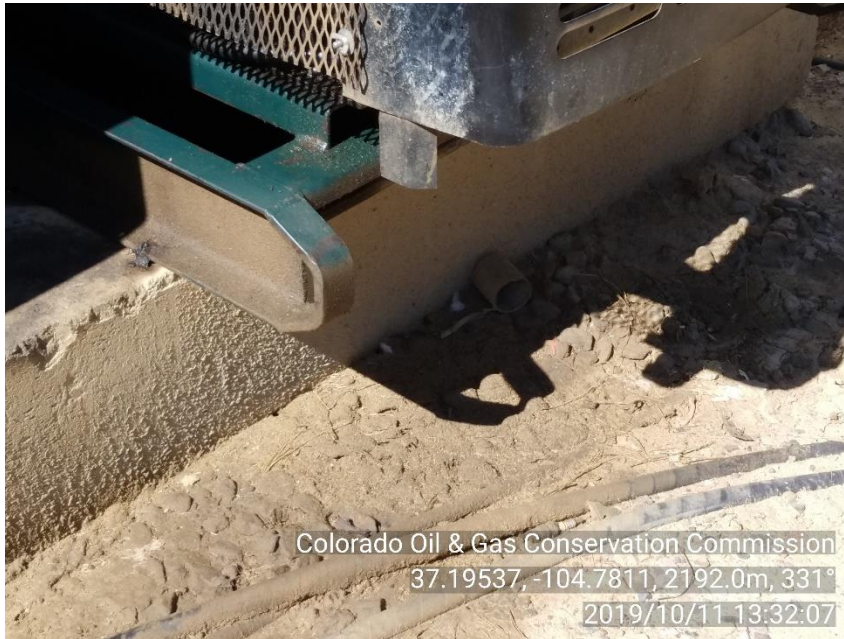
**PHOTO 3: SEVERAL AREAS OF IMPACTED SOIL AROUND ENGINE SKID. Properly treat or dispose of oily waste in accordance with 907.e. CA DATE 11-11-19.**

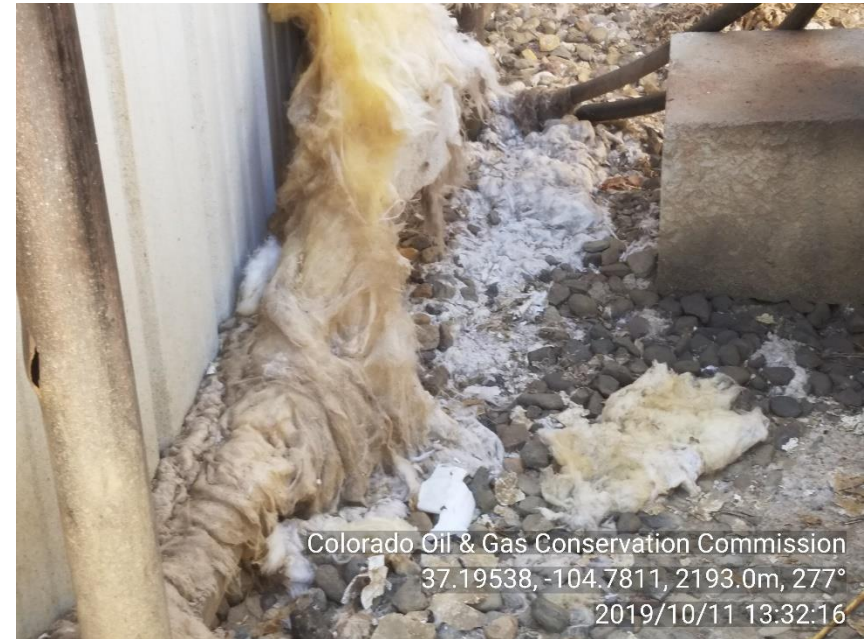
**PHOTO 4: TRASH, THE INSULATION ON SOUND WALL IS DETERIORATING AND PREADING ON LOCATION INSIDE SOUDWALL AND OUT. COMPLY WITH 603.f. CA DATE 10-18-19**

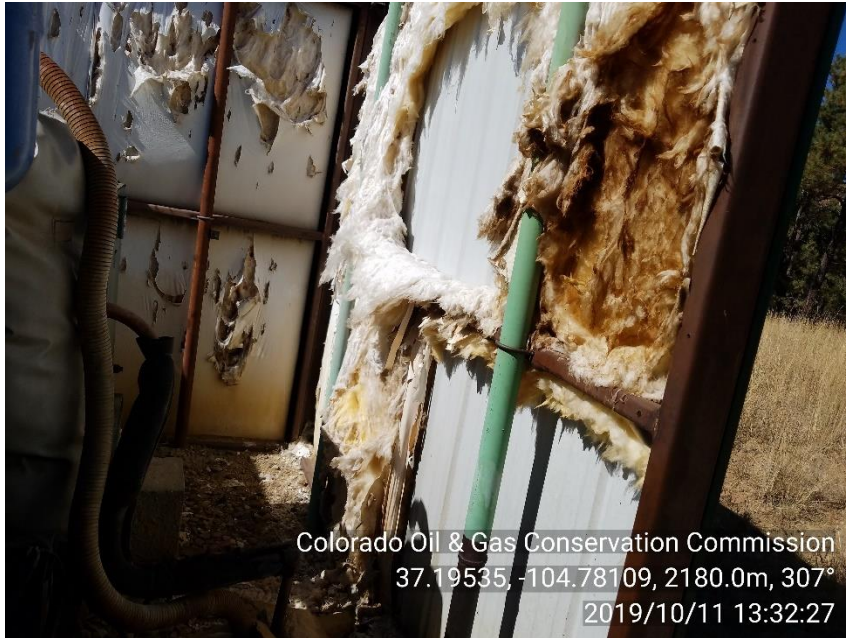
**PHOTO 5: A NOTHER PHOTO SHOWING THE DETERIORATING  
INSOLATION.**
