Construction and Stormwater Inspection

October 9, 2019

Operator: HIGHPOINT OPERATING CORPORATION- #10071

Location ID: 462024

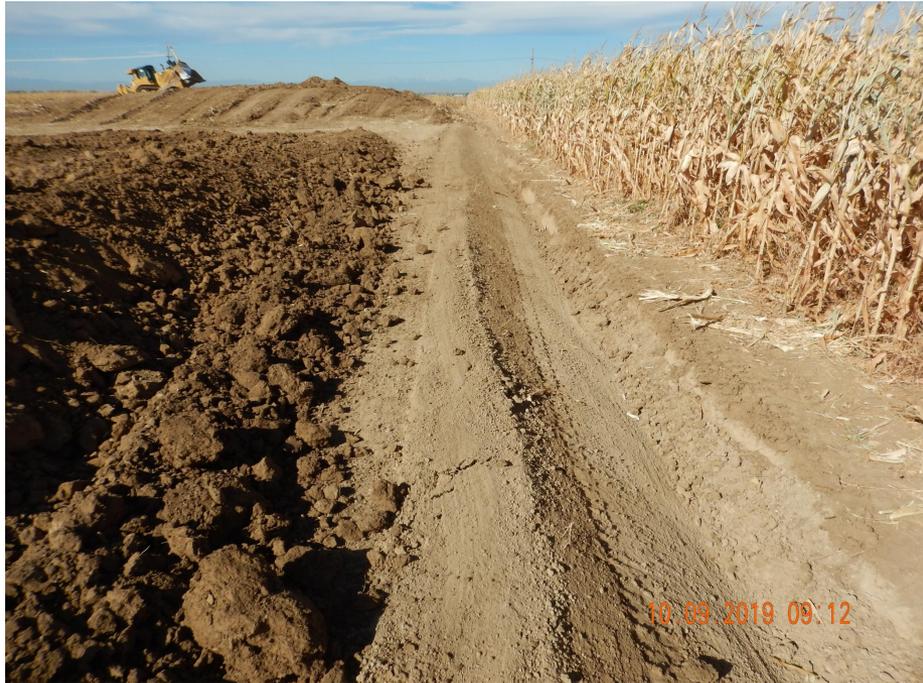
Photo 1. Photo taken from the northeastern perimeter of location, facing West. Photo illustrates a ditch BMP which is directed to a sediment trap along the northwestern perimeter of location.

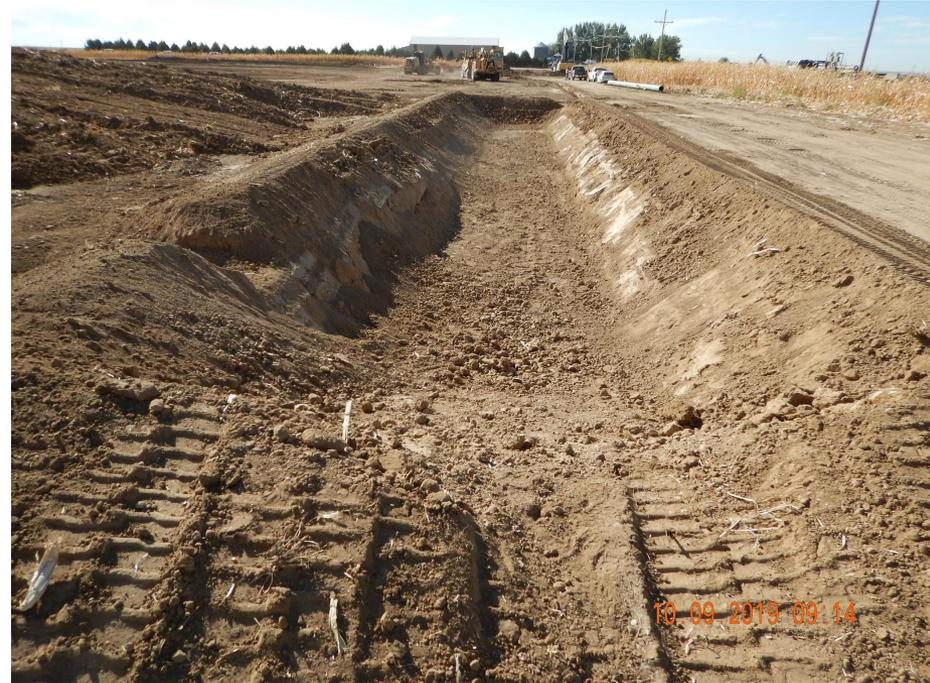
Photo 2. Photo taken from the northwestern perimeter of location, facing South. Photo illustrates a sediment trap that was previously referenced.

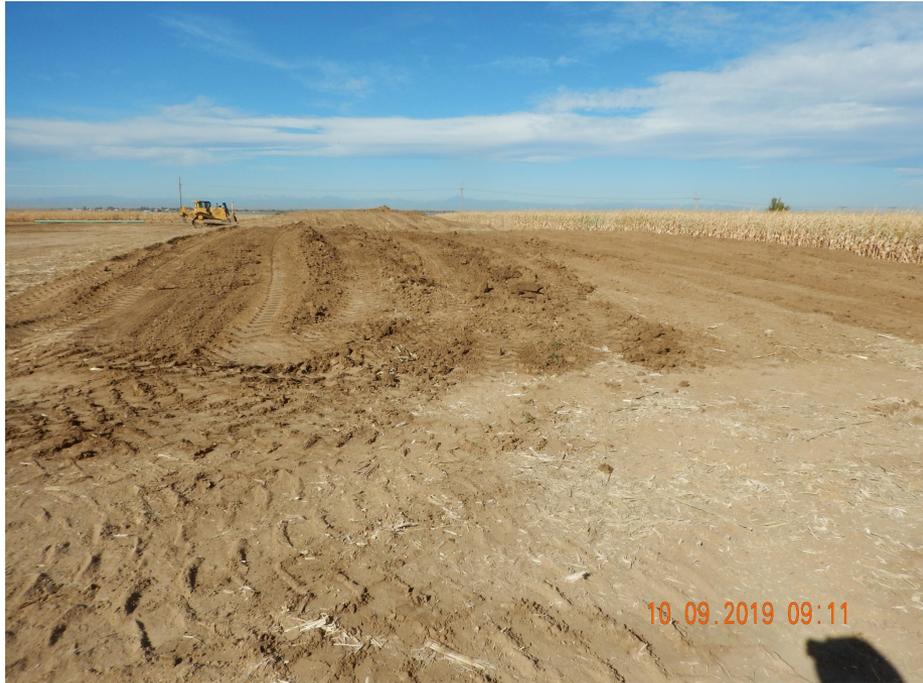
Photo 3. Photo taken from the northeastern perimeter of location, facing West. Photo illustrates one of two topsoil stockpiles being stored along the northern perimeter of location.

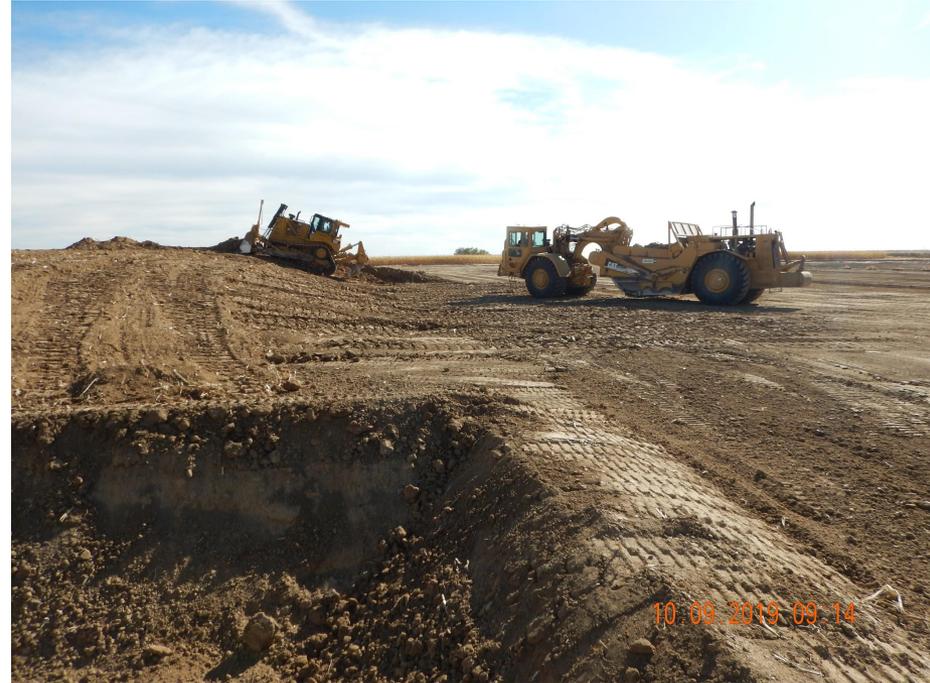
Photo 4. Photo taken from the northwestern perimeter of location, facing East. Photo illustrates the second topsoil stockpile. Operator was still conducting topsoil salvage operations at the time of this inspection.
