GRAY-N37N17W 15SWSW Sundry Notice Supplement

This document supplements the Form 4 Sundry notice submitted on the COGCC e-form system by High Point Resources (HPR) GRAY-N37N17W 15SWSW, subsequently referred to as the reclamation site. This document provides information on qualitative and quantitative monitoring and results of the final reclamation effort. This document also provides justification for the Form 4 request for inspection and release of HPR from further obligation at the reclamation site.

Location Name: GRAY-N37N17W 15SWSW
COGCC ID: 313626
API #: 05-083-06651

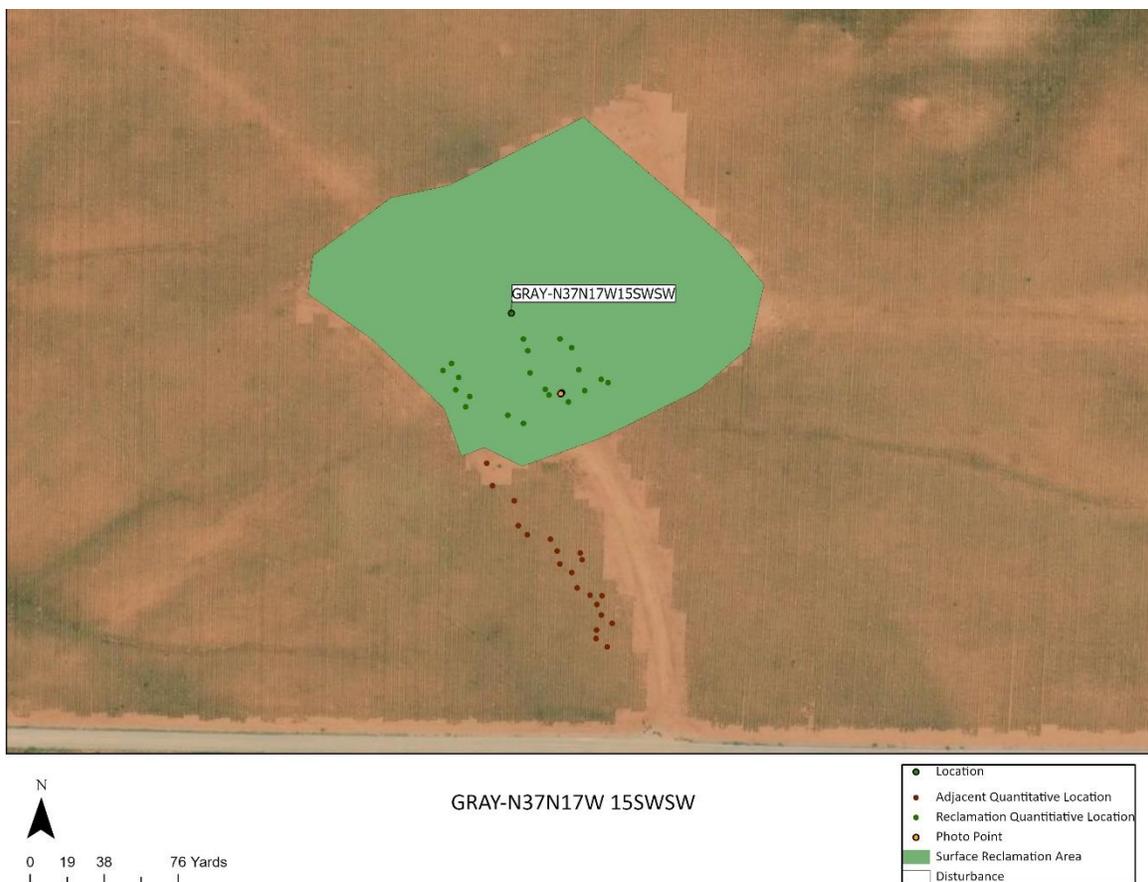
Qualitative monitoring was performed in the spring of 2019 at the reclamation site. Qualitative monitoring consists of capturing reclamation and reference site photos and inspecting the reclamation site in order to determine the reclamation activities appropriate to satisfy COGCC rule requirements (Map 1). The GPS coordinates of the photo point are 37.45803 N, -108.71672 W.

The points used where quadrats were placed can be seen above in Map 1.

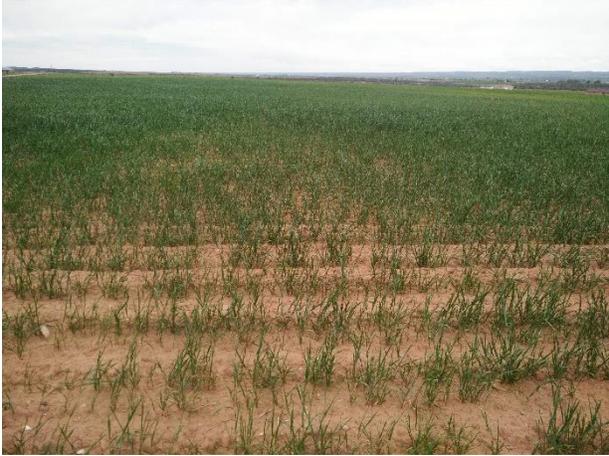
Photo 1. North facing

The most recent qualitative sampling occurred on May 16, 2019. Photographs of the sampling events are included in Appendix A. The site was observed to be in good condition with little to no differences in hay production compared to off-site. There are some sparse areas compared to off-site, however these are minimal and should improve with time.

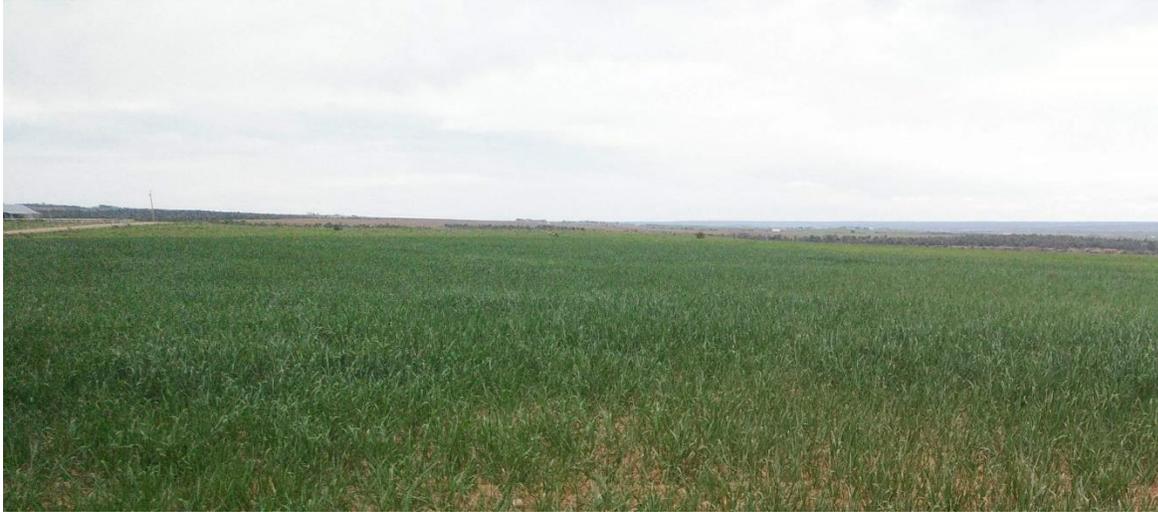
Reference Photo from Fall Qualitative Sampling

A reference site photo was captured on the N of the reclamation.
