SUNDRY NOTICE SUPPLEMENT

NEELY 39N 17W 7SWSW

HIGH POINT RESOURCES

October 2019

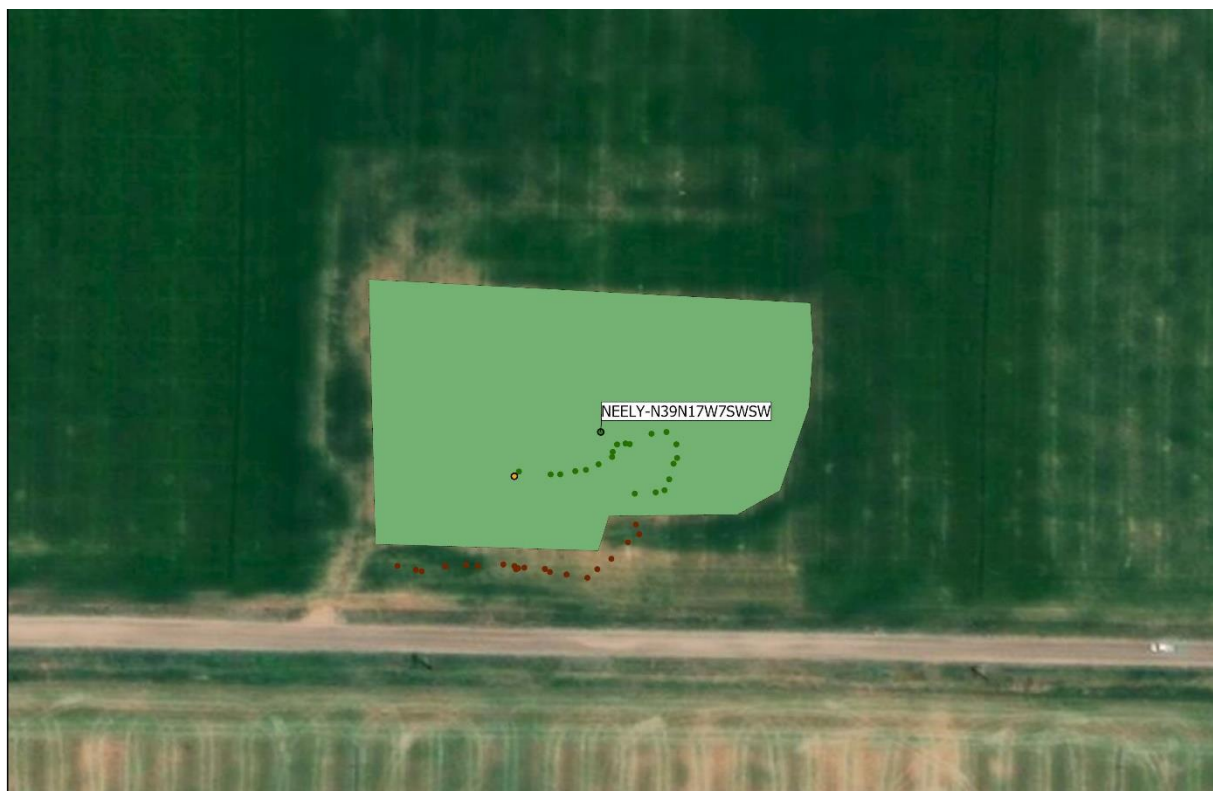
Map 1: Site Map and Monitoring Point Location

Qualitative monitoring was performed on May 17, 2019 at the reclamation site. Qualitative monitoring consists of capturing reclamation site photos and inspecting the reclamation site in order to determine if the reclamation activities are appropriate to satisfy COGCC requirements. The GPS coordinates of the photo point are 37.646688, -108.7717325, see Map 1.

The points used where quadrats were placed can be seen in Map 1.

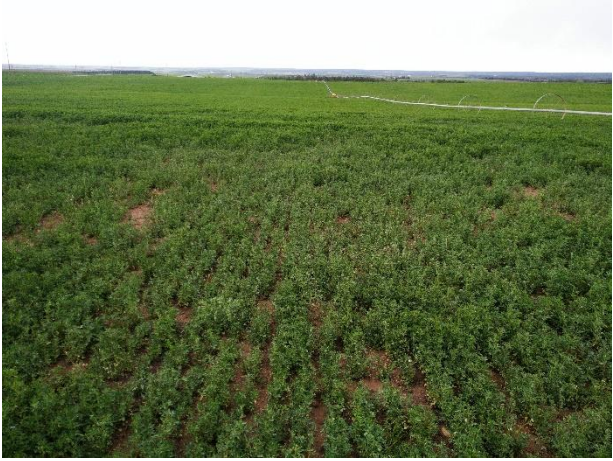
Photo 1. North facing

The qualitative sampling occurred on May 17, 2019. Photographs of the sampling events are included in Appendix A. The site was observed to have slightly lower production than the adjacent area but is still being used for agricultural production. There are no noxious weeds present. This site is recommended for release.

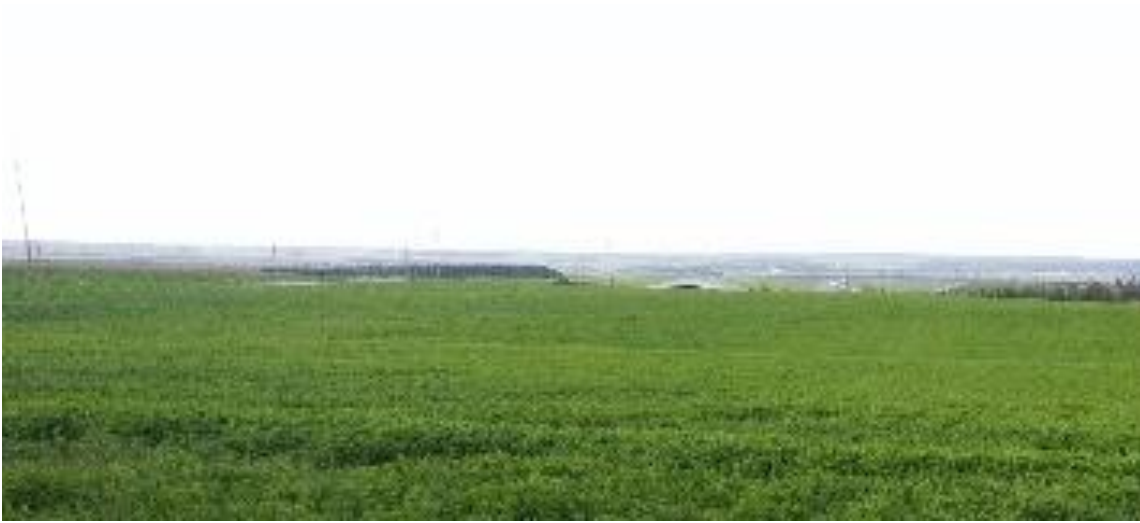
Reference Photo

A reference site photo was captured on the E of the reclamation.
