Final Reclamation Inspection

Operator: GREAT WESTERN OPERATING COMPANY LLC- #10110

Location ID: 317511

Inspection Photos
Location Name: KENNEDY #1
Location ID: 317511

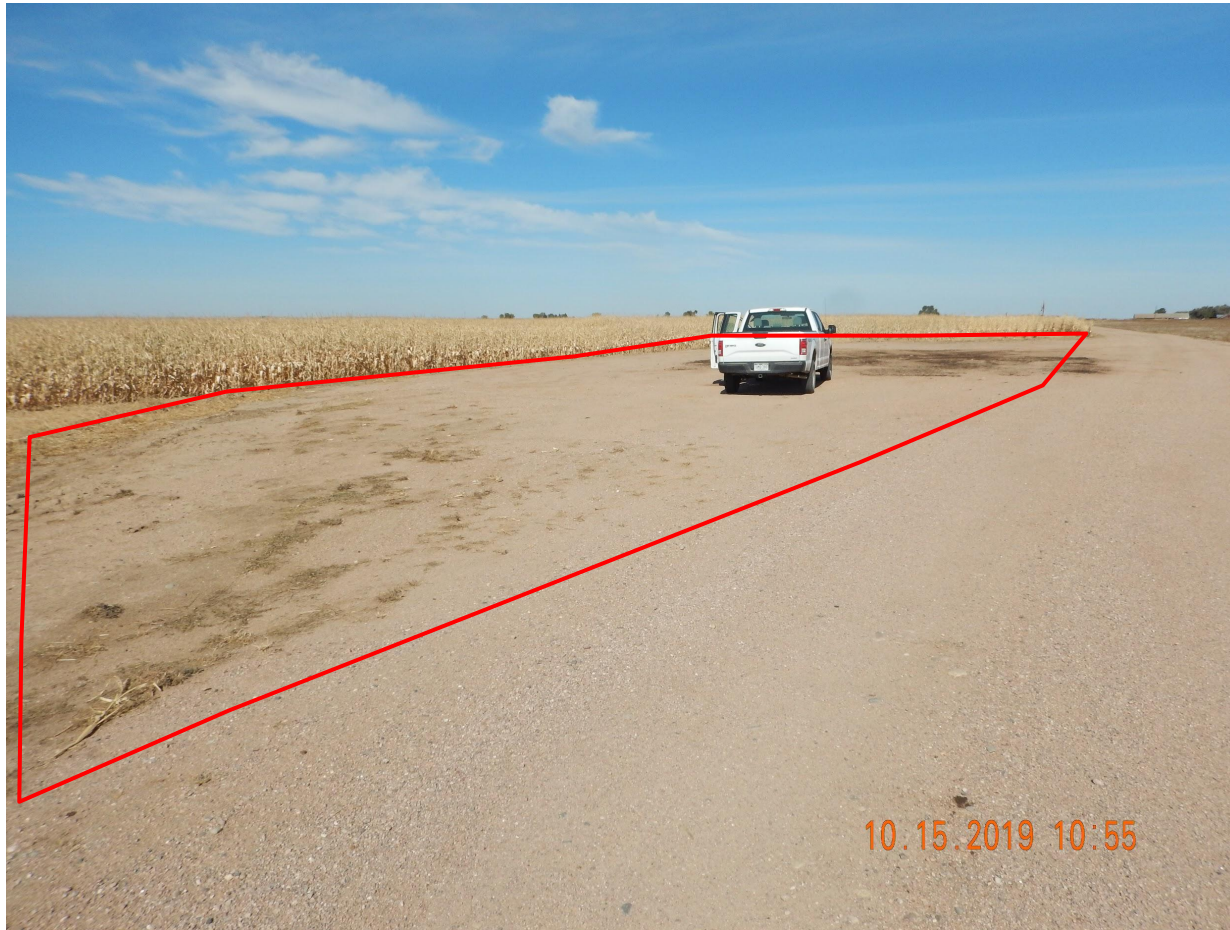
Photo 1. Photo taken from the southern location, facing North. Operator has failed to perform final reclamation activities at the location (i.e., remove gravel, decompact, seedbed prep and seed).

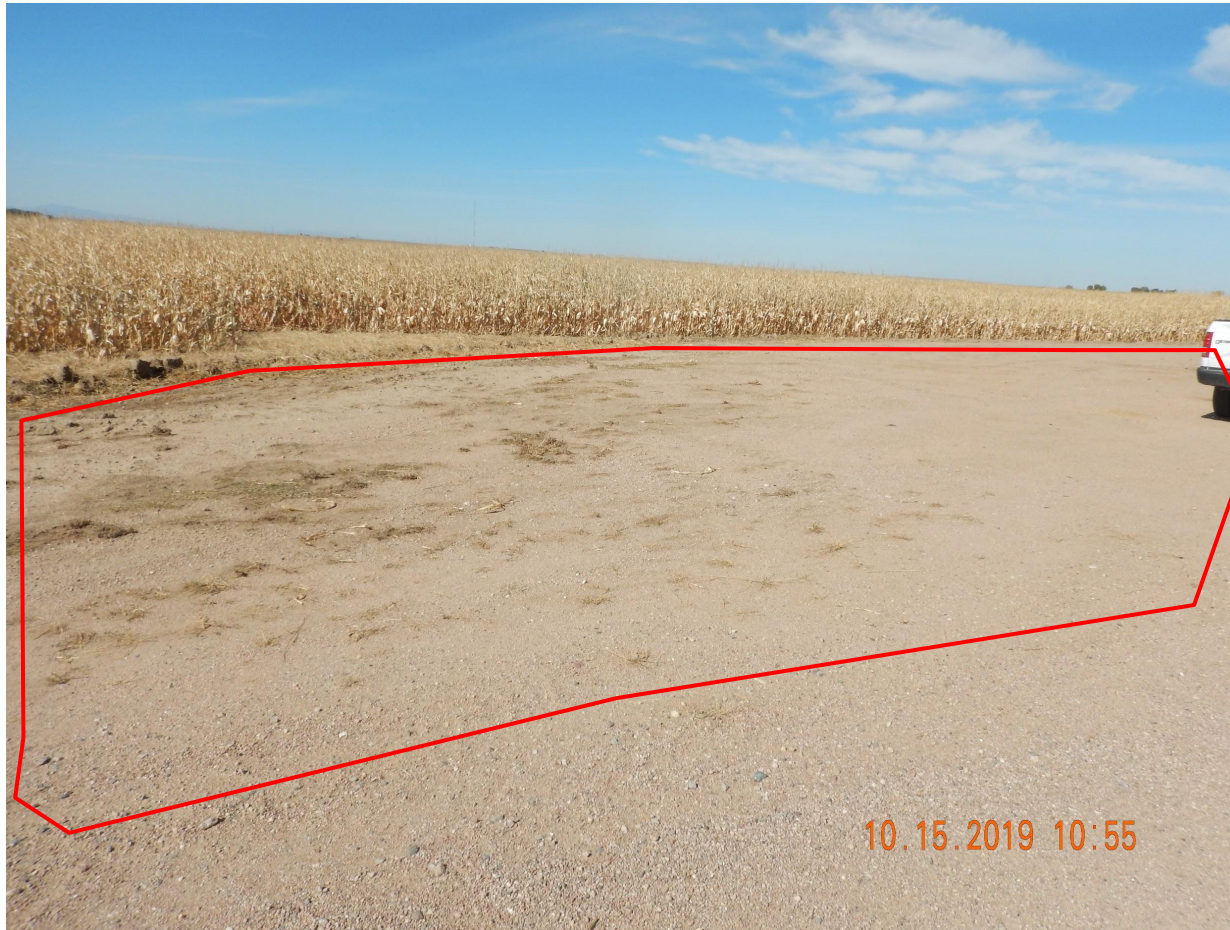
Photo 2. Photo taken from the southern location, facing West. See comments under Photo 1.
