Inspection Photos

Inspection Photos
Location Name: MANWAY 13-32 FOLLOWUP
API#: 05-071-06371
INSP. #: 695101580

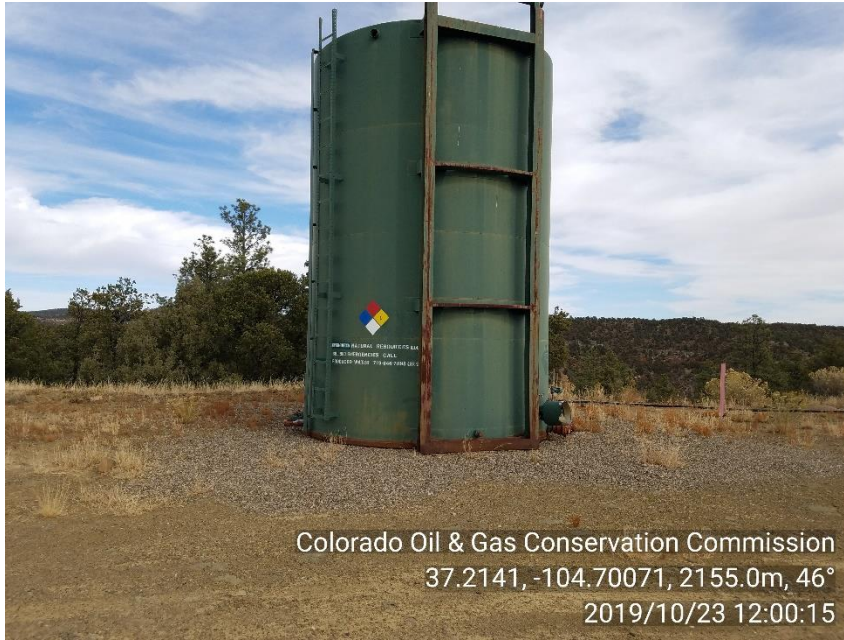
PHOTO 3: Inadequate berms around tank. Repair or install berms or other secondary containment devices per Rule 605.a.(4). CA DATE 11-23-19.

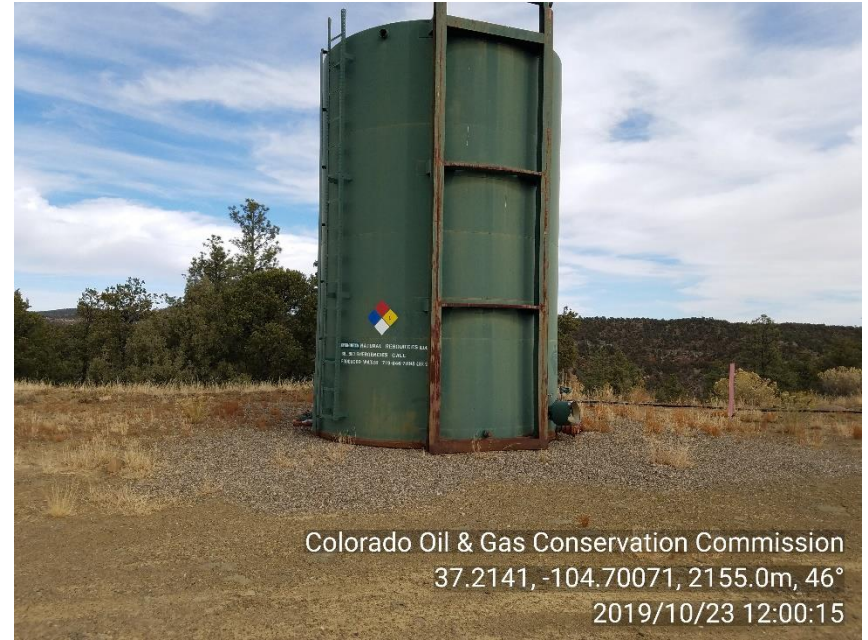
PHOTO 4: THIS TANK DOES NOT APPEAR TO BEING PLUMBED IN OR IN USE. UNUSED EQUIPMENT. REMOVE UNUSED EQUIPMENTN PER RULE 603.f. CA DATE 11-23-19.
