RE: COGCC Rule 1004 (Final Reclamation of Well Sites and Associated Production Facilities)
Well Name: Matt 1
API: 05-123-20011
Location ID: 331001
Location Name/No: MATT-64N67W /24NWSW
PLSS/Location: NWSW, Sec. 24, T4N R67W, 6 P.M., Weld County, Colorado

PDC Energy, Inc. (PDC) has prepared a summary report documenting the progress in meeting the vegetative standard specified by Rule 1004.c for the former Matt 1 (331001) wellhead and production facility locations in response to COGCC Order No. 1V-678. This report contains reclamation inspection findings from a qualified third party consultant conducted between November 2018 to September 2019.

Reclamation Inspection Report

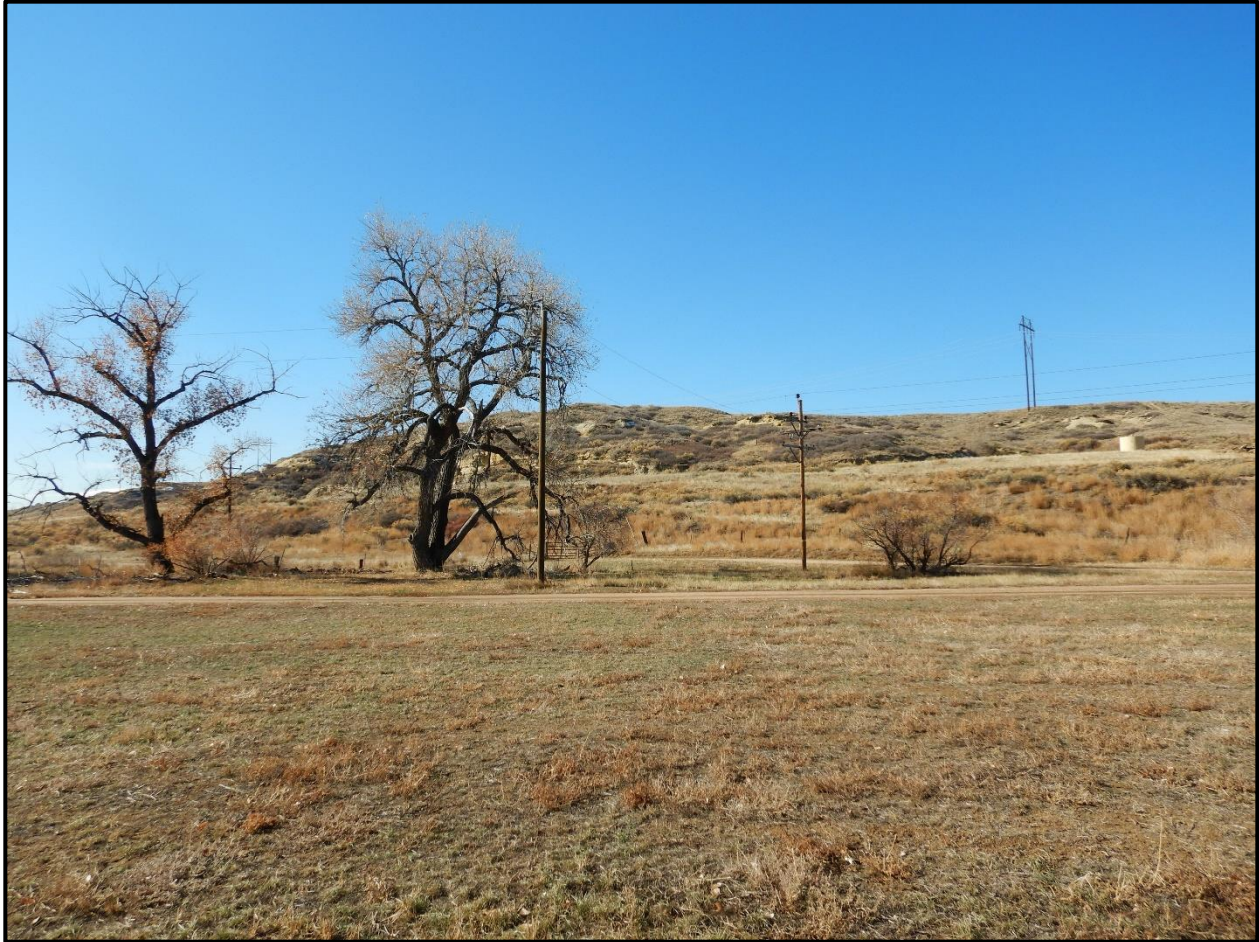
Site Name: Matt 1 (production facility)
Overview photo

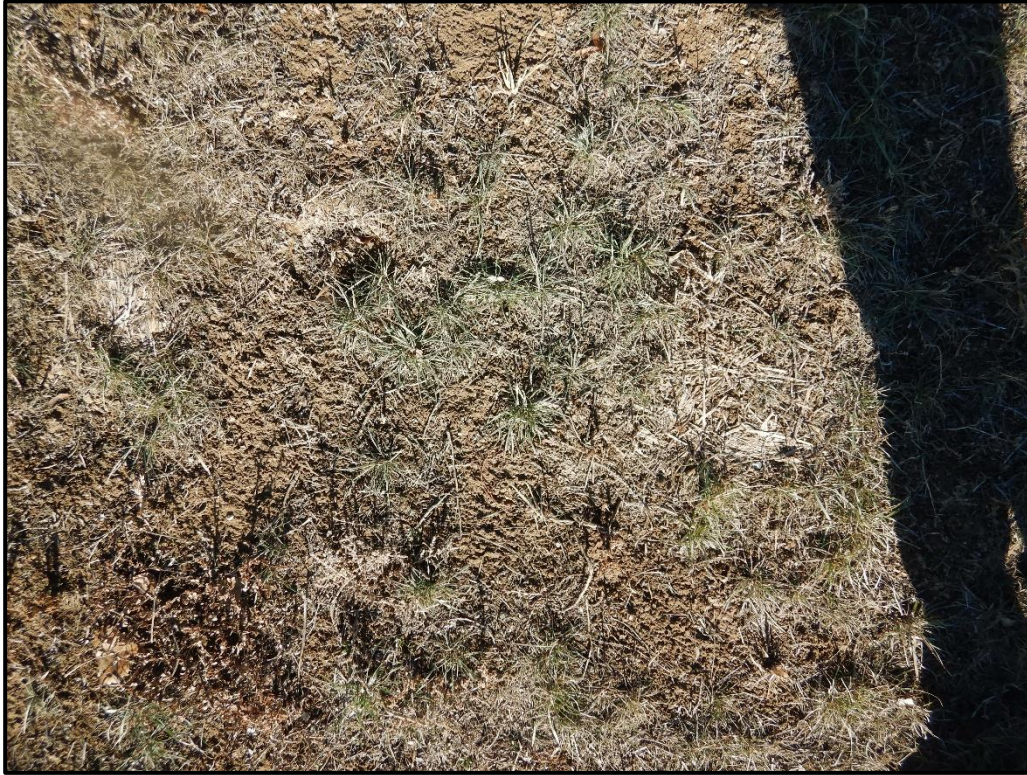
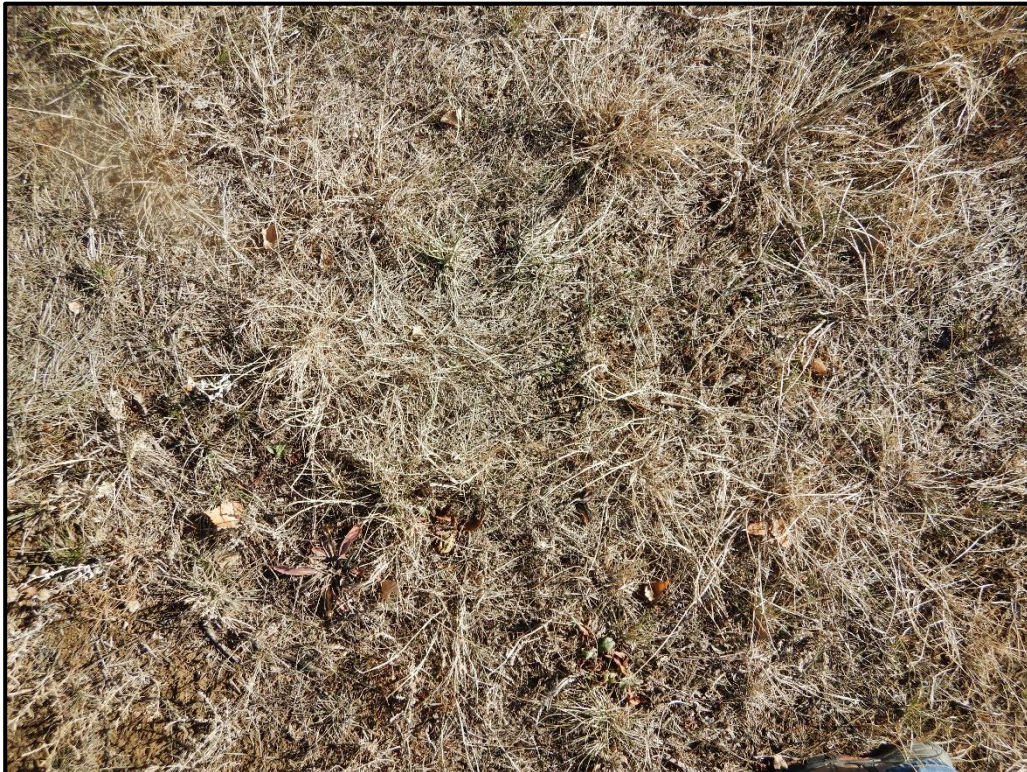
Site Name: Matt 1 (production facility)

Reclaimed disturbance vegetation cover (upper) vs. background/reference area vegetation cover (lower)

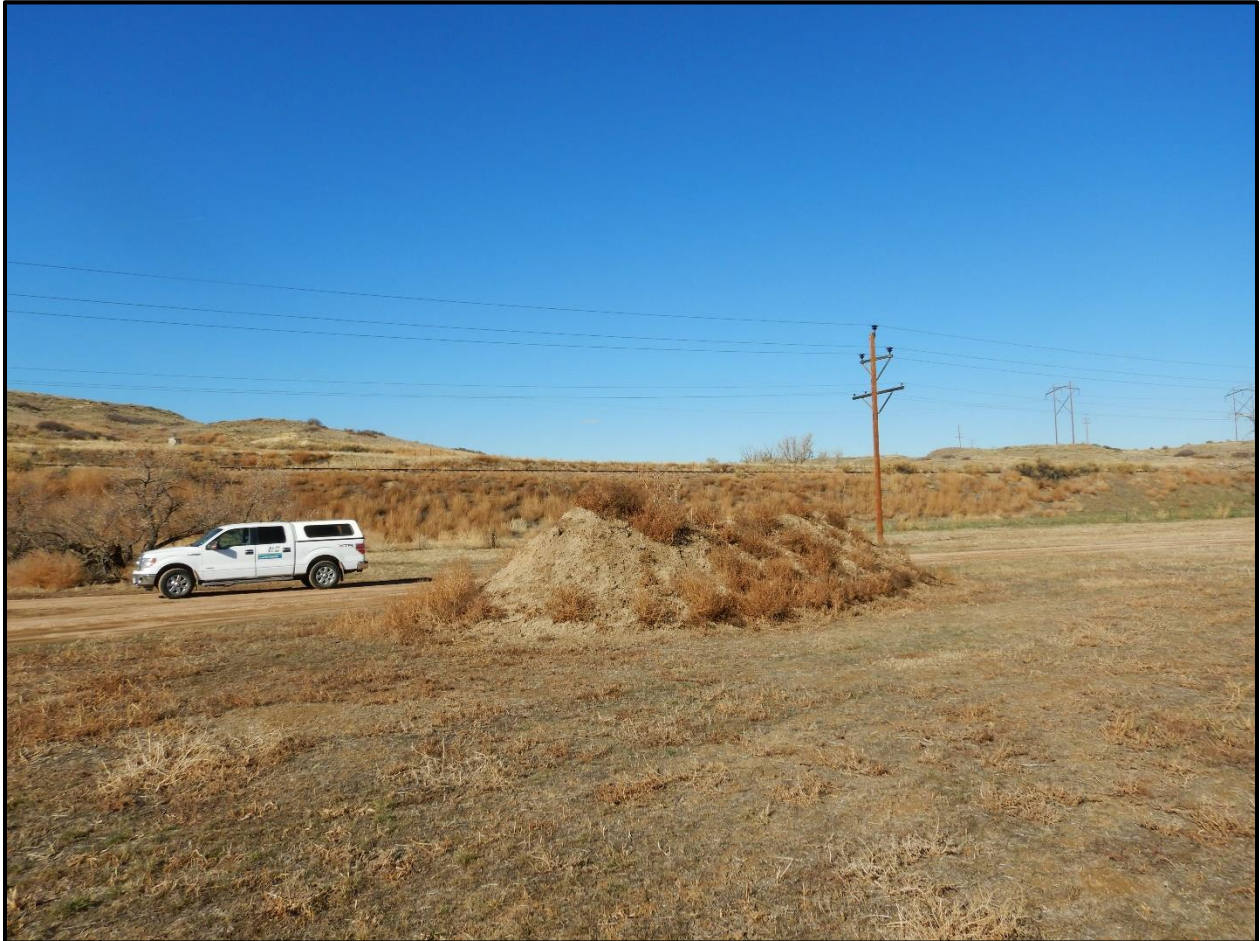
Site Name Well 1 (production facility)
Finddown dirt pile leftover from facility demolition; pile approved by the COGCC on March 1, 2018 via email by Chris Binchus.

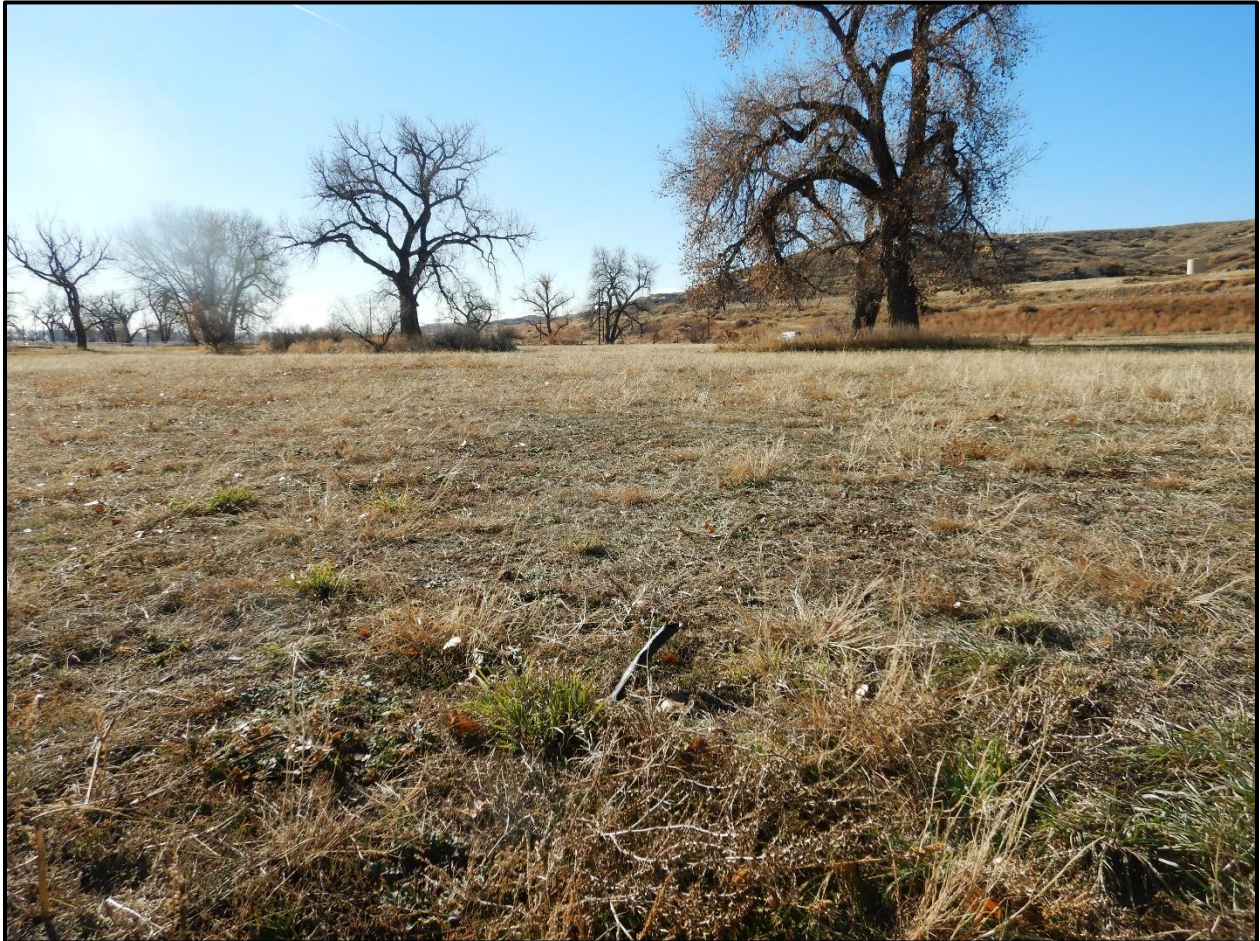
Site Name: Matt 1 (wellhead)

Oil and Gas Well/Pad	
Does any Oil and Gas equipment remain on location?	Yes
If No, describe remaining equipment: Partially buried poly pipe observed directly southwest of well location at November 19, 2018 inspection. Poly pipe was removed immediately after this observation.	
Are there noxious/listed weeds present?	No
Are the noxious/listed weeds originating from the surrounding land or from the reclamation?	
Describe Weeds and Extent:	
Does the well/production facility pad remain and need dirt work to reclaim?	No
If Yes, describe pad features that remain on location:	
Are there any signs of settling on location?	No
If Yes, describe settling:	
Is there any evidence of SWMP erosion, sediment movement or future potential for SWMP concerns?	No
If Yes, describe erosion and/or sediment issues/concerns:	
What are the land use(s) of the location?	Pasture/Grazing
If the land use includes cropland, has the former pad/well location been reestablished by the landowner as cropland?

Partially buried poly pipe observed directly southwest of well location at November 19, 2018 inspection. Poly pipe was removed immediately after this observation.

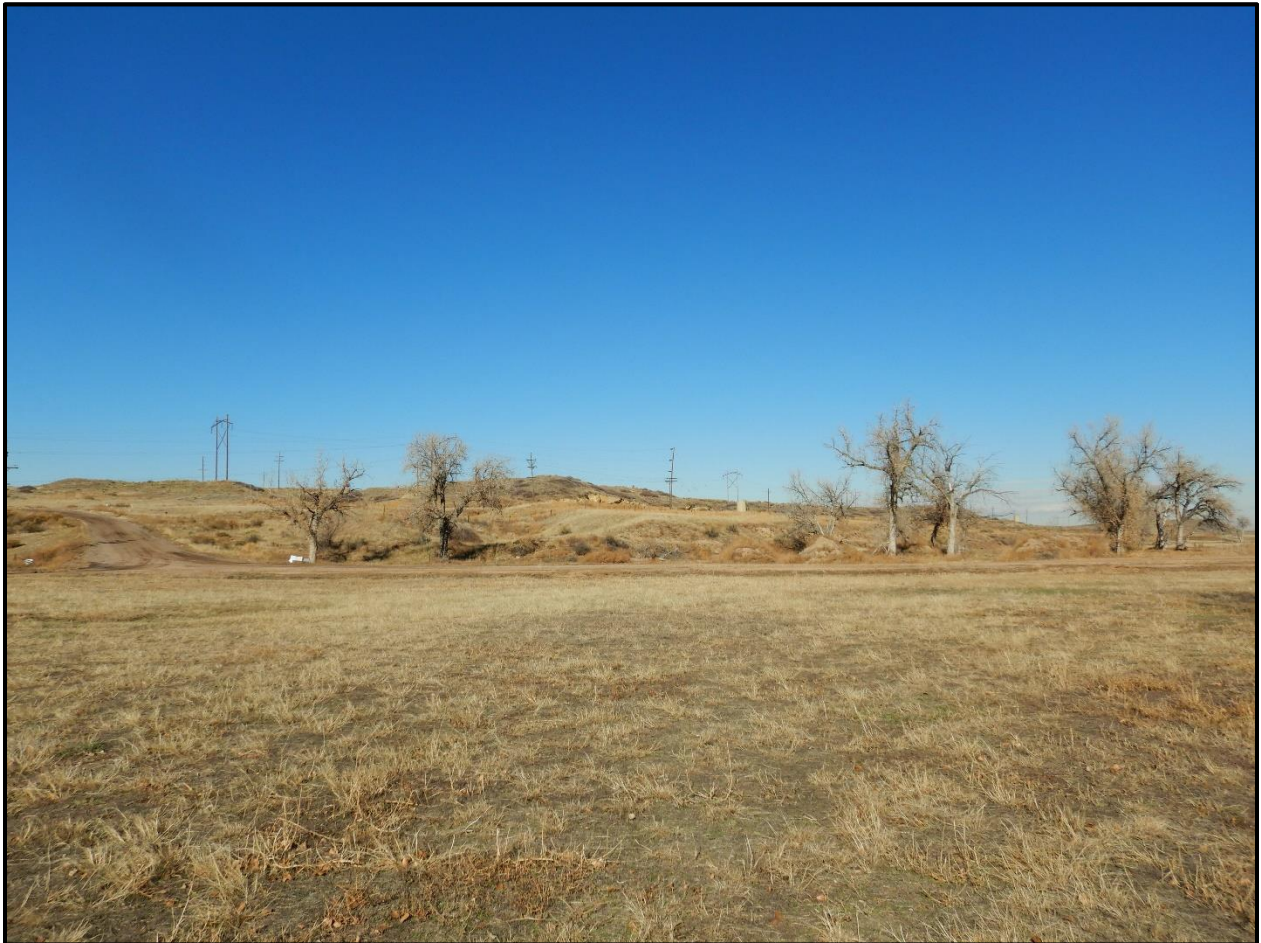
Site Name: Matt 1 (wellhead)
Overview photo

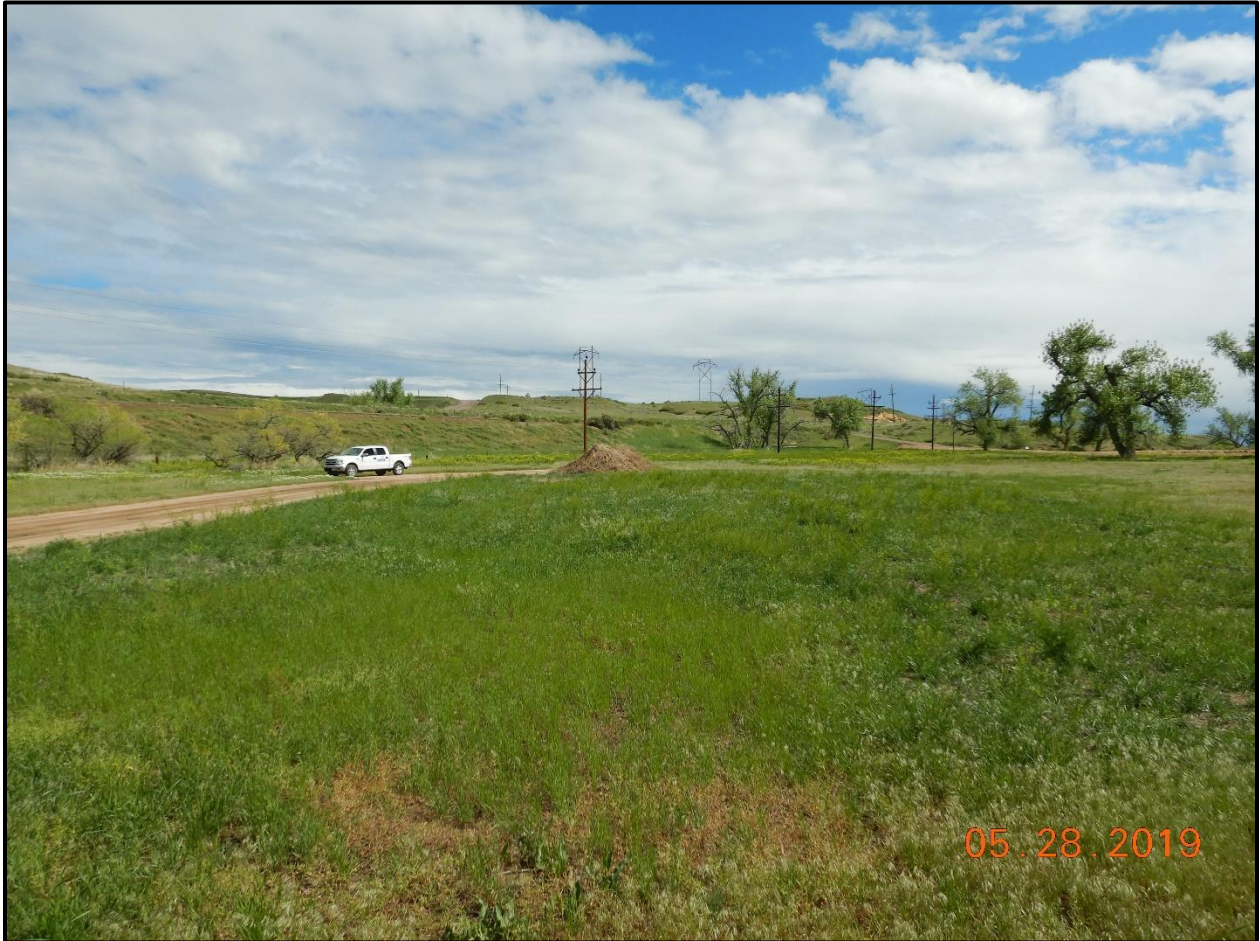
Site Name: Matt 1 (production facility)
Overview photo looking north

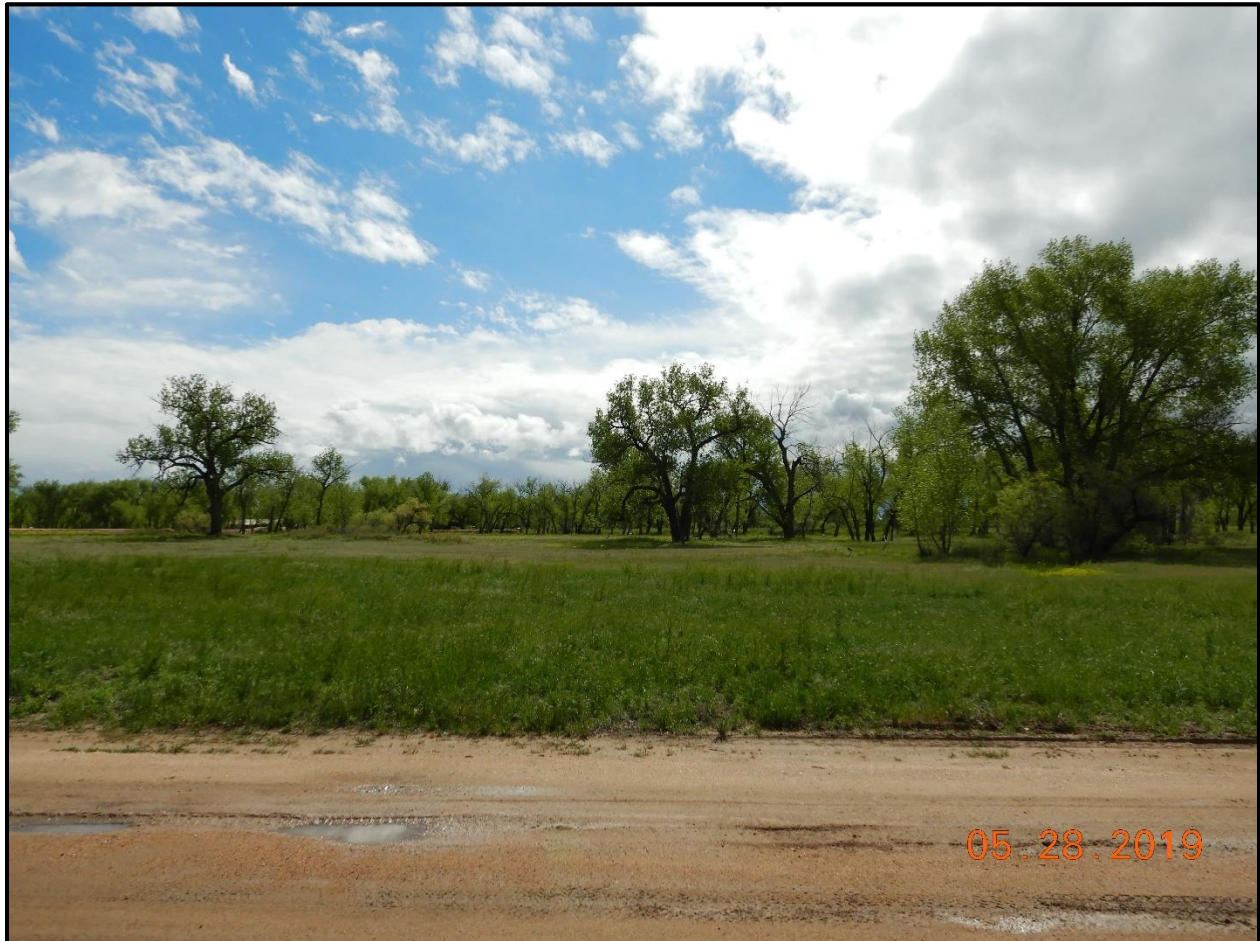
Site Name: Matt 1 (production facility)
Overview photo looking east

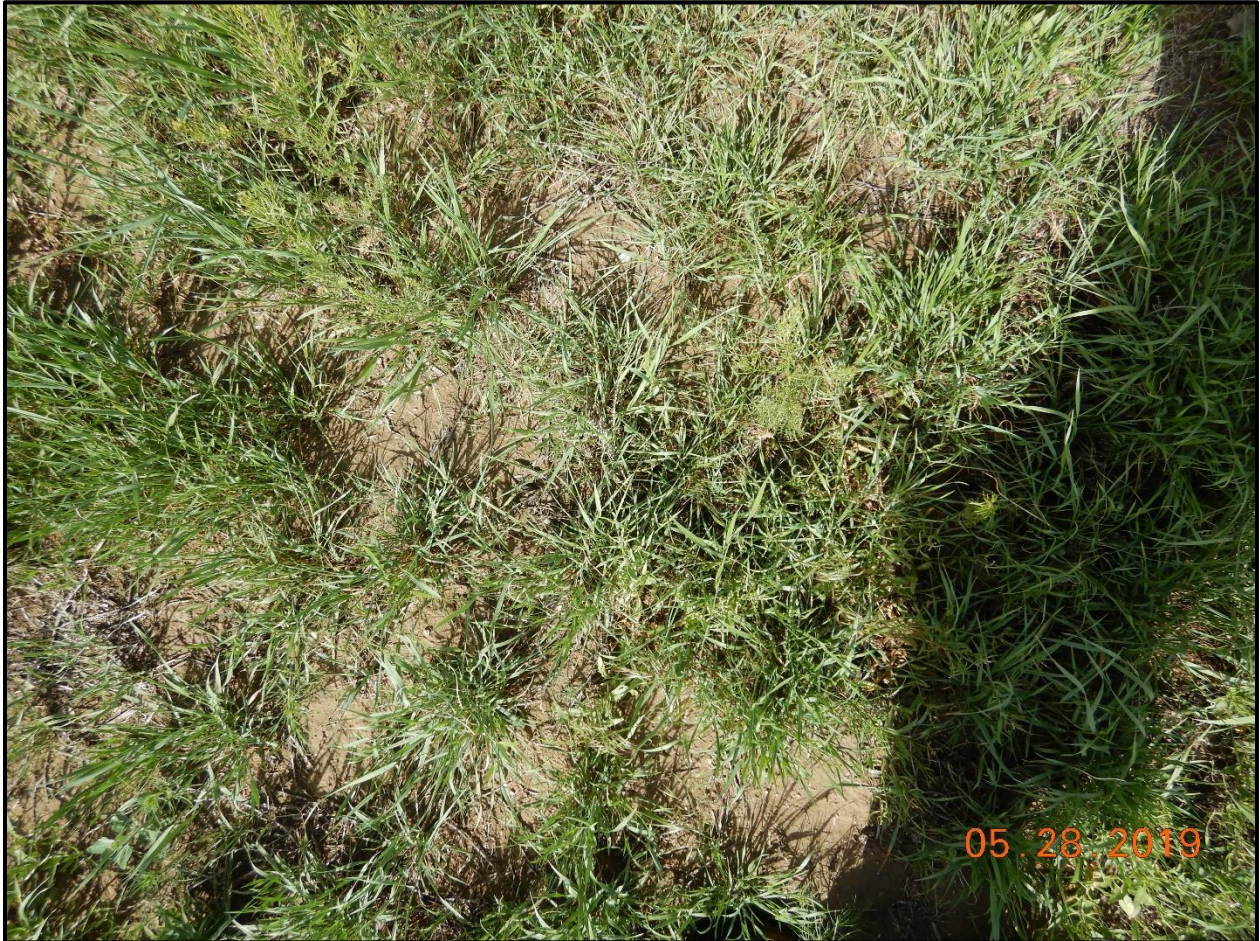
Site Name: Matt 1 (production facility)

Ground photo of canopy cover in reclaimed area. Overall, seeded perennial grasses have taken well with little annual grass/forb content present.

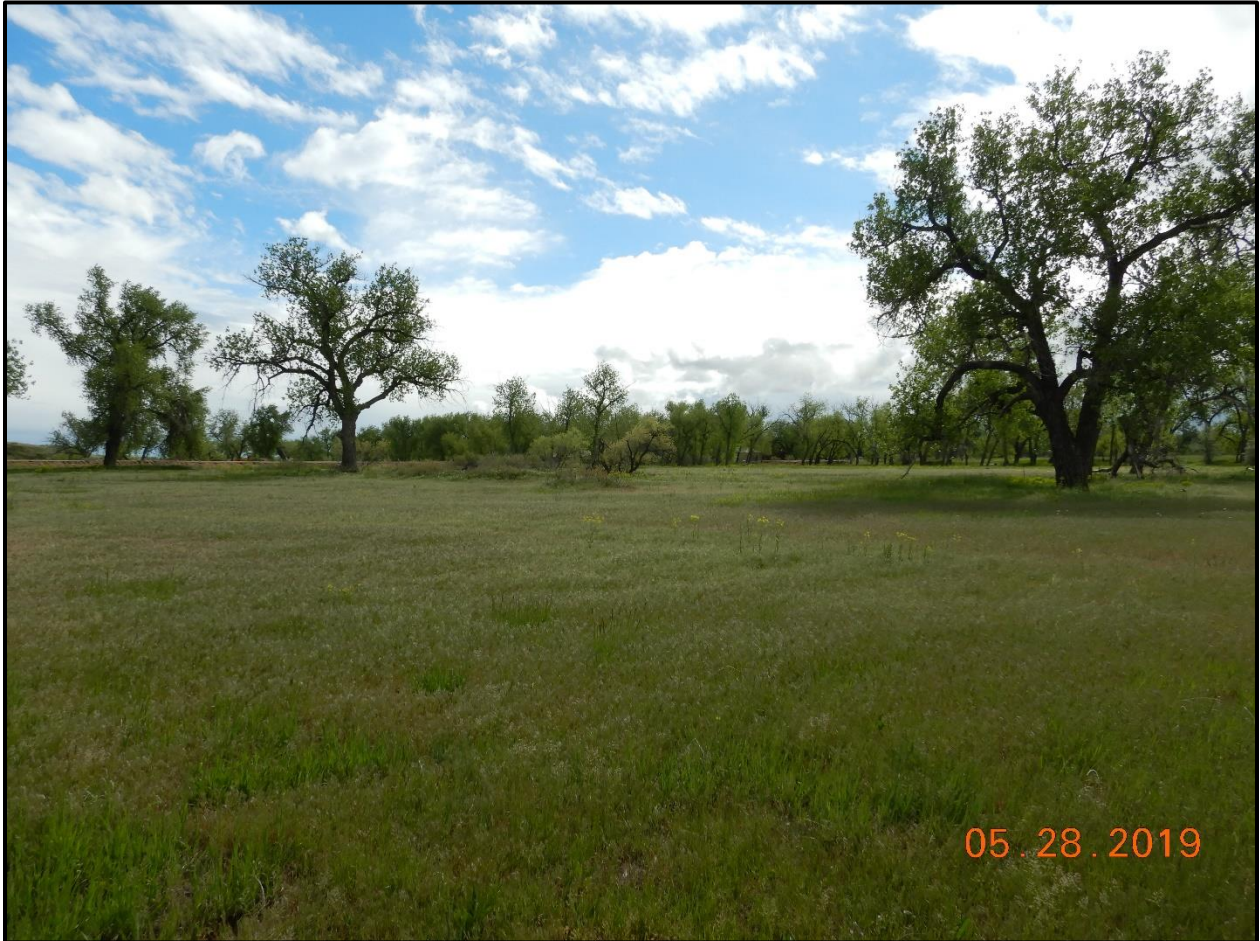
Site Name: Matt 1 (production facility)

Reference photo of background vegetation, a mixture of annual/perennial grasses and forbs with high cheatgrass content

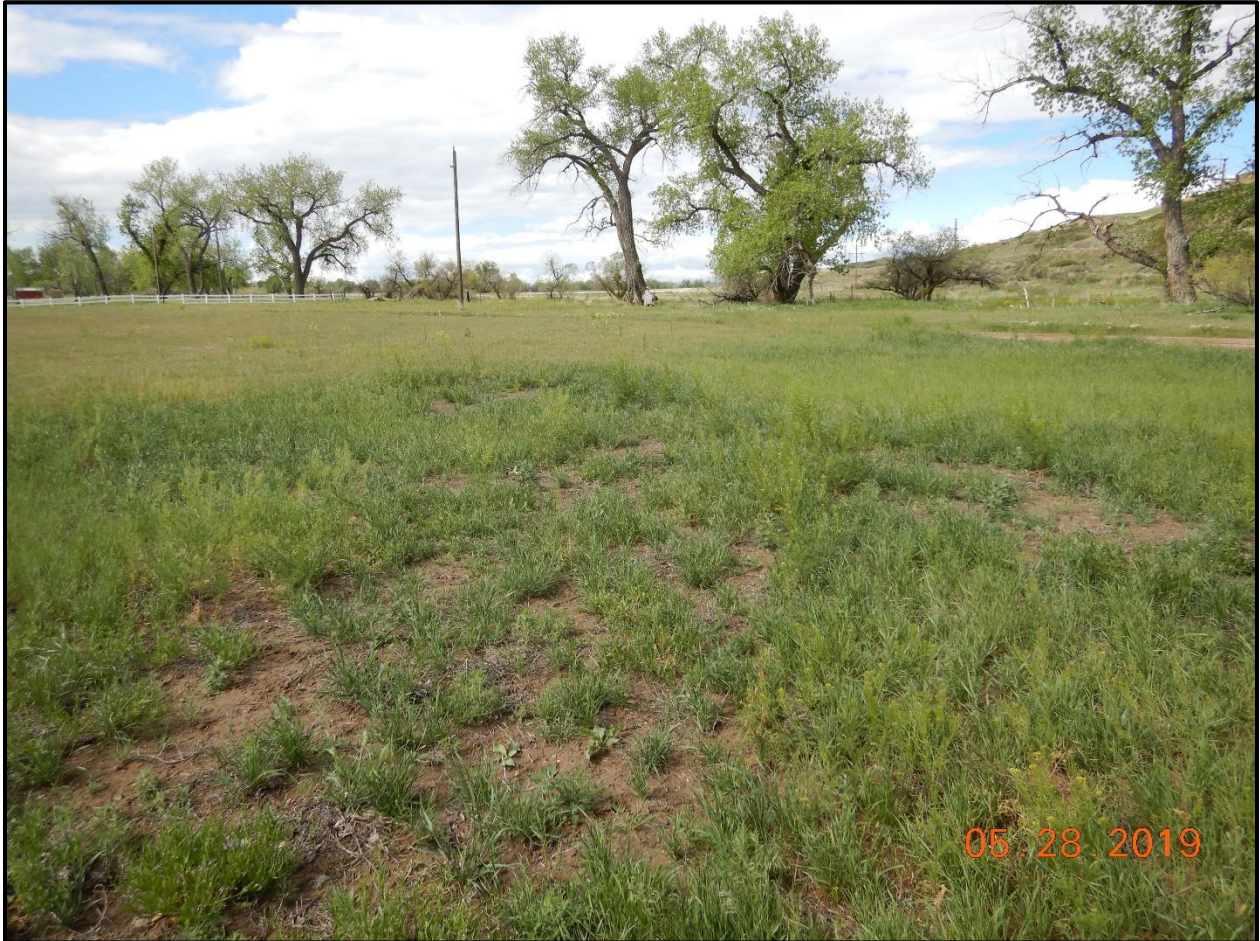
Pad Final Assessment	
Ocular Estimate of desirable species density relative to adjacent native/undisturbed vegetation?	80 +
As the inspector, are you confident this pad/well site will meet all of the release criteria (including at least 80% plant cover over the entire location, equipment left on location, weeds, etc.)?	No
* If no, describe what is needed to get the location to final reclamation:	
Does a SamplePoint or line point analysis need processed to confirm final reclamation status on the well/pad location?	No
Pad Reclamation Notes:	Desirable species present in the reclaimed area include crested wheatgrass and snow-on-the-mountain. Some patchy areas are present the site's northern and southern ends, which would presumably benefit from additional growing season time.

Site Name: Matt 1 (production facility)
Patchy vegetation (with more bare ground) at site's southern end

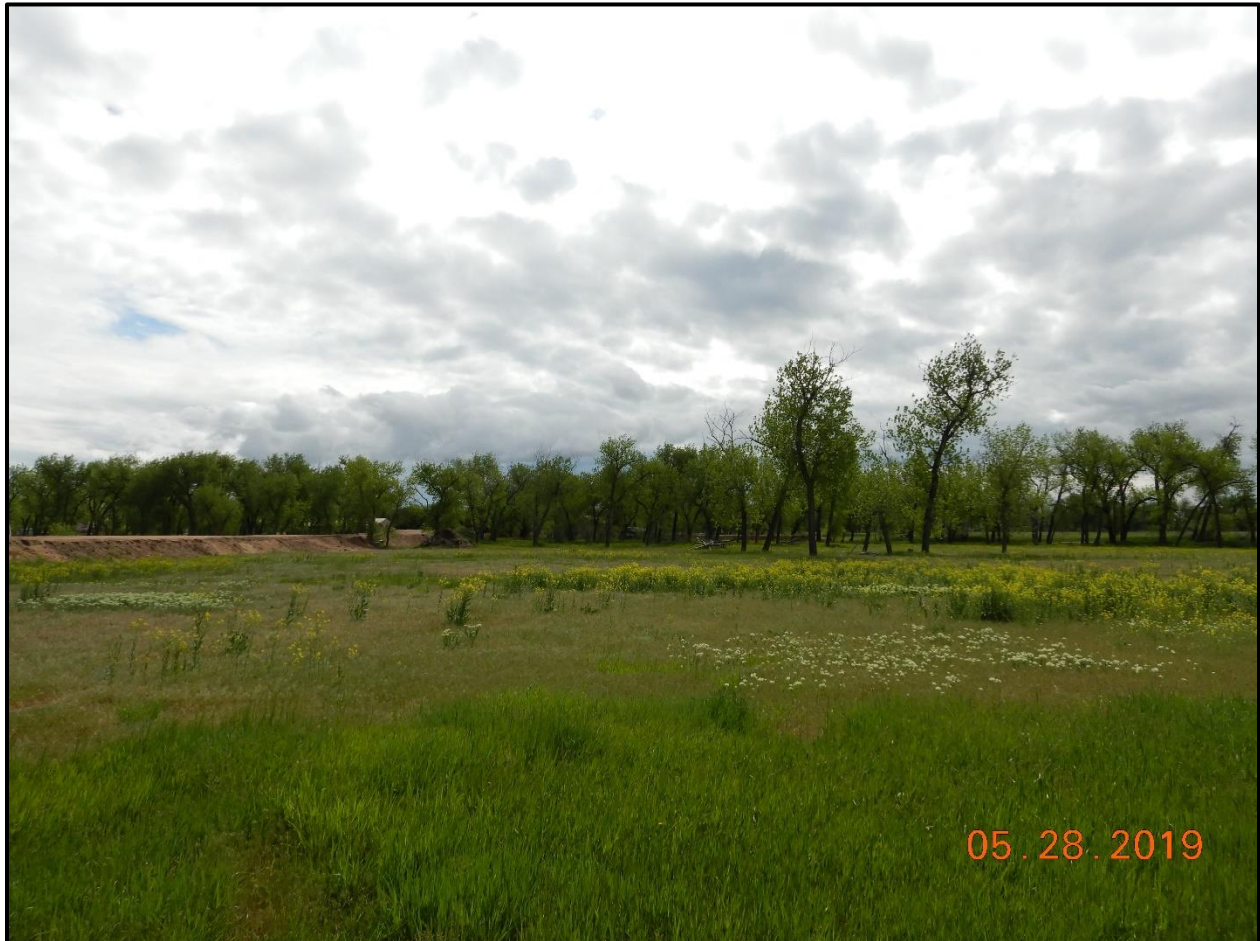
Site Name: Matt 1 (wellhead)

Overview photo looking east. Though the wellhead location hasn't received traditional reclamation techniques (e.g., seeding/mulching) in recent memory, this area is nearly indistinguishable from the background due to repeated disturbance such as grazing, mowing, etc., as shown by historical Google Earth imagery.

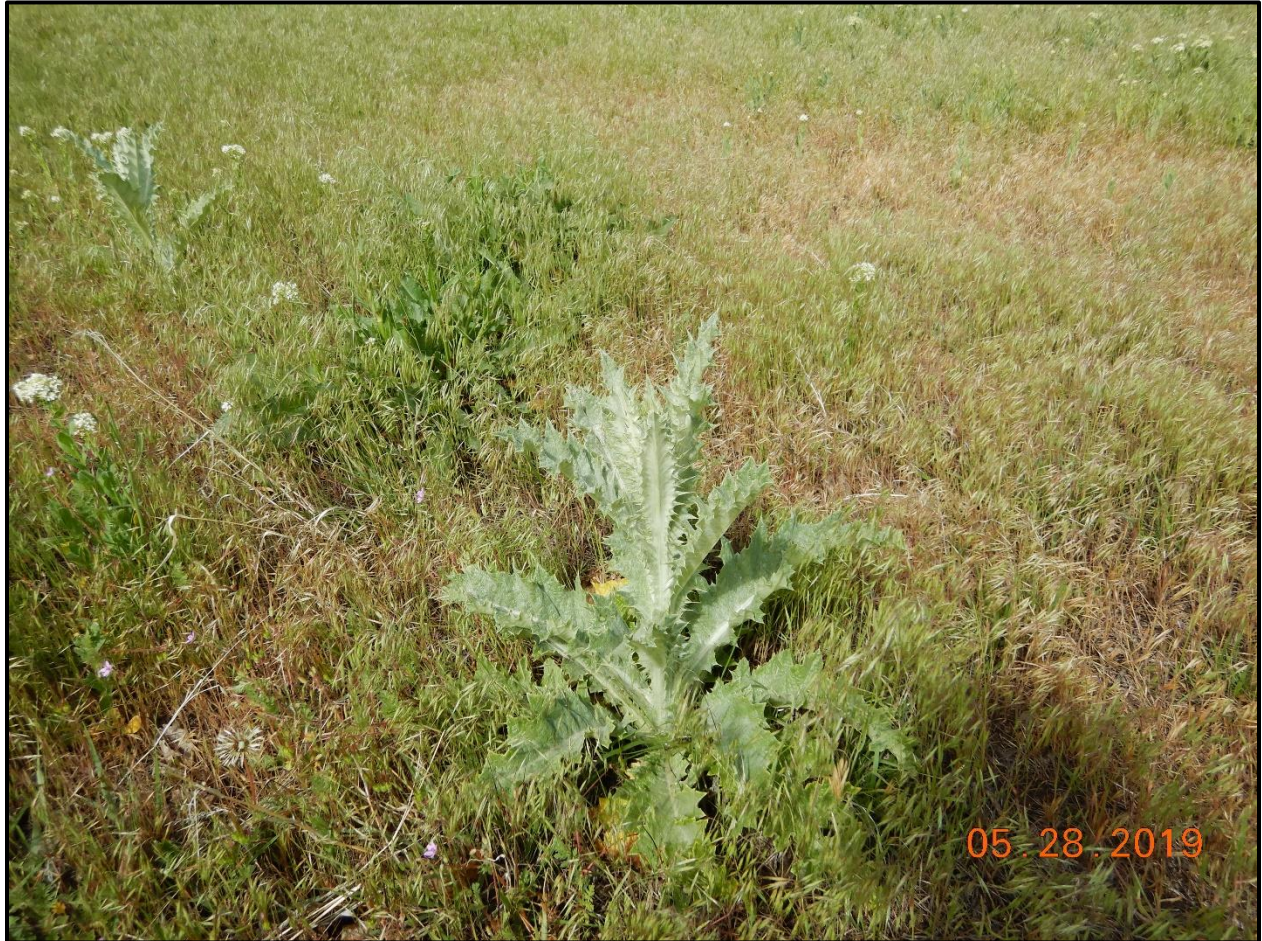
Site Name: Matt 1 (wellhead)

* If weeds are present, where are they originating from?	Surrounding Landscape	
* If weeds present, describe:	Cheatgrass throughout and Canada thistle sprouting near (or on) SE edge of former disturbance	
Does any oil and gas equipment remain on location?	No

Pad Final Assessment	
Ocular Estimate of desirable species density relative to adjacent native/undisturbed vegetation?	80 +
As the inspector, are you confident this pad/well site will meet all of the release criteria (including at least 80% plant cover over the entire location, equipment left on location, weeds, etc.)?	No
* If no, describe what is needed to get the location to final reclamation:	
Does a SamplePoint or line point analysis need processed to confirm final reclamation status on the well/pad location?	No
Pad Reclamation Notes:	Desirable species present in the reclaimed area include crested wheatgrass, western wheatgrass, and smooth brome. Canopy cover of assumed original disturbance matches the immediate background the south, however, noxious weeds such as cheatgrass (list C) and Canada thistle are present on or near disturbance area.

Noxious weeds - Canada thistle (list B) and cheatgrass (list C)

Inspection Date	Production Facility Observations	Wellhead Observations	PDC Corrective Actions
11/19/2018	<p>Production facility disturbance in process of re-vegetation. Good initial germination rate.</p> <p>Dirt pile labeled "landowner dirt" present just north of former battery. This pile was approved to be on location by the COGCC via email dated March 1, 2018.</p> <p>Vegetation percentages (of background): ~19%</p>	<p>Wellhead location re-vegetation nearly match background.</p> <p>One inch poly-pipe was observed in the ground</p> <p>Vegetation percentages (of background) 80%</p>	<p>No corrective actions performed.</p> <p>Poly-Pipe was removed.</p>
5/28/2019	<p>Disturbance's vegetative cover increased substantially;. Several Class C noxious weeds observed.</p> <p>Vegetation percentages (of background): ~60-80%</p>	<p>The ground cover matches background. Some Canada/Musk thistle at edge of disturbance.</p> <p>Vegetation percentages (of background) ~80%</p>	<p>PDC performed weed control on June 13, 2019 on the well pad and production facility.</p>

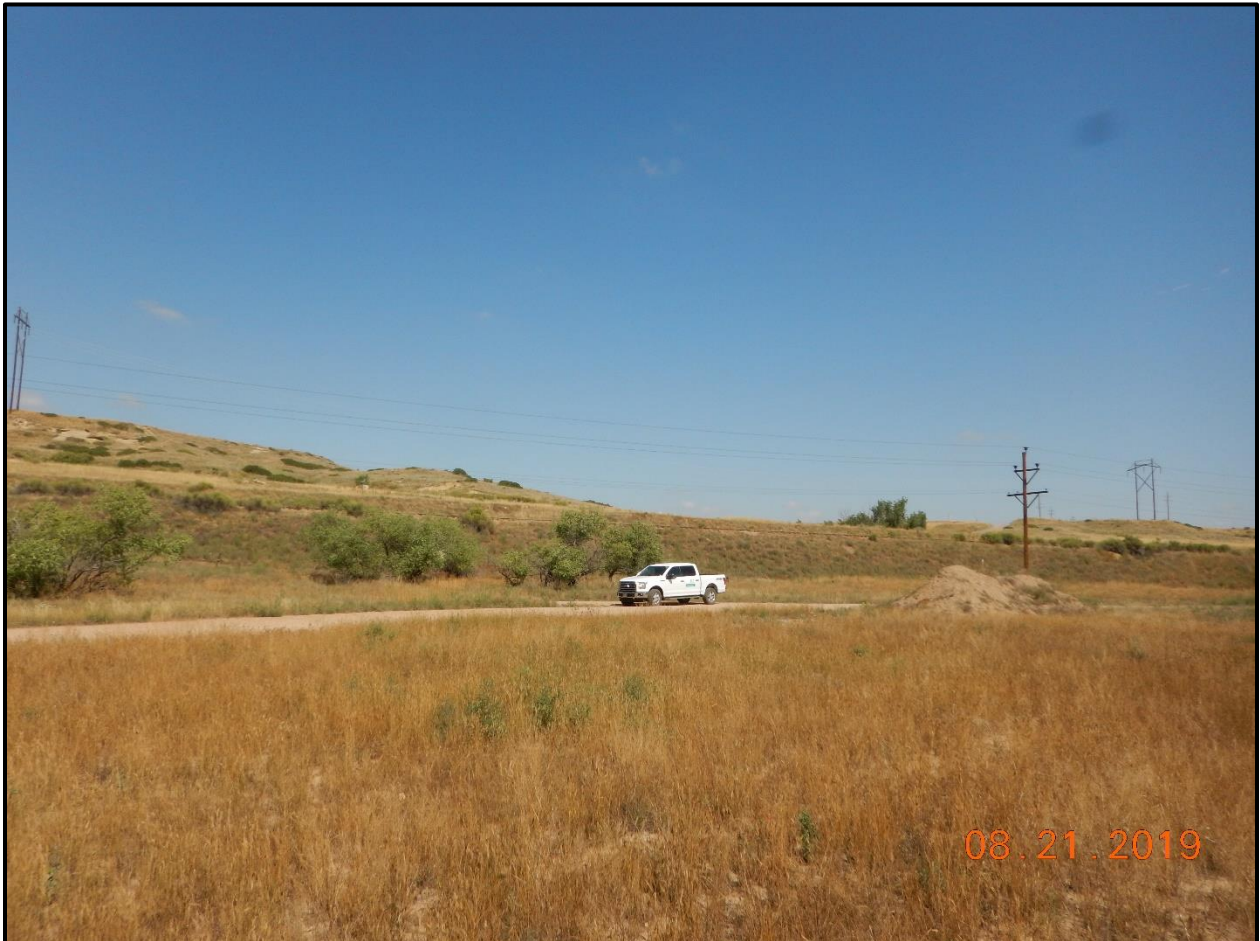
Site Name: Matt 1 (production facility)
Overview photo looking north

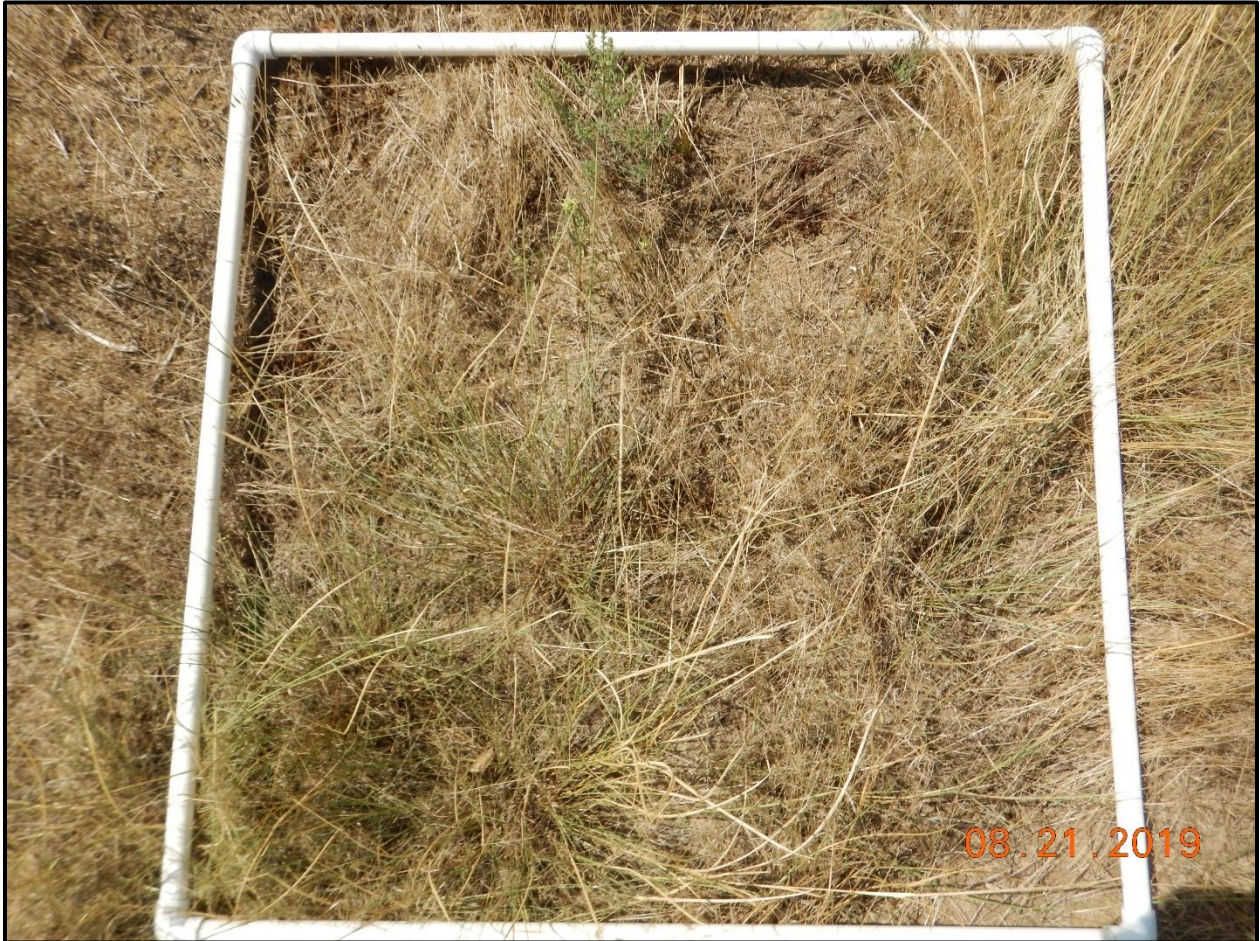
Site Name: Matt 1 (production facility)
Reference/native vegetation

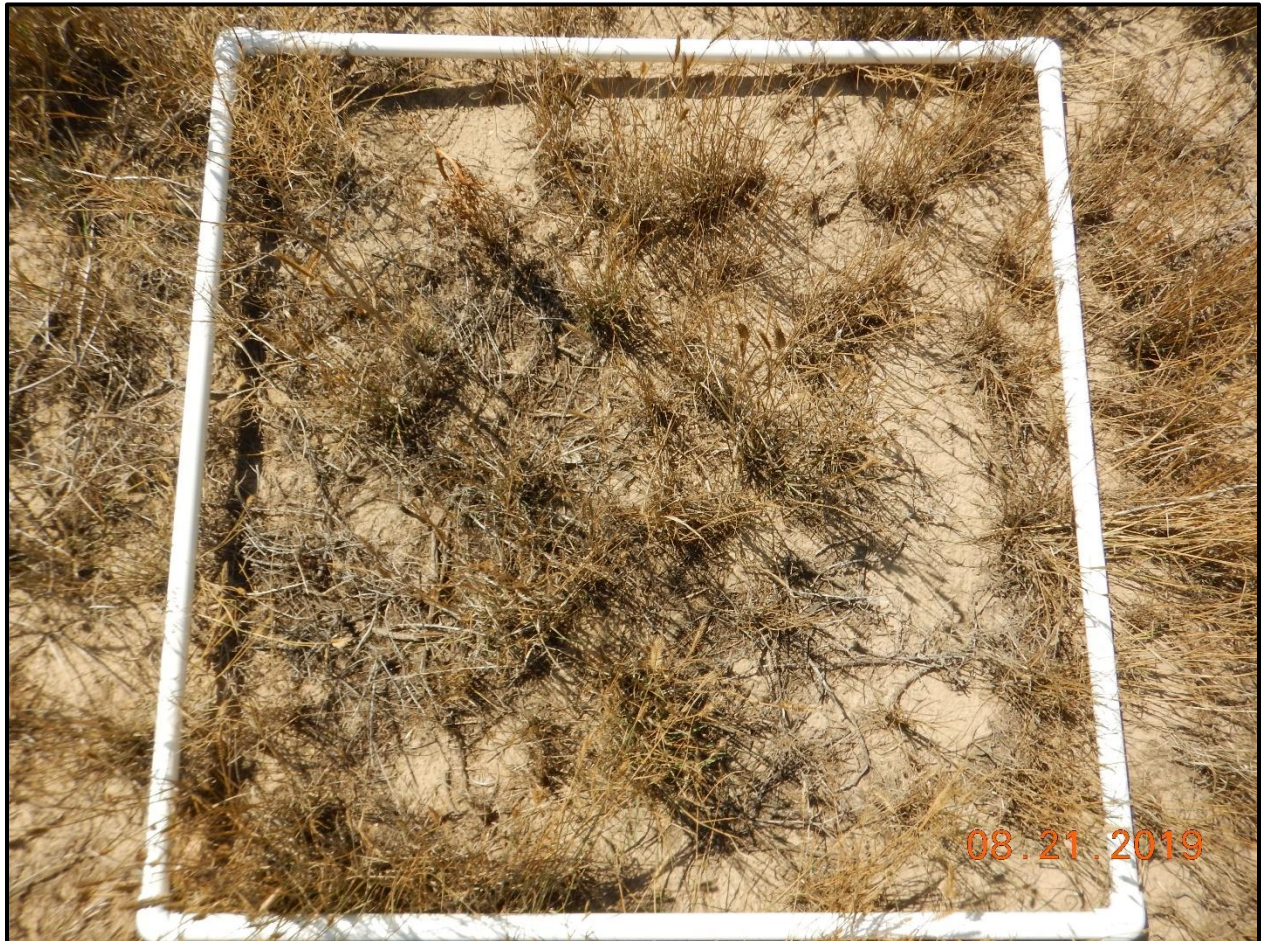
Describe Impaired Crops:	
Has the pad/well location been seeded and is the vegetation cover uniform?	Yes
% of uniform vegetative cover over entire pad/well site (ocular evaluation):	60 to 79
When was this inspection conducted (season)?	Growing Season
Should this location be seeded/reseeded?	
As the inspector, you are confident this pad/well site will meet all of the release criteria (including at least 80% plant cover over entire location, equipment left on location, weeds, etc.)?	
Does a SamplePoint or Line Point analysis need run to confirm final reclamation status on the well/pad location?	No
Describe what is needed to get location to final reclamation: More time for sufficient vegetation.	
Additional well/pad comments: Species findings the same as at the May 2019 inspection. Some bare areas with patchy vegetation are present at the site's northern and southern ends.

Site Name: Matt 1 (production facility)
Reclamation vegetation

8/21/2019	<p>Vegetation cover similar as May 2019 inspection.</p> <p>List B & C noxious weeds were observed</p> <p>Vegetation percentages (of background): 60-80%</p>	<p>The ground cover matches background.</p> <p>List C noxious weeds were observed</p> <p>Vegetation percentages (of background): ~80%</p>	<p>PDC will conduct pre-emergent weed control prior to next growing season.</p>

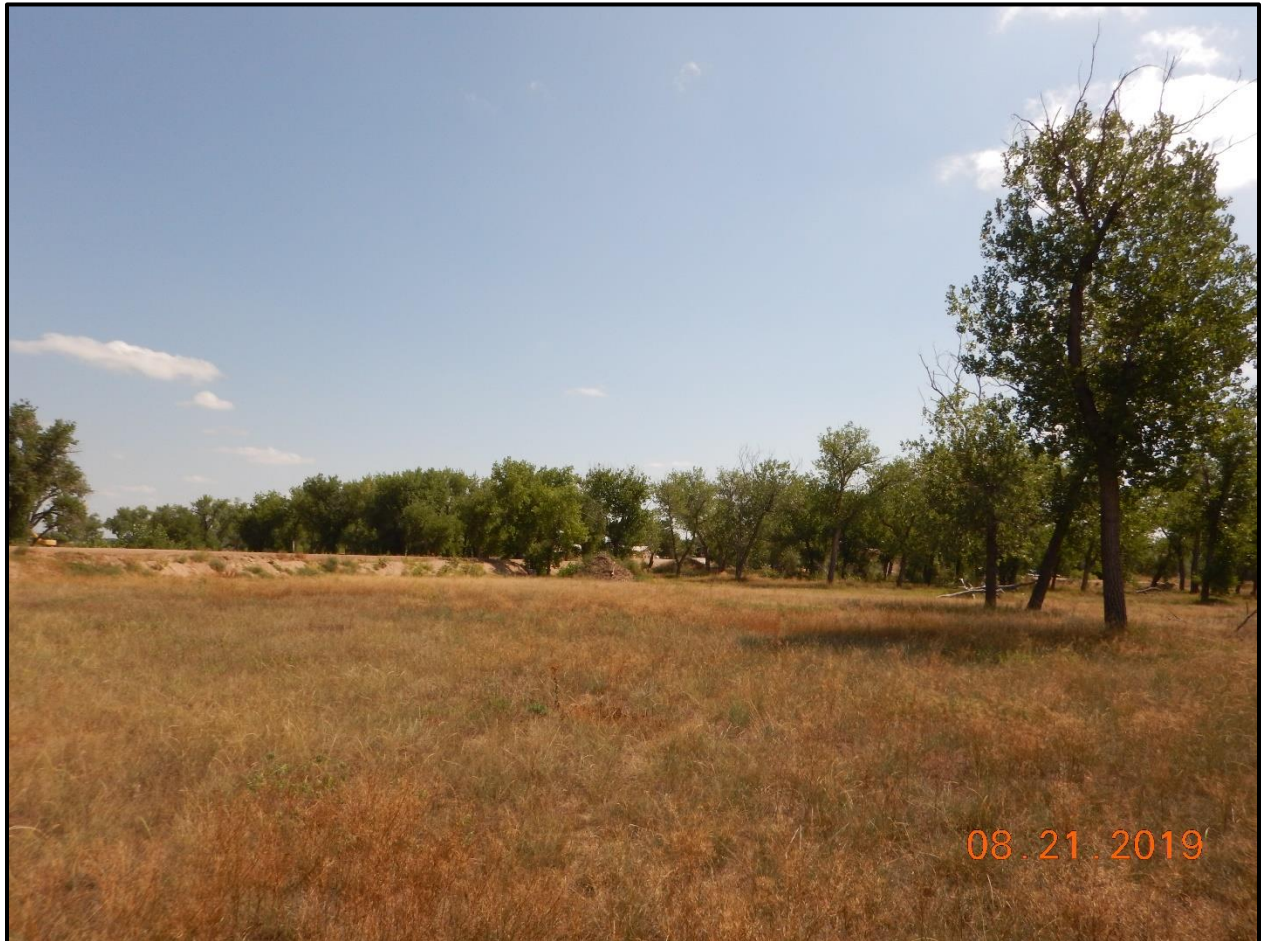
Site Name: Matt 1 (wellhead)
Overview photo looking east

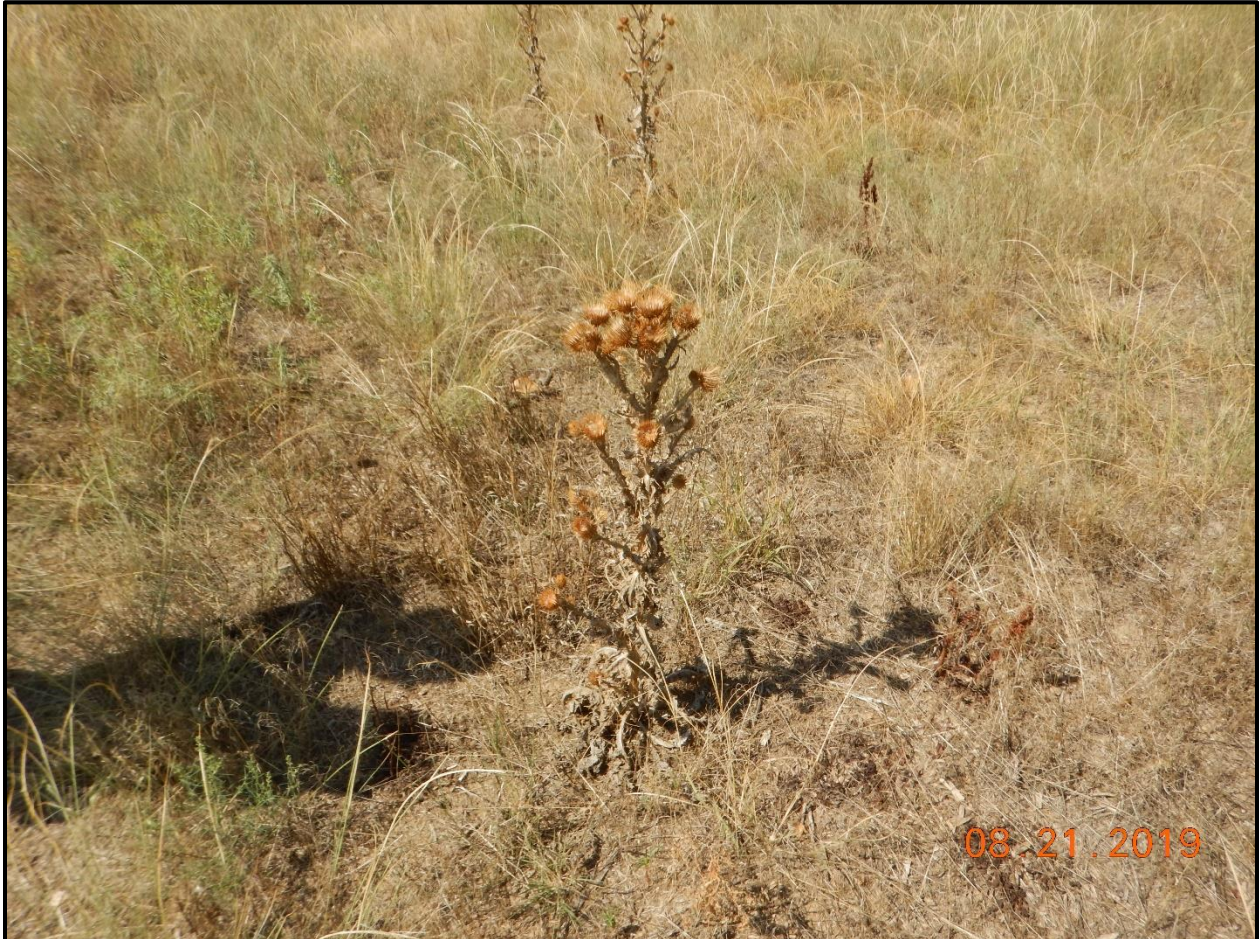
Oil and Gas Well/Pad	
Does any Oil and Gas equipment remain on location?	No
If No, describe remaining equipment:	
Are there noxious/listed weeds present?	Yes
Are the noxious/listed weeds originating from the surrounding land or from the reclamation?	Surrounding Landscape
Describe Weeds and Extent: Musk thistle (class B, prevents attaining final reclamation completion status), Cheatgrass & Field bindweed (both class C)	
Does the well/production facility pad remain and need dirt work to reclaim?	No
If Yes, describe pad features that remain on location:	
Are there any signs of settling on location?	No
If Yes, describe settling:	
Is there any evidence of SWMP erosion, sediment movement or future potential for SWMP concerns?	No
If Yes, describe erosion and/or sediment issues/concerns:	
What are the landuse(s) of the location?	Pasture/Grazing
If the land use includes cropland, has the former pad/well location been reestablished by the landowner as cropland?

Site Name: Matt 1 (wellhead)
Musk thistle – Class B noxious weed
