Inspection Photos
Operator: Logos Operating
Location/API #: 067-05588
Date: 10-24-2019

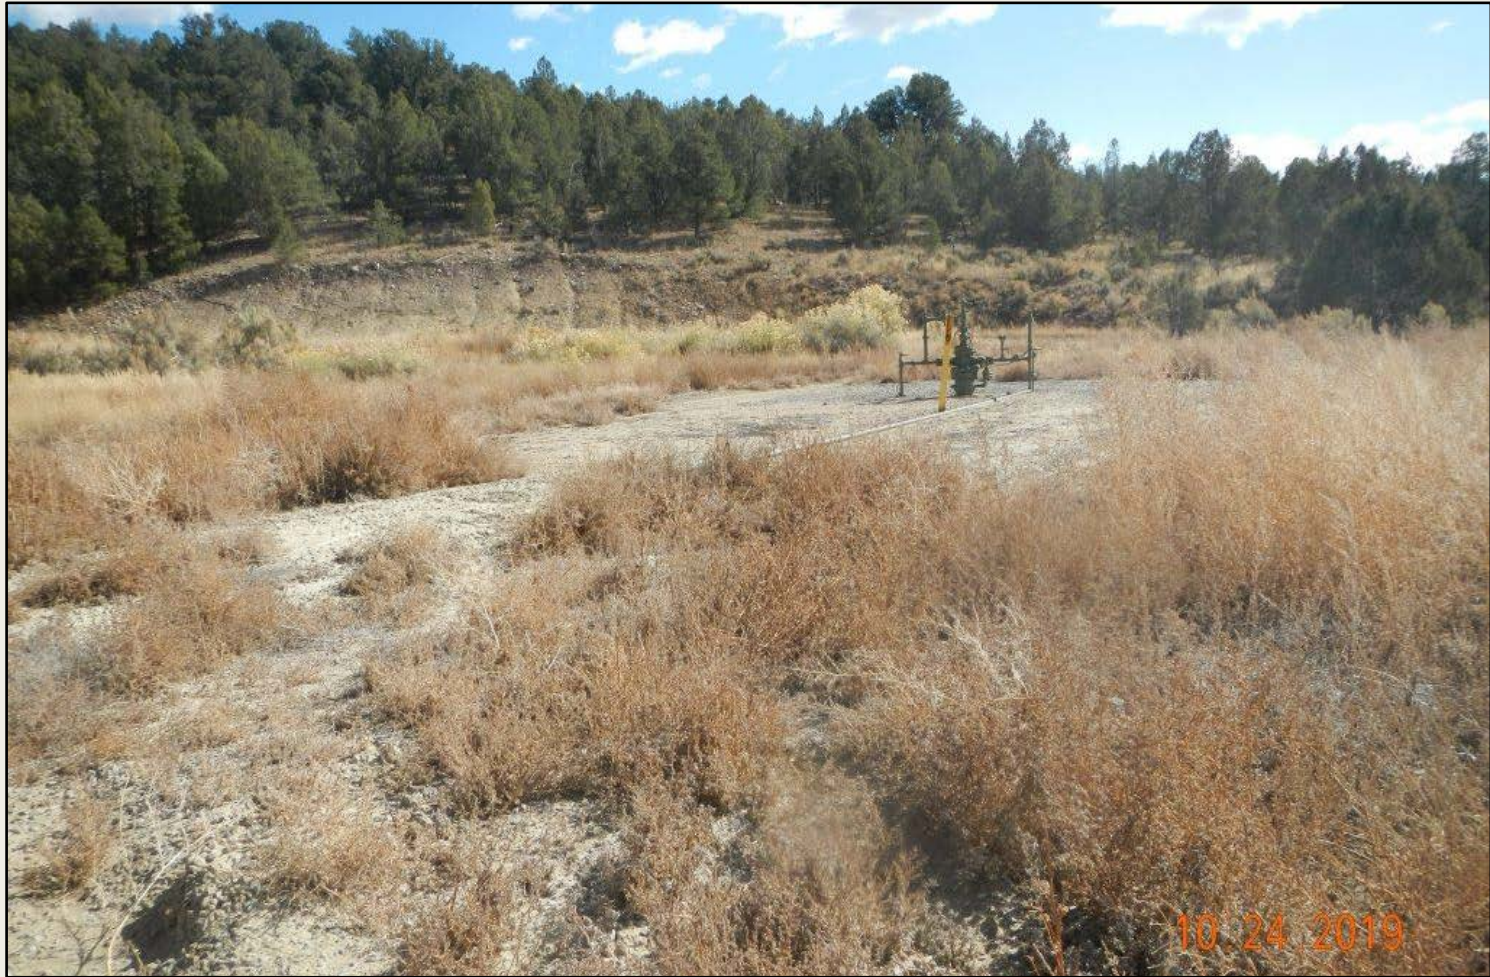
Photo 1. View of the project area from the western edge facing center. Portions of the well pad are infested with kochia weeds growing up to 4 feet tall.

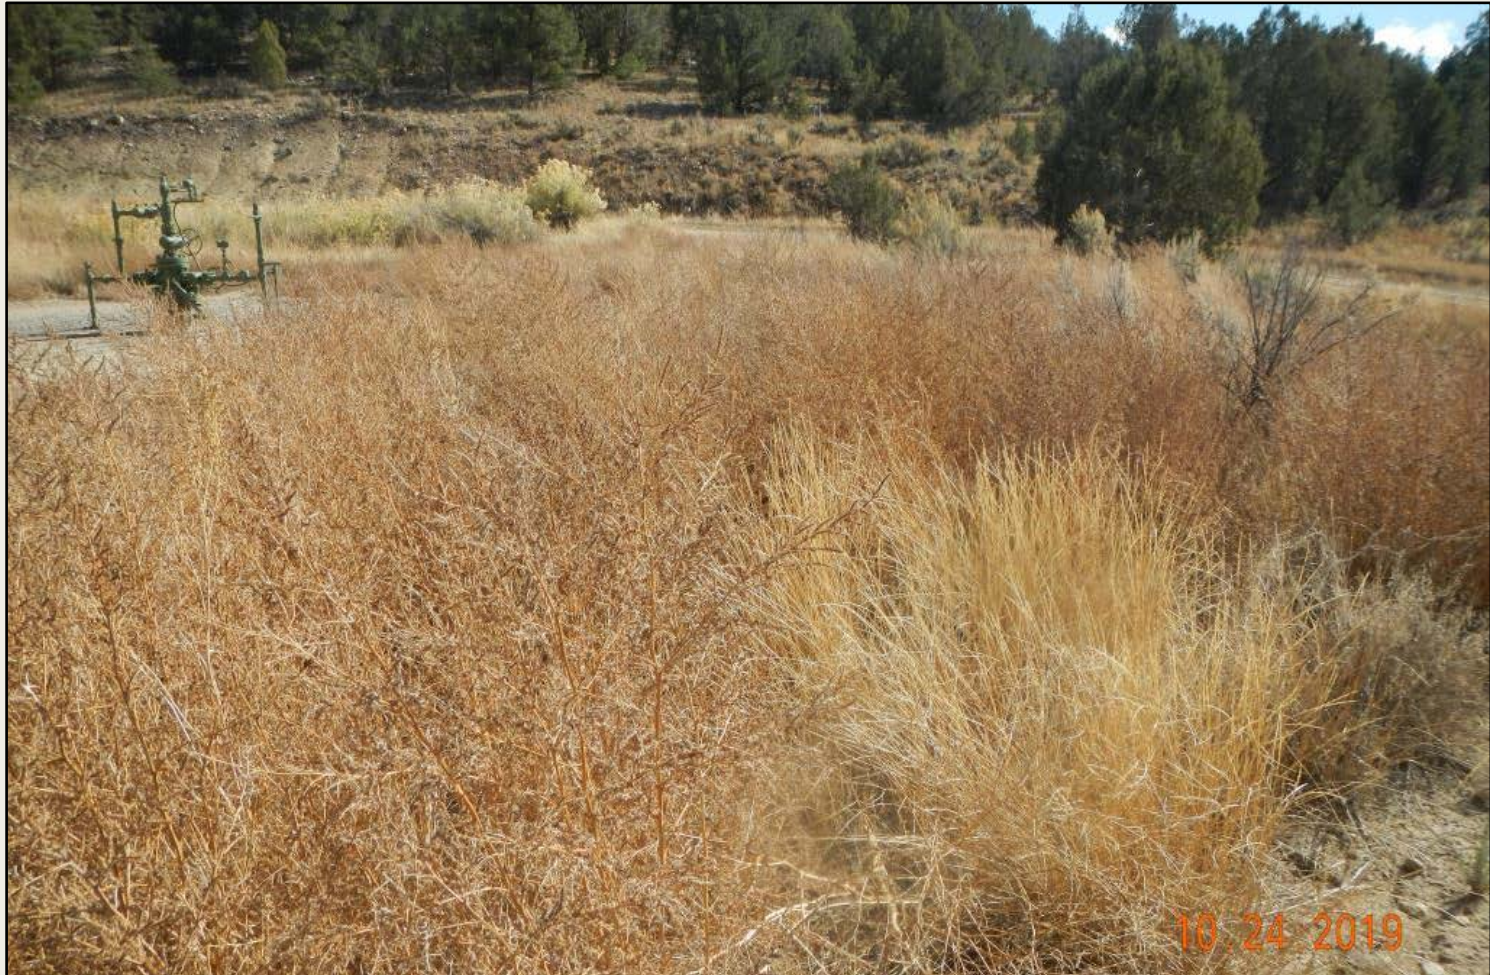
Photo 2. View of the western revegetation area from the northwestern access facing southward. Some desirable vegetation is becoming established, although location is infested with tall kochia weeds and debris.

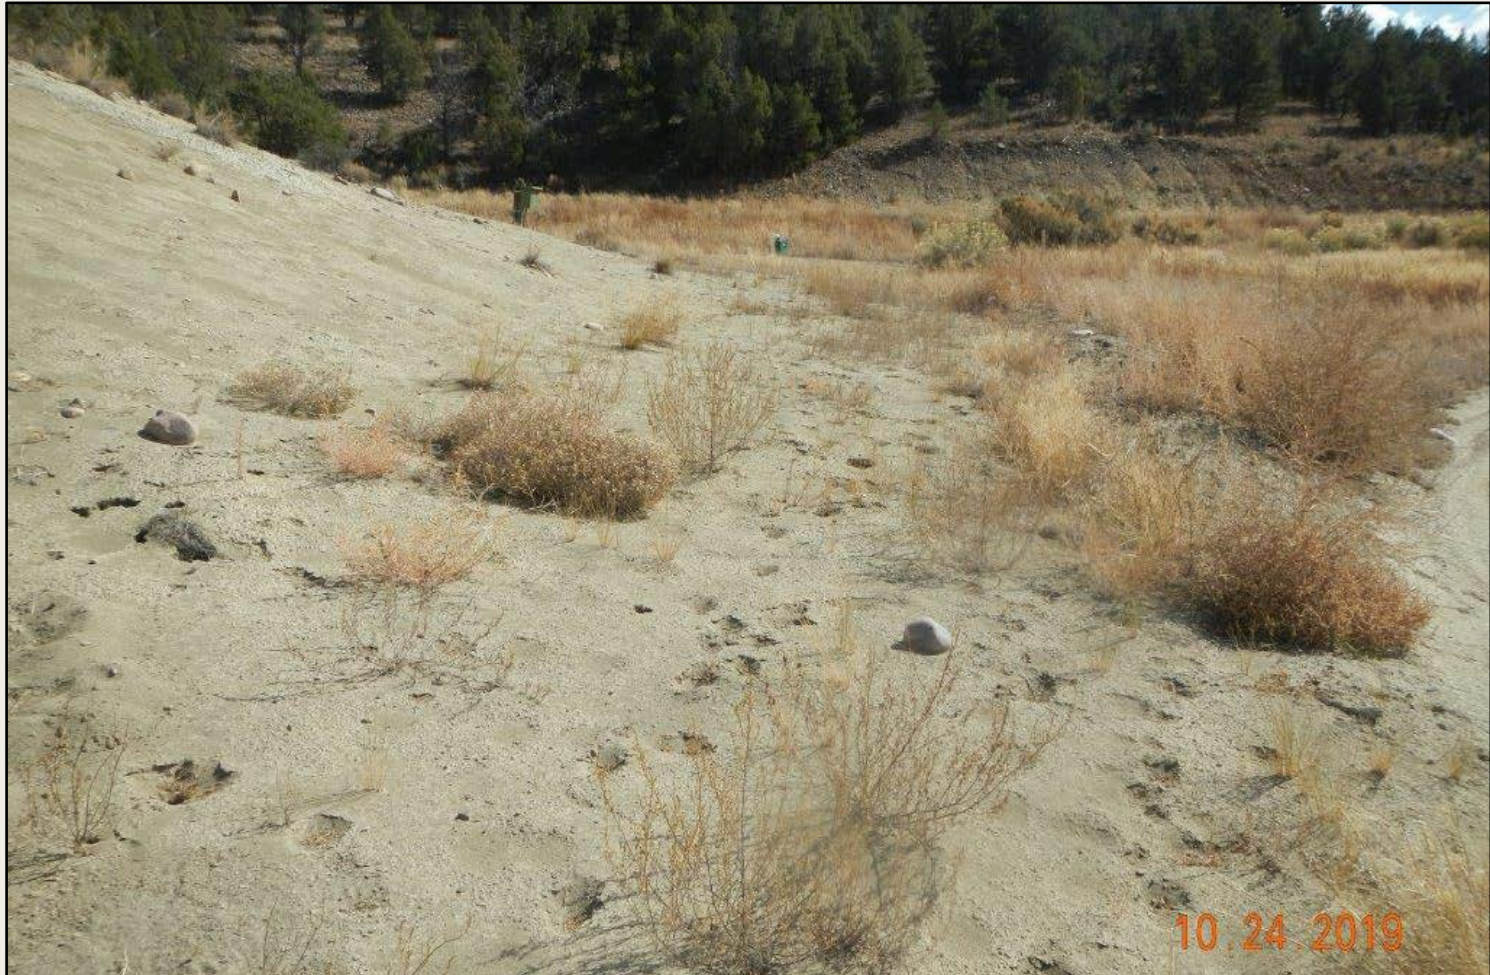
Photo 3. View of sediment deposition at the toe of the eastern cut-slope.

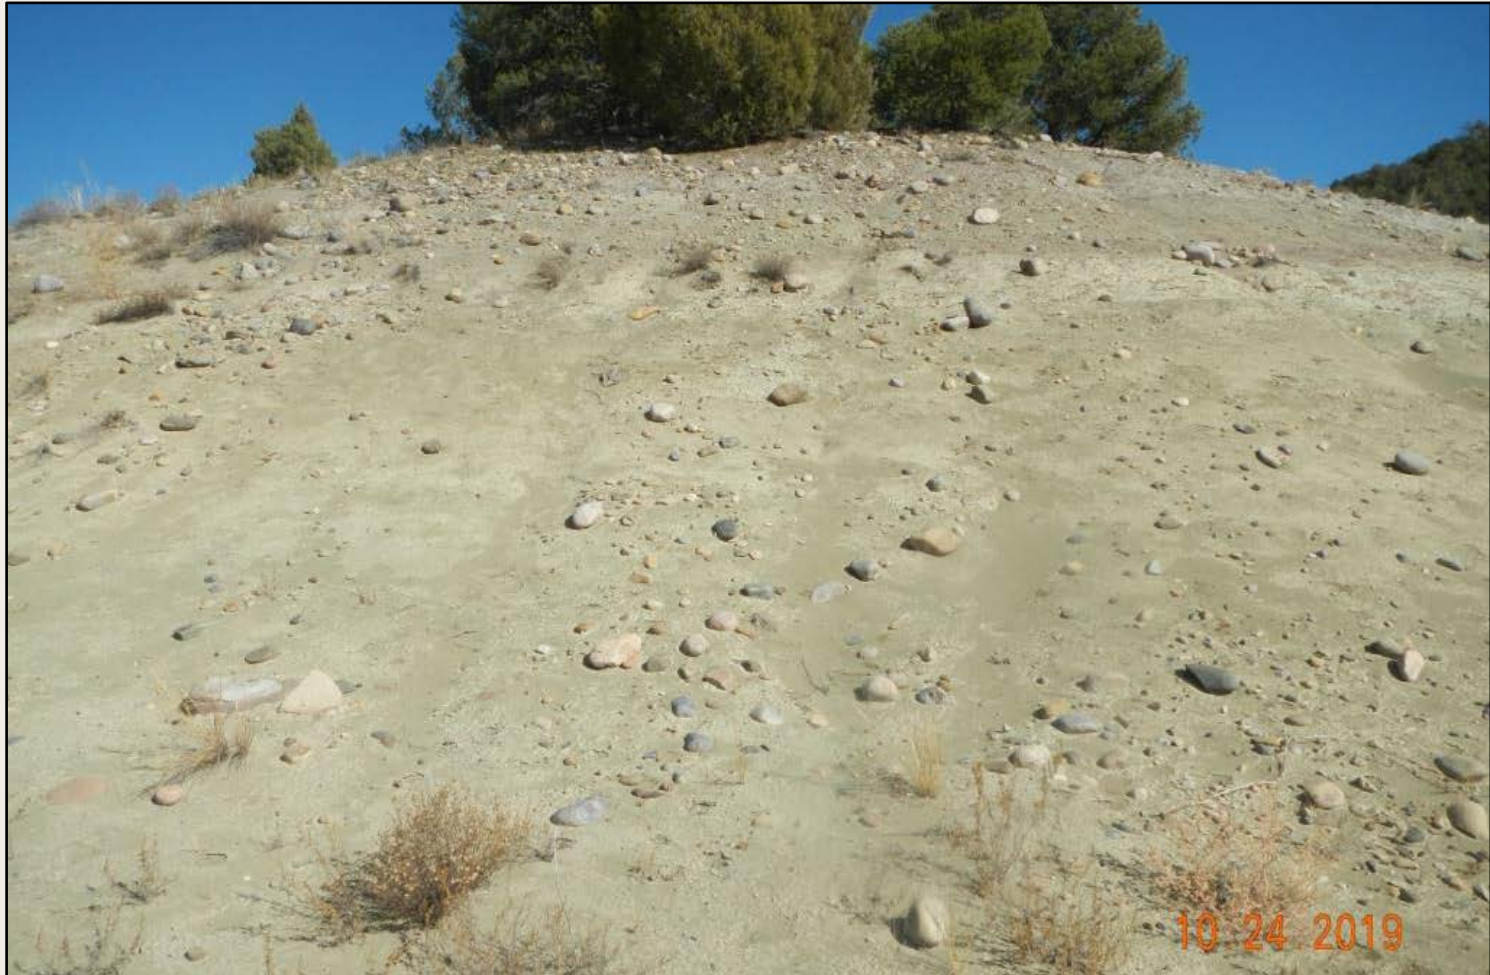
Photo 4. View of bare and eroding soils on the well pad cut slope.

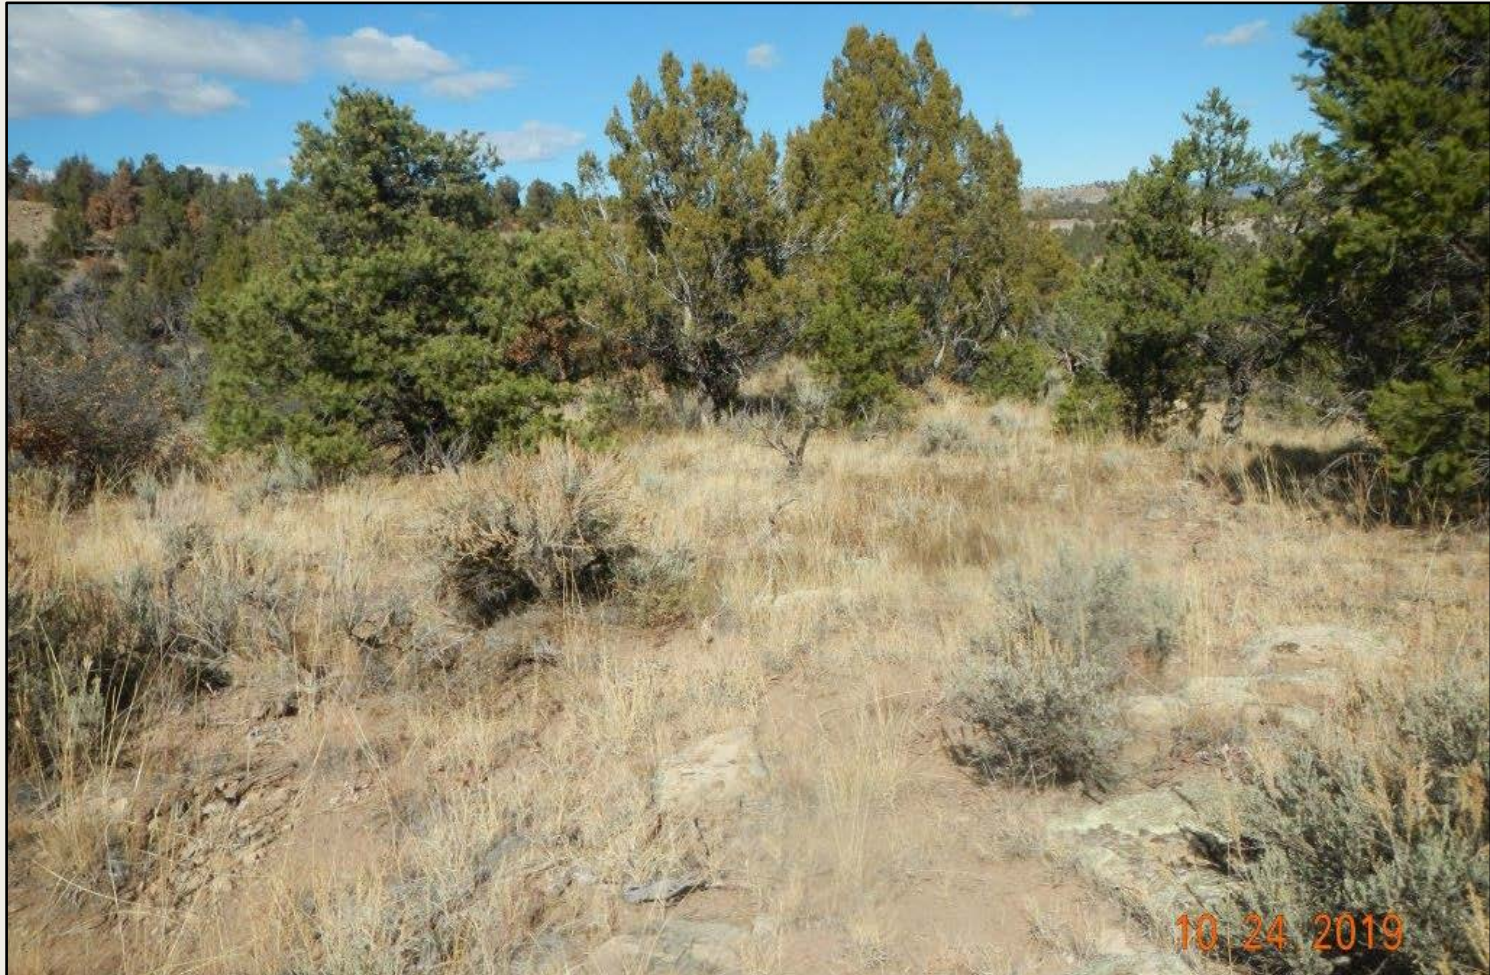
Photo 5. View of reference are vegetation comprised of mixed pinyon juniper woodland, and sagebrush shrubland with native grasses such as James galleta and forbs such as *Tetaneuris* sp.
