Inspection Photos
Operator: Logos Operating
Location/API #: 067-08102
Date: 10-24-2019

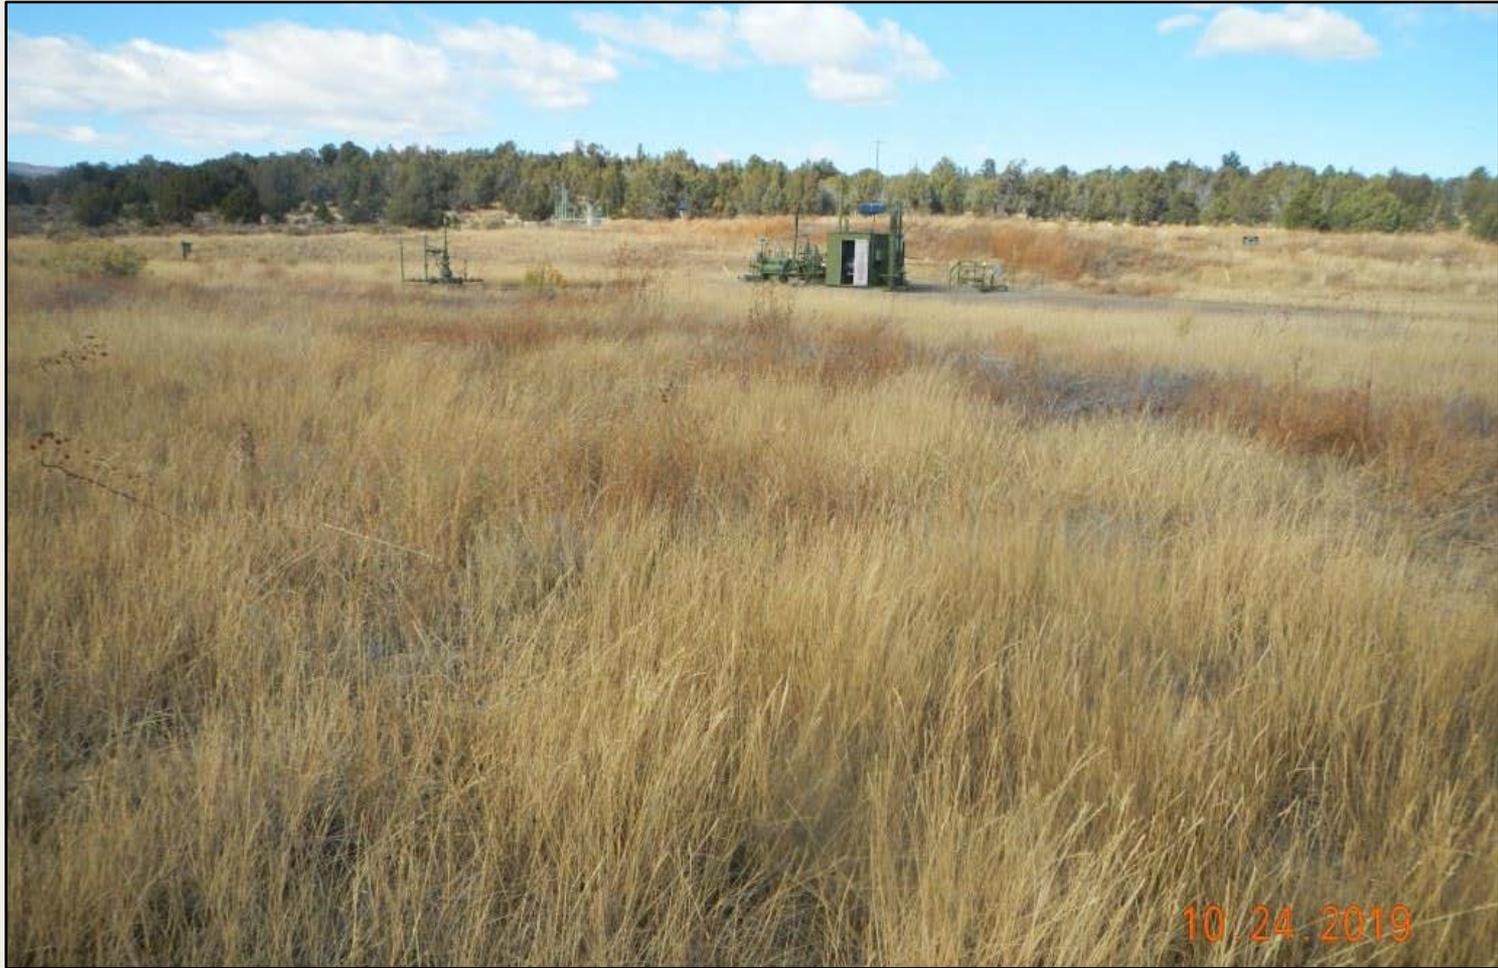
Photo 1. View of the project area from the southern edge facing center.

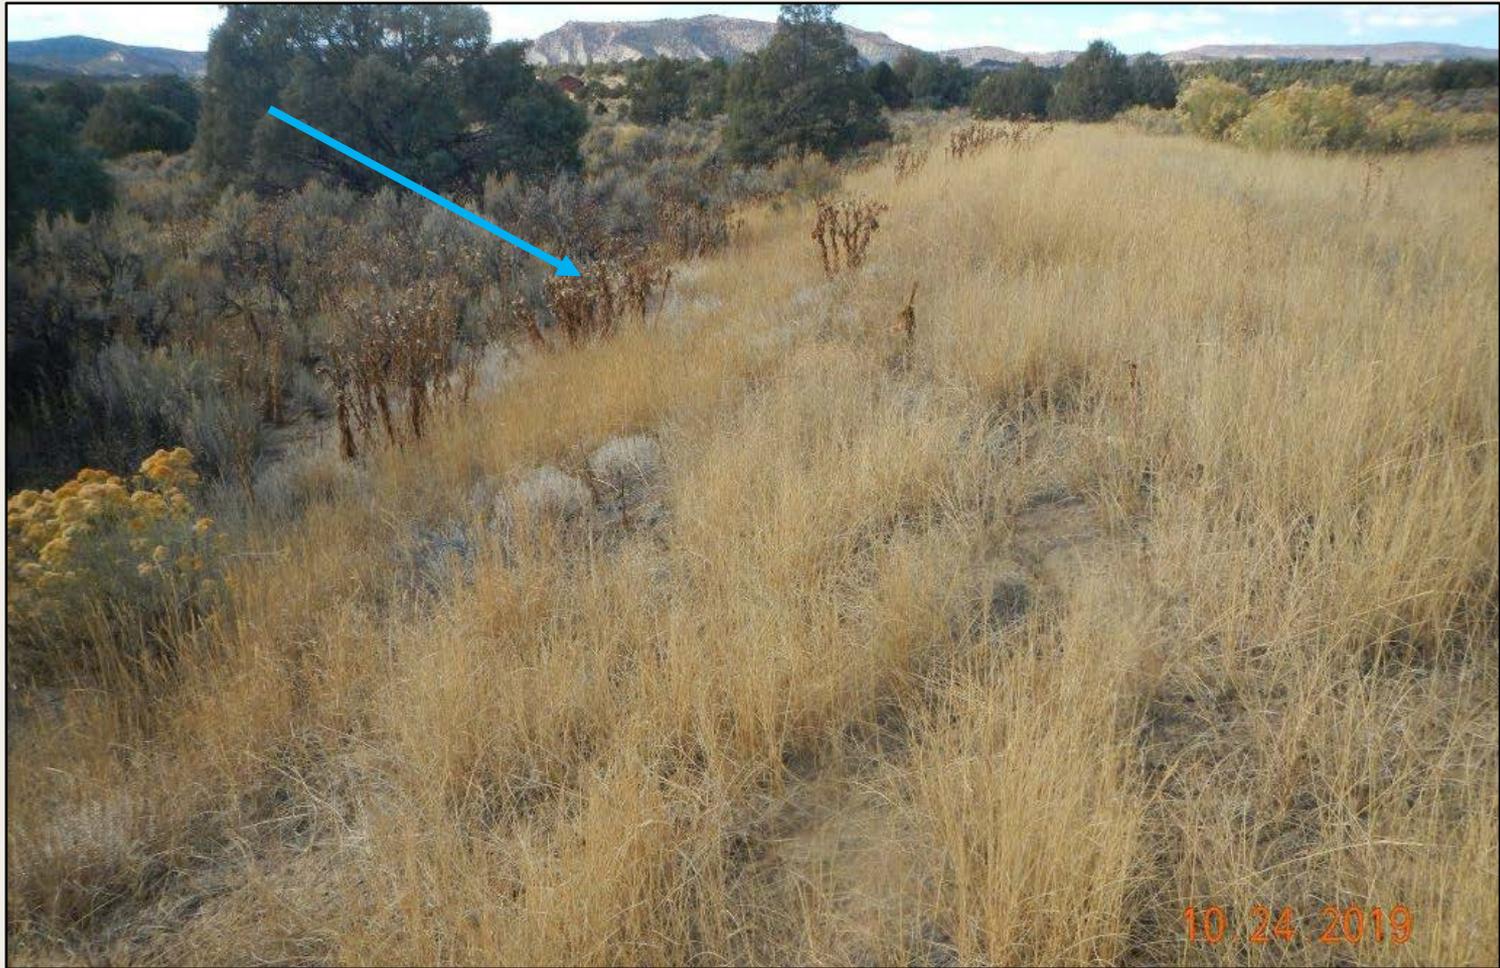
Photo 2. View of the southern project area from the southeastern edge facing westward. Revegetation is progressing with western wheatgrass and sand dropseed. Blue arrow points to Scotch thistles in the southern project area. Approximately 100 individuals observed.

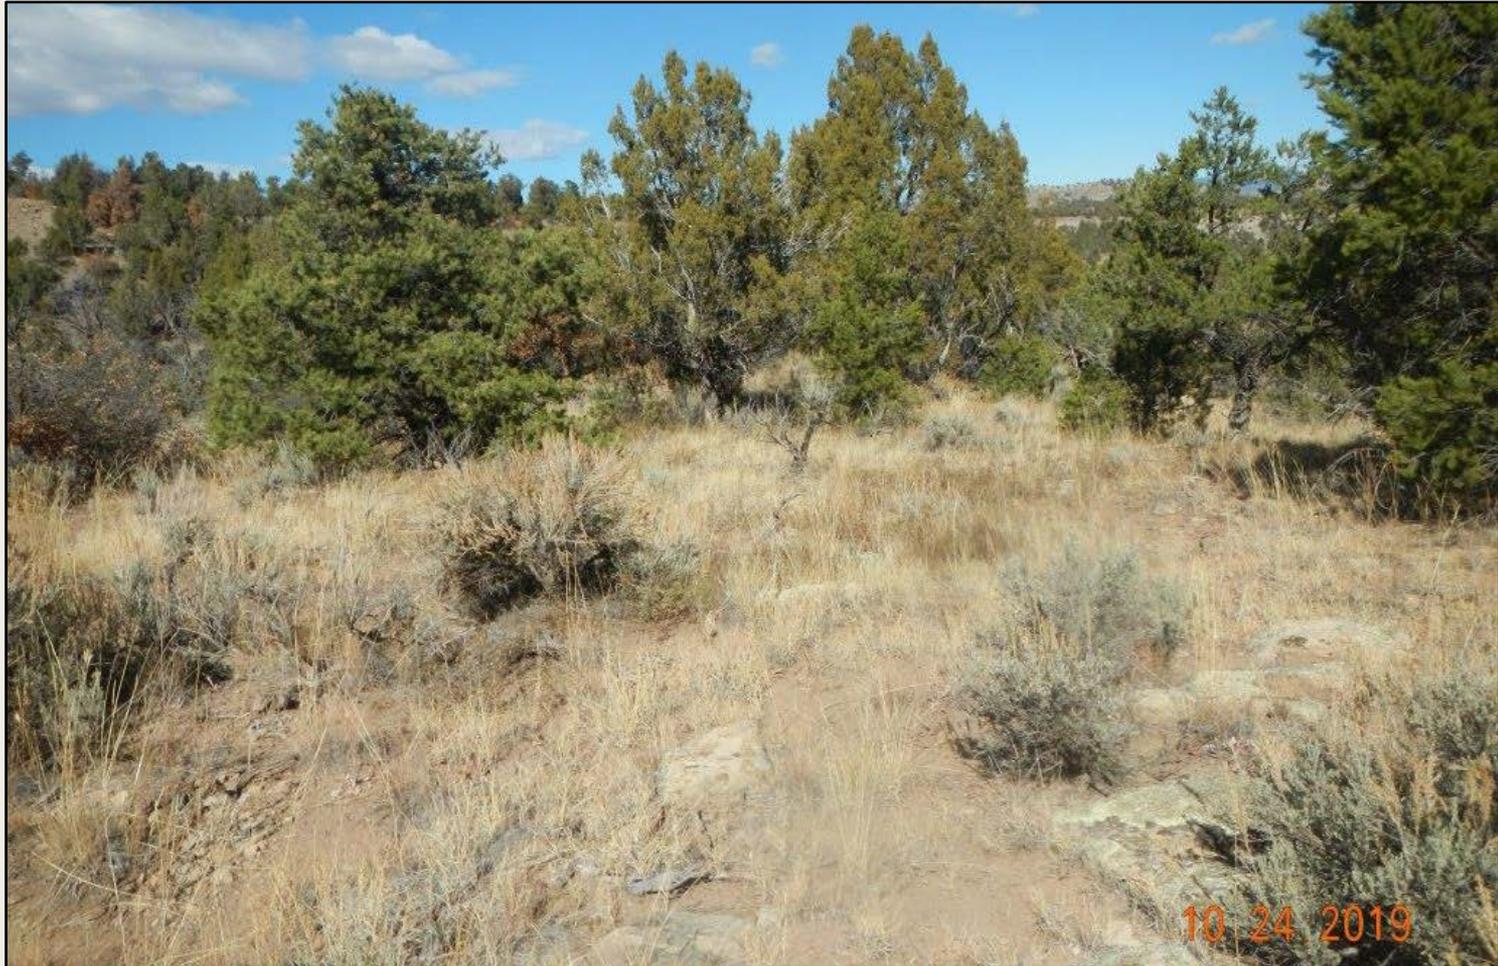
Photo 3. View of reference are vegetation comprised of mixed pinyon juniper woodland, and sagebrush shrubland with native grasses such as James galleta and forbs such as *Tetaneuris* sp.
