Inspection Photos  
Operator: BP America  
Location/API #: 067-08496  
Date: 10-24-2019

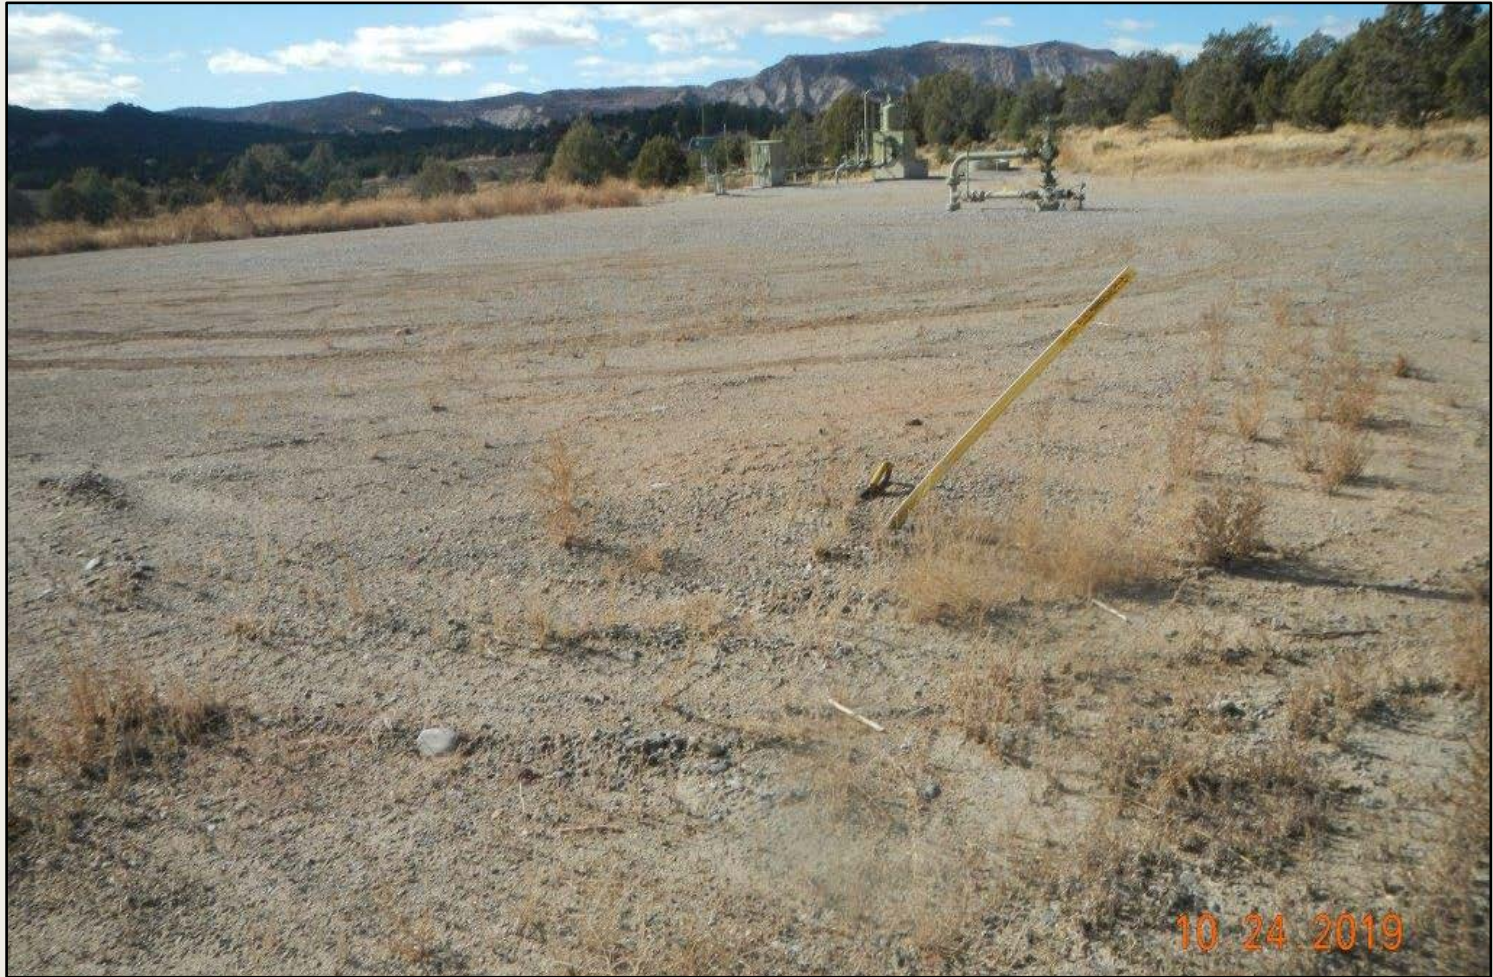
Photo 1. View of the project area from the eastern corner facing center.

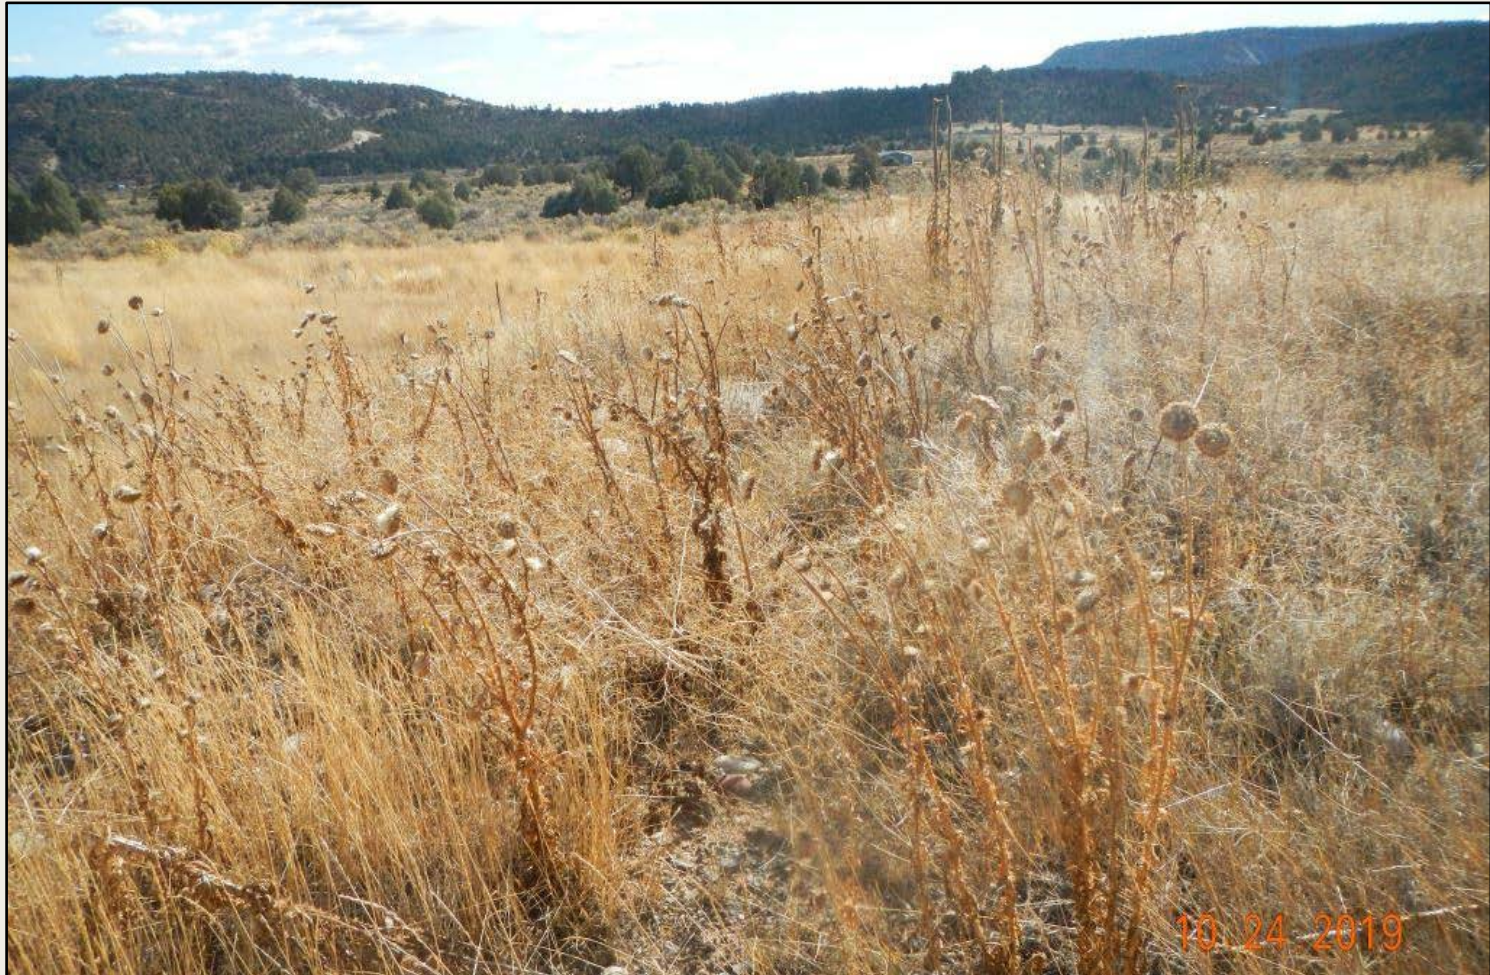
Photo 2. View of the southeastern fill slope from the eastern edge facing southwestward. Interim reclamation area is infested with musk and Scotch thistles. Approximately 2000 individuals observed.

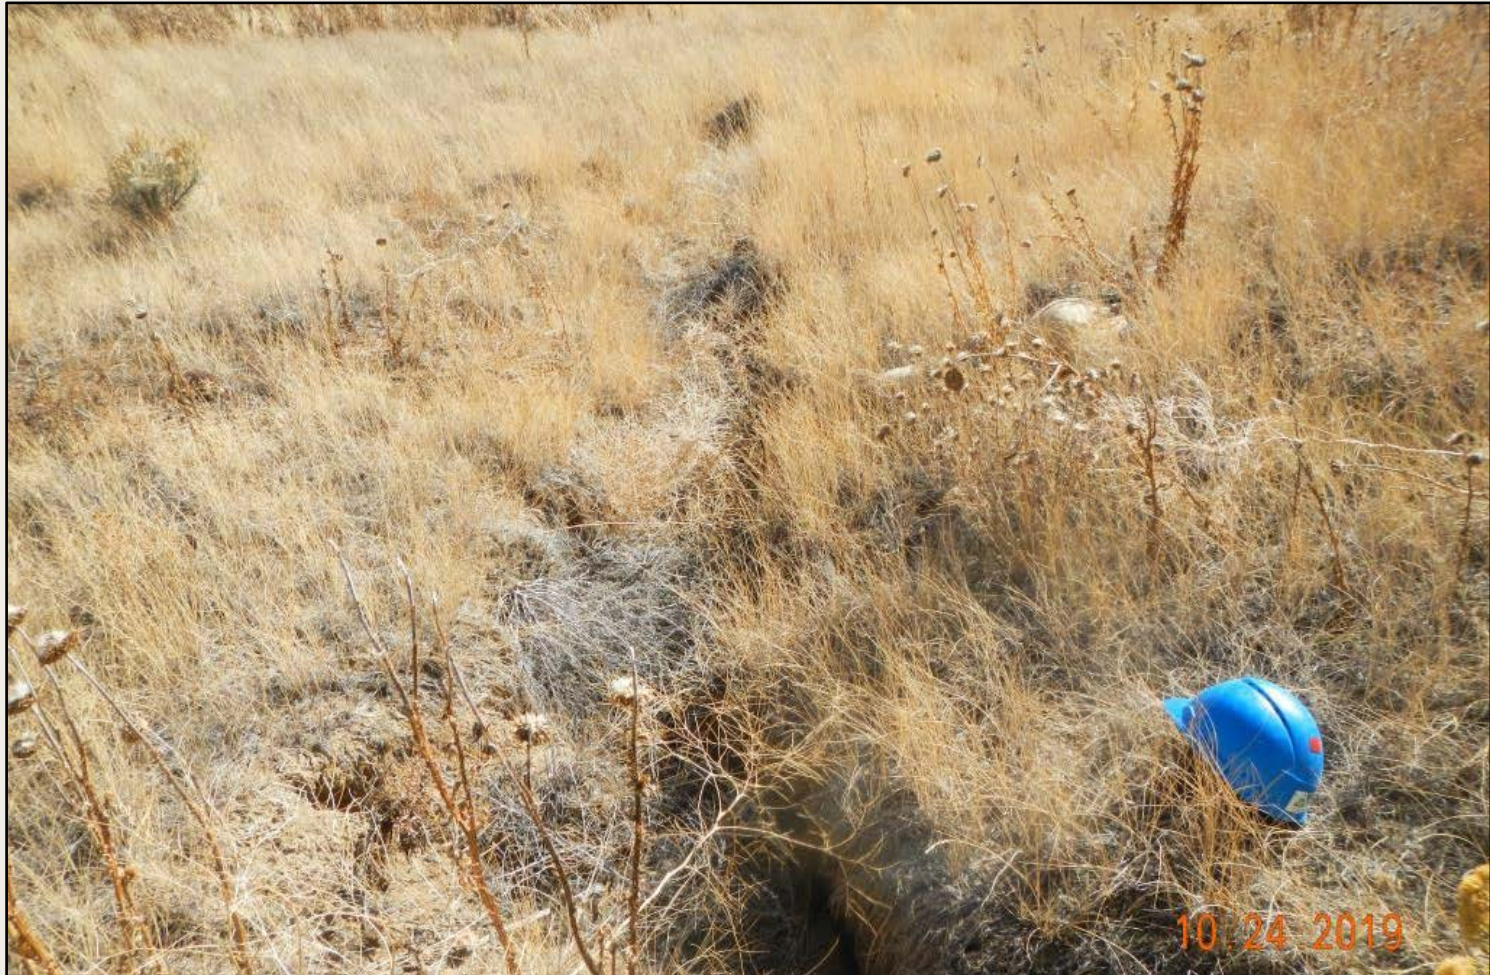
Photo 3. View of erosional channel approximately 2 feet wide and 1 foot deep, forming within the eastern project area.
