Interim Reclamation and Stormwater Inspection

Operator: LONGS PEAK RESOURCES LLC- #10611

Location ID: 440192

Inspection Photos
Location Name: Pismo East
/35-26-23-2-1CH
Location ID: 440192

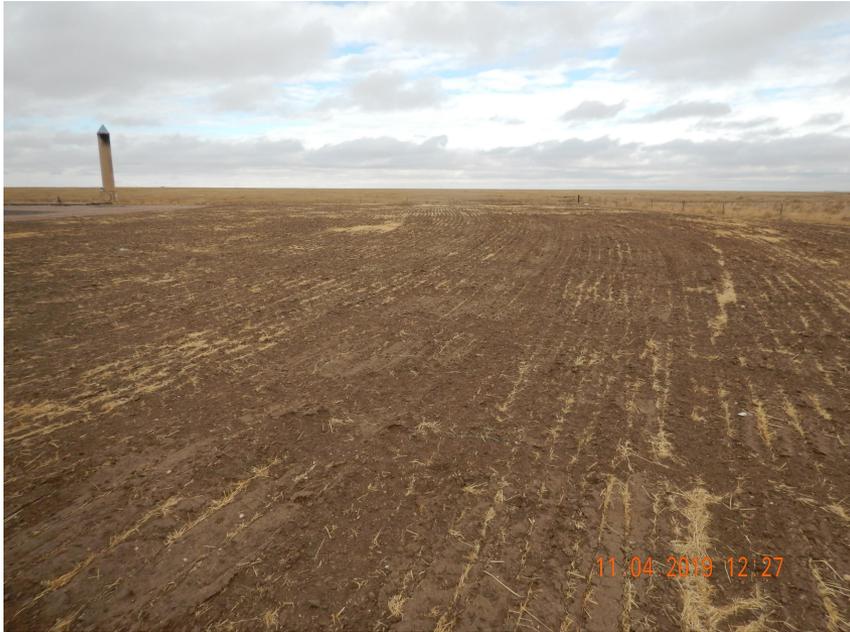
Photo 1. Photo taken from the eastern interim area, facing North. Photo illustrates Operator has performed interim reclamation to reduce areas only needed for production operations per Rule 1003. Note: Appears straw mulch was crimped as an erosion control but has already blown off location which will not ensure the seeded soil is stabilized. COGCC staff would recommend re-installing erosion controls and using long-fiber weed-free mulch.

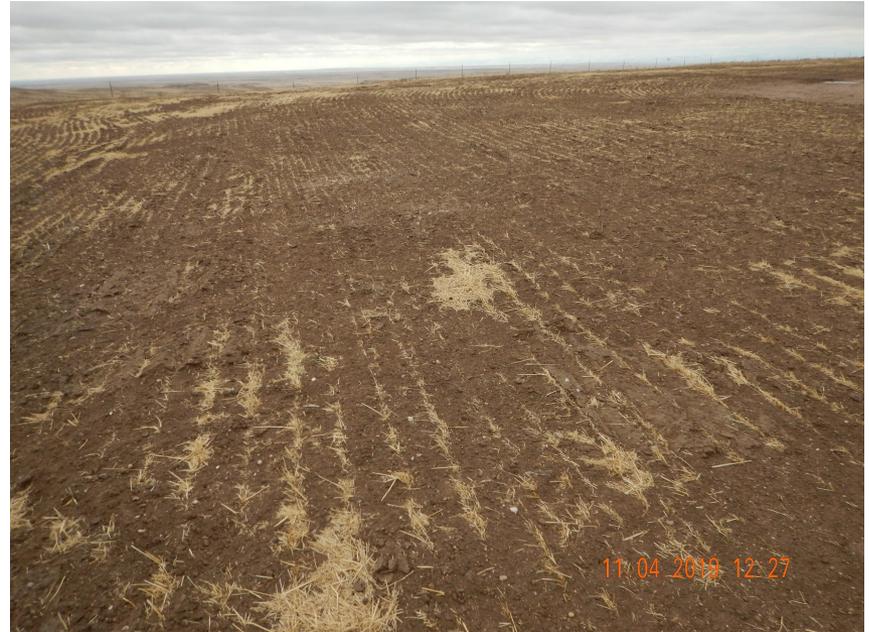
Photo 2. Photo taken from the eastern interim area, facing South. See comments under Photo 1.

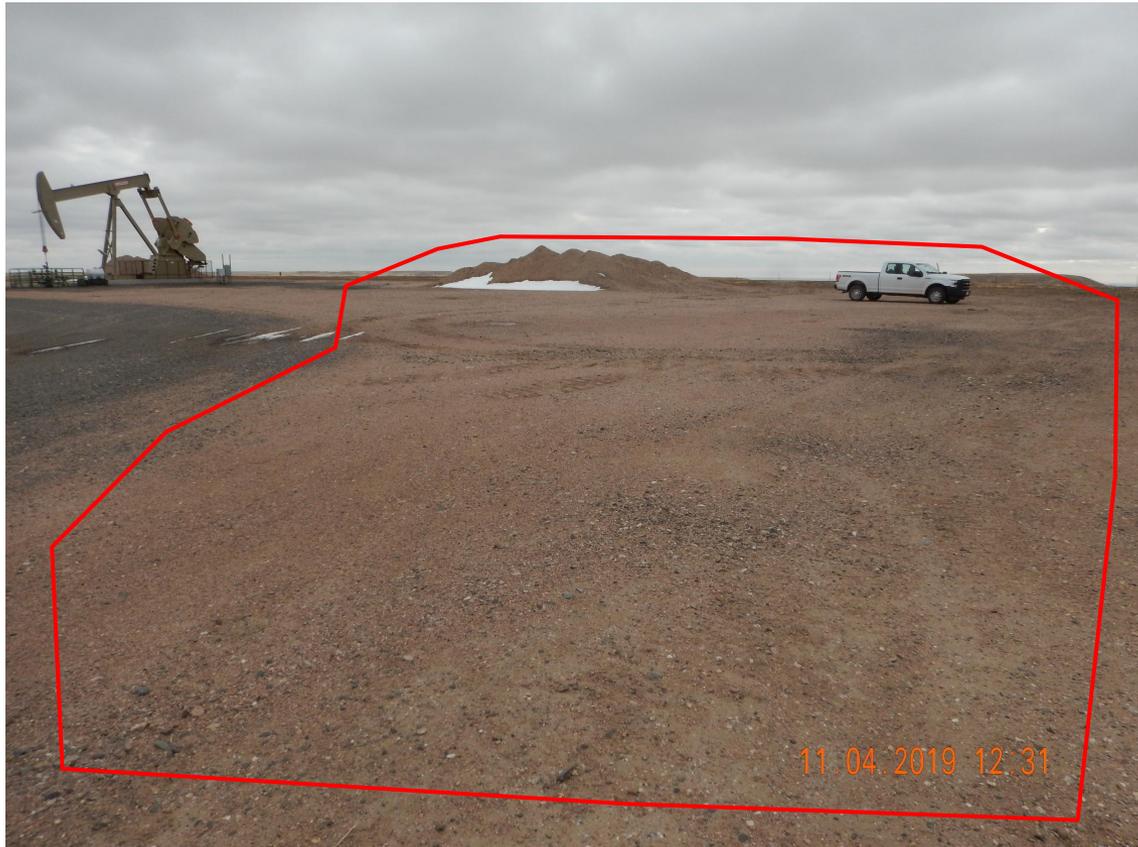
Photo 3. Photo taken from the western well pad, facing South. Photo illustrates that portions of the western and southwestern well pad can be further reduced in size to comply with Rule 1003. Currently, the Operator is storing gravel along a portion of this area where interim reclamation shall be performed.

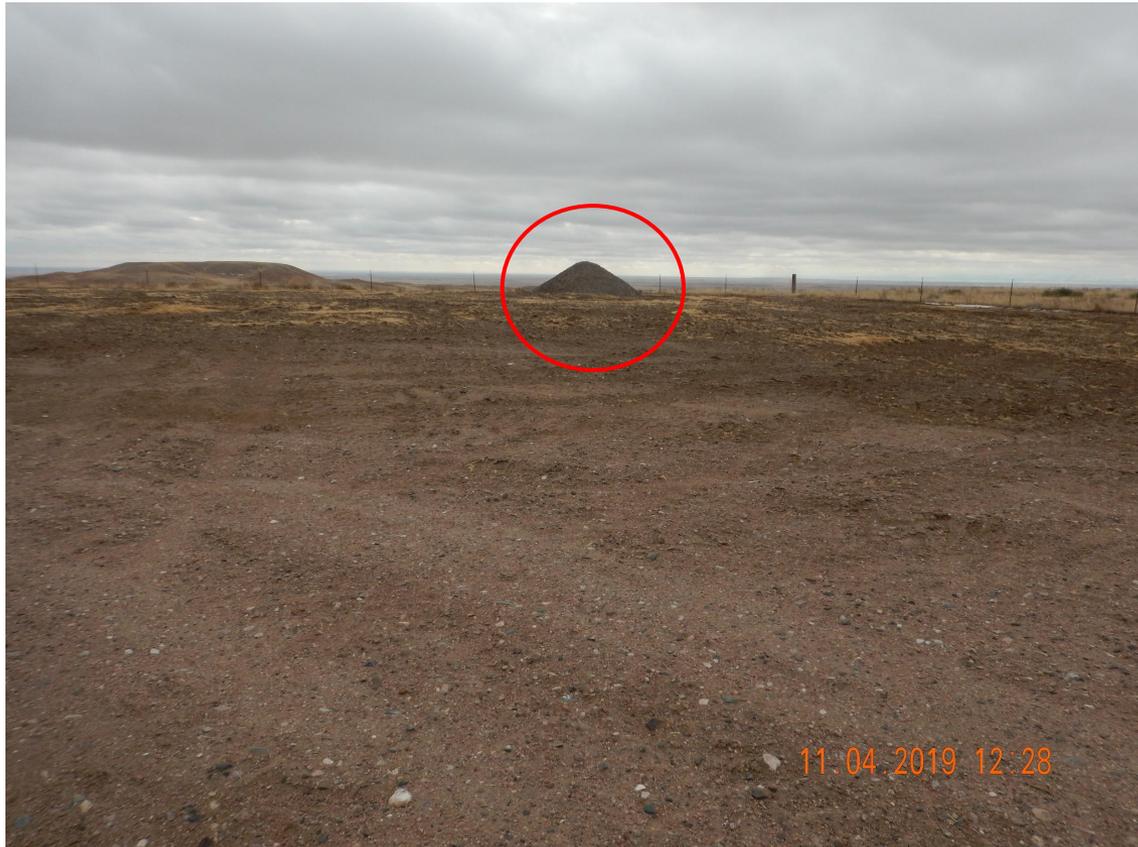
Photo 4. Photo taken from the southwestern well pad, facing South. Operator shall remove this gravel pile from the interim area.
