Inspection Photos

Location Name: Piceance 28-11 Tank Battery & Historical Spill/Release

Location ID: #467201

Inspection Date: November 8, 2019

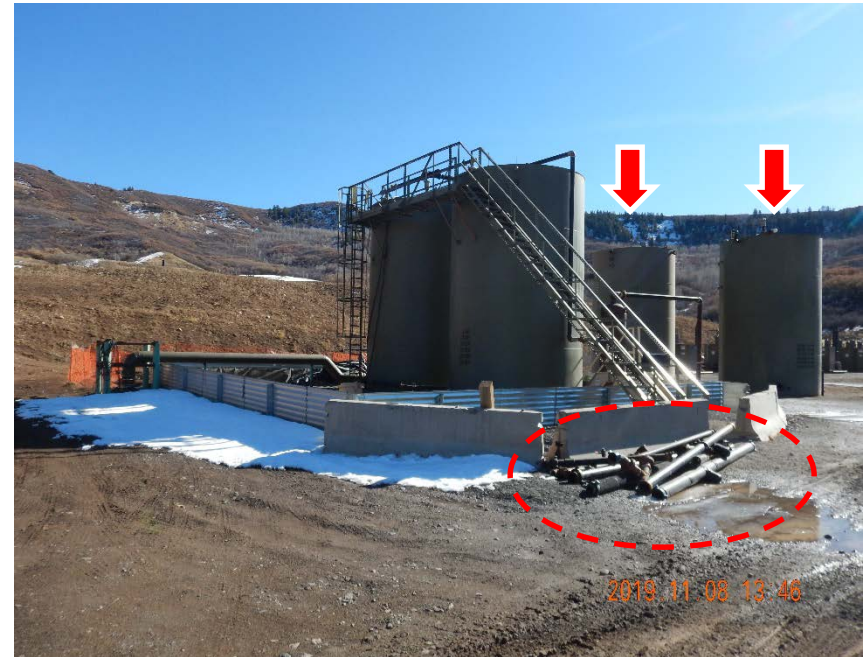
Photo #2 – Overview of tank battery from northwest. Note storage of unused pipe (circled) and two 400 bbl ASTs (red arrows).

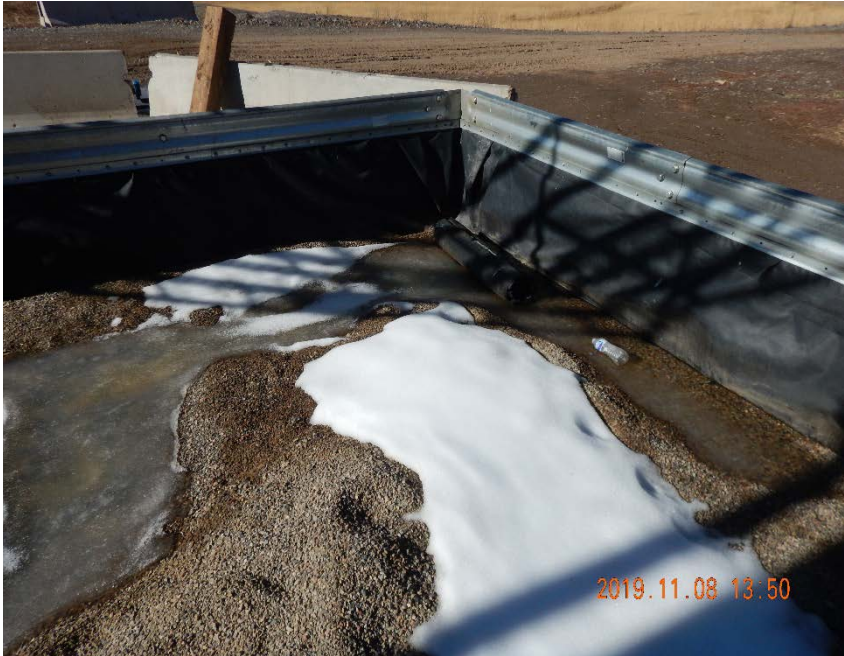
Photo #3 – Lined tank battery area contained snow/ice and fluids on inspection date. No hydrocarbon odors or sheen were observed during inspection. Note trash (water bottle) depicted inside northwest corner of tank battery.

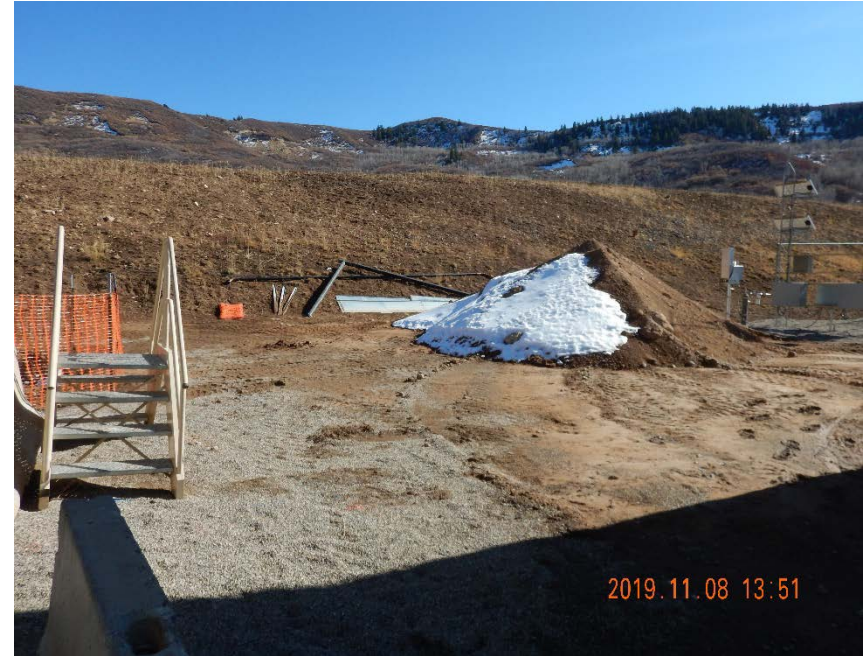
Photo #4 – Unidentified soil stockpile and additional unused equipment located southeast of tank battery.

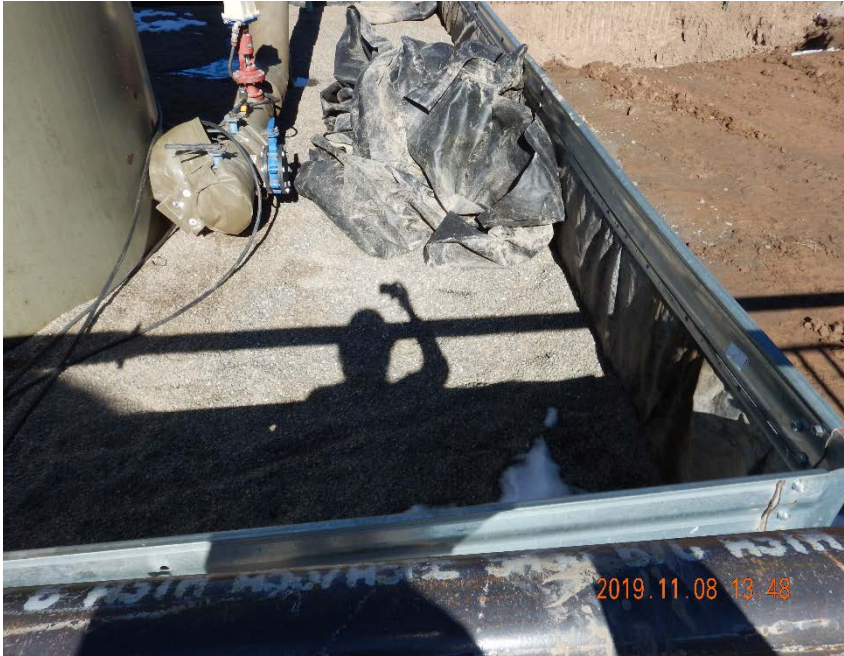
Photo #5 – Unused liner material stored inside of tank battery (east side).

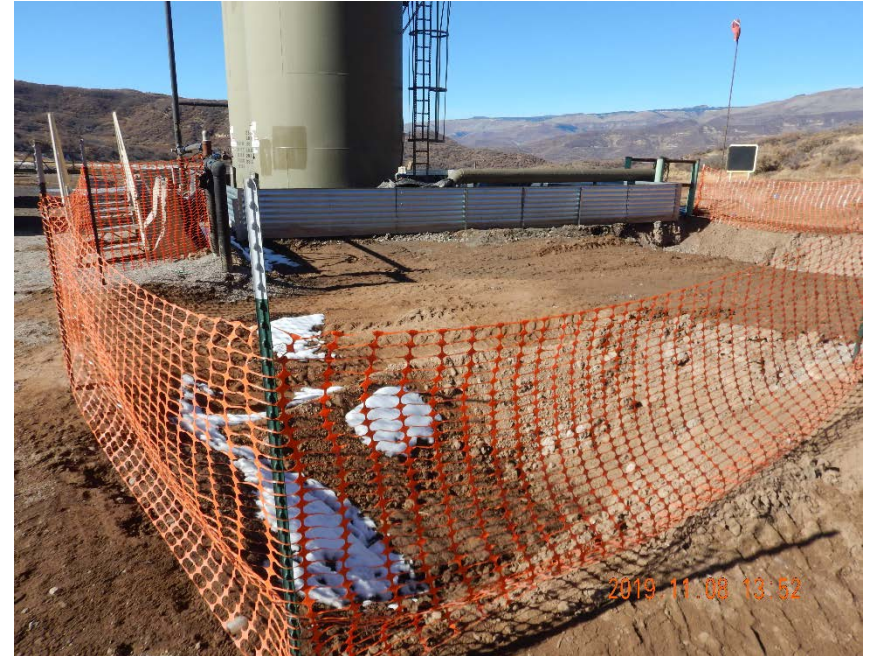
Photo #6 – View of fenced, scraped area east of tank battery from southeast corner. Open excavations were observed in southeast and northwest corners of this area on inspection date.

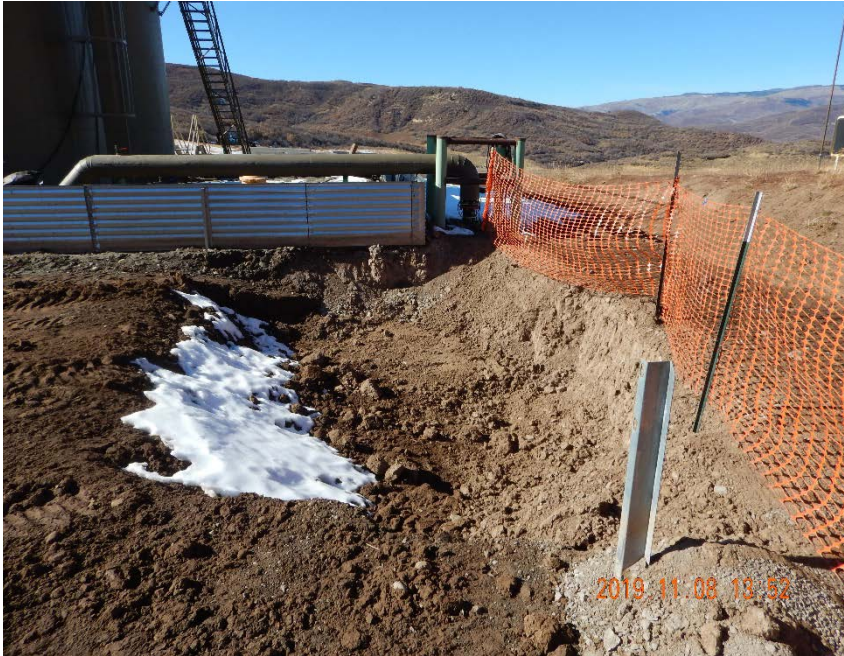
Photo #7 – Looking into northwest excavation, from east.
No hydrocarbon staining or sheens were observed in visible portions of either excavation on inspection date.

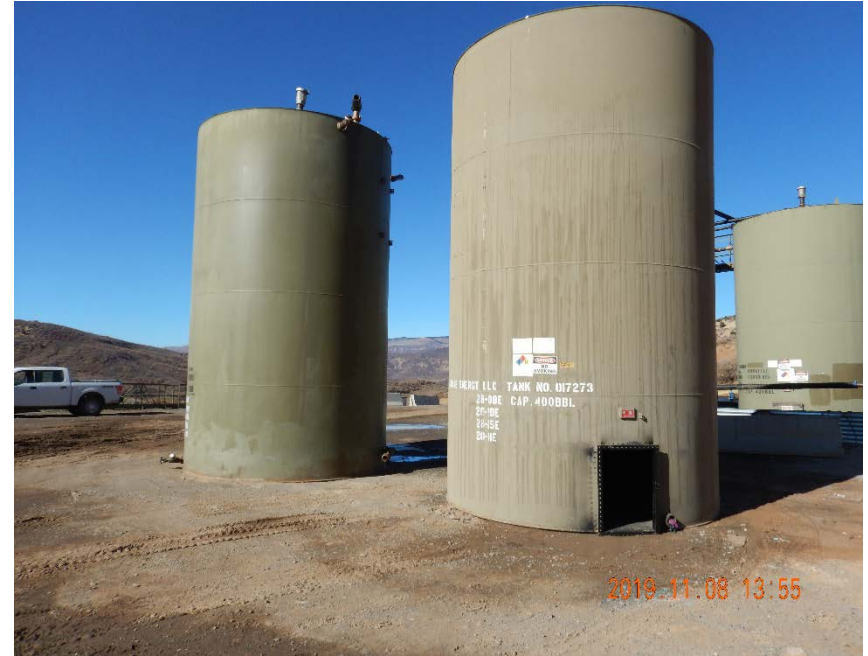
Photo #8 – View of unused 400 bbl ASTs from southeast.
Note open access panel on east tank.

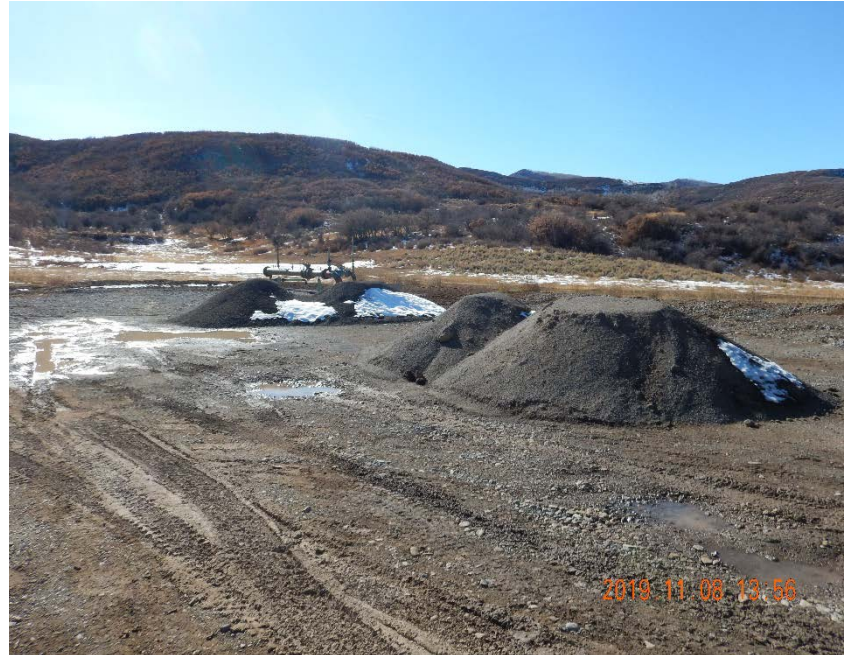
Photo #9 – Unidentified gravel stockpiles located west of separators.
