Final Reclamation Inspection

Operator: EXTRACTION OIL & GAS INC - #10459

Location ID: 434253

Inspection Photos
Location Name: Staley Pad /7-J
Location ID: 434253

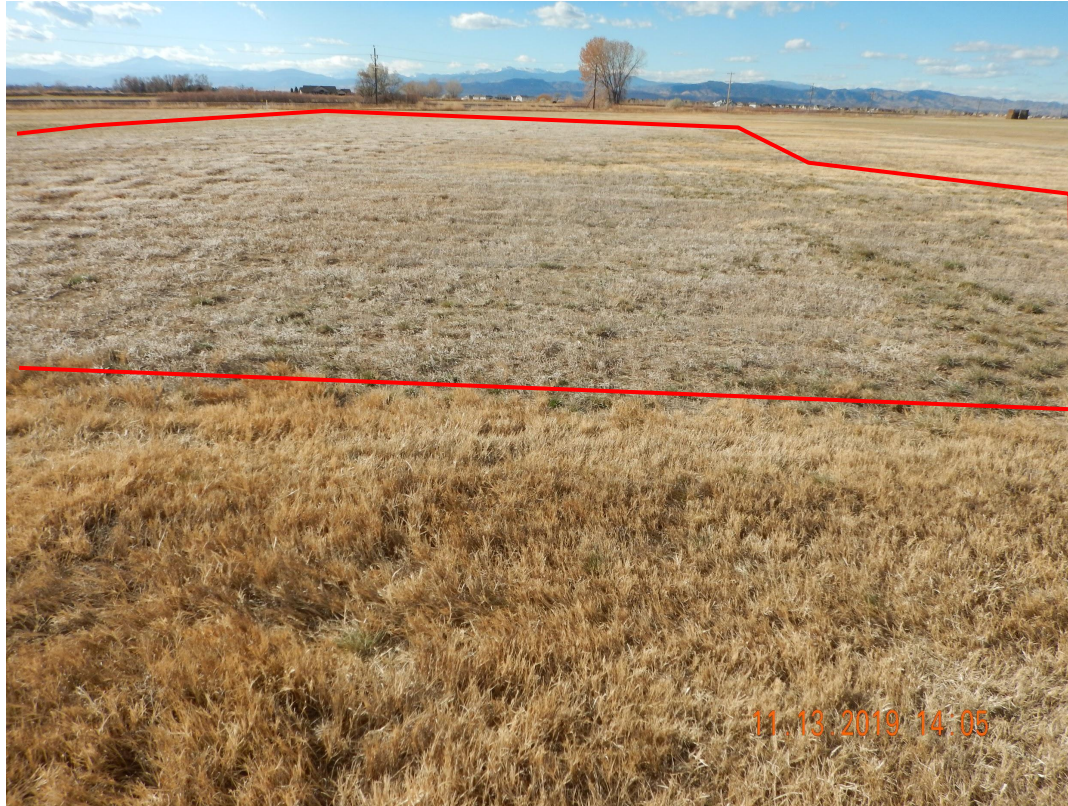
Photo 1. Photo taken from the northwestern location, facing West. Photo illustrates final reclamation activities have been performed; however, vegetation is not reflective of reference area vegetative levels. Photo illustrate weedy, annual vegetation, Kochia, (inside the red area), as compared to the surrounding reference vegetation.

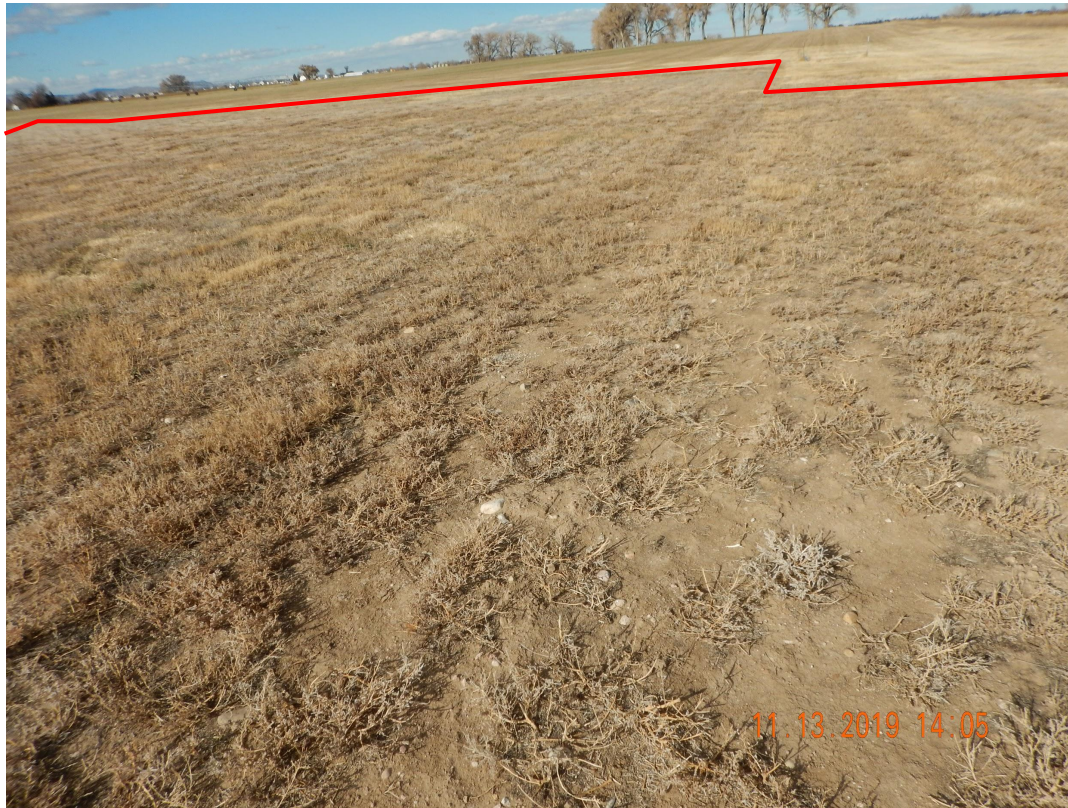
Photo 2. Photo taken from the northwestern location, facing North. See comments under Photo 1.

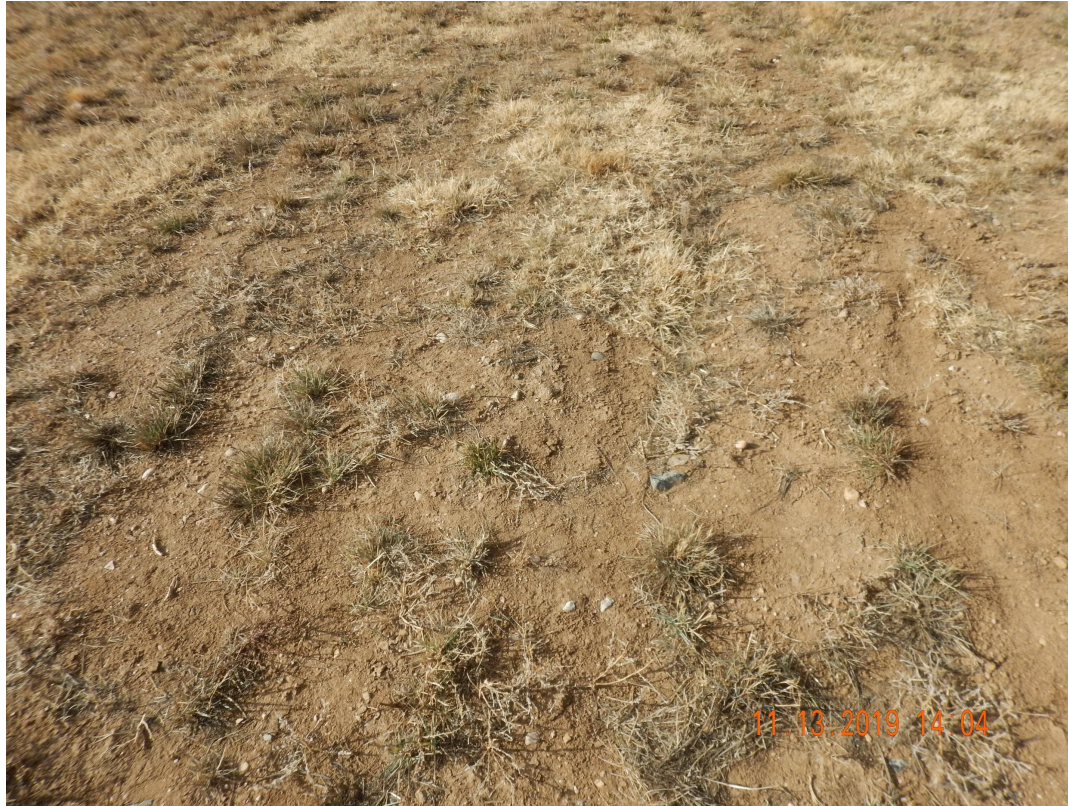
Photo 3. Photo taken from a portion of the southern location. Photo illustrates bare patches and weedy, annual vegetation.

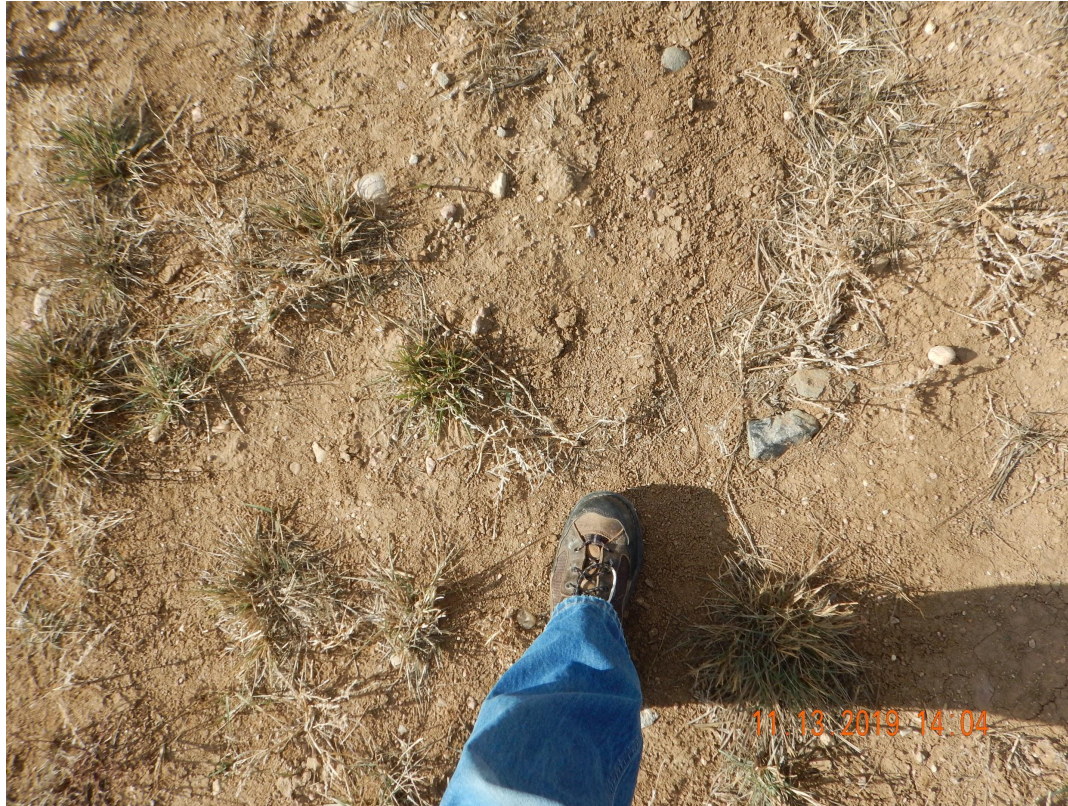
Photo 4. Photo taken from a portion of the southern location. See comments under Photo 2.

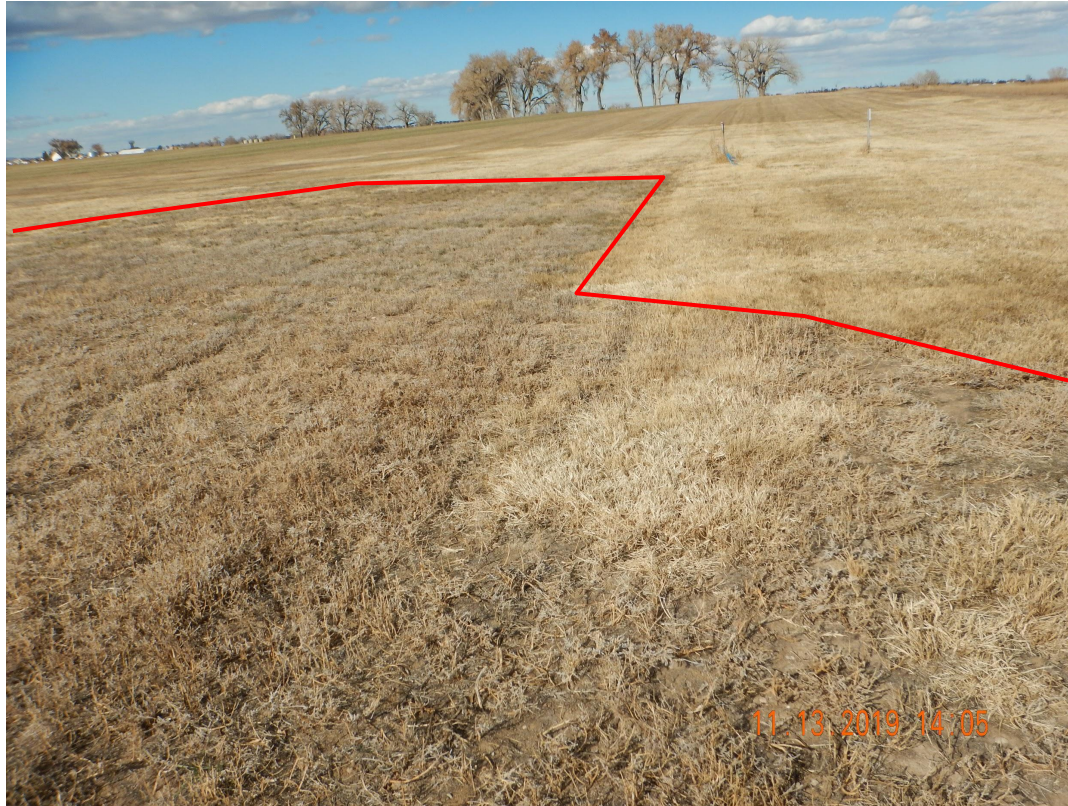
Photo 5. Photo taken from the northwestern location, facing North. See comments under Photo 1.

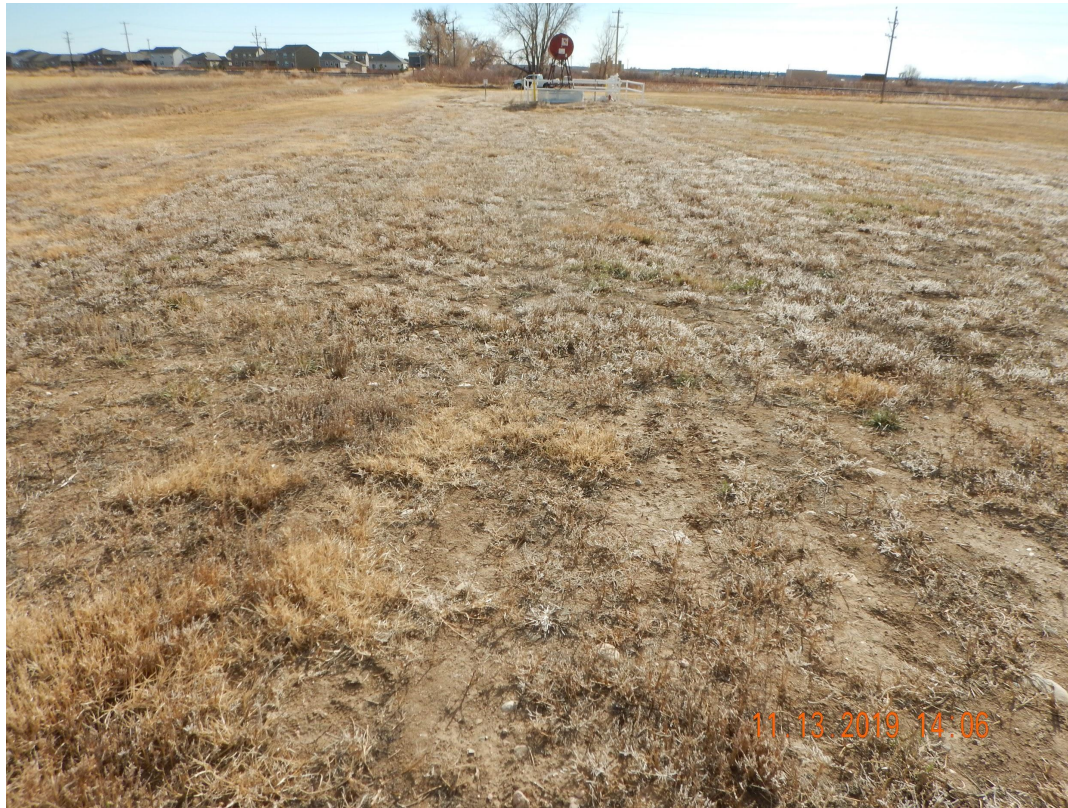
Photo 6. Photo taken from the northwestern location, facing South. See comments under Photo 1.

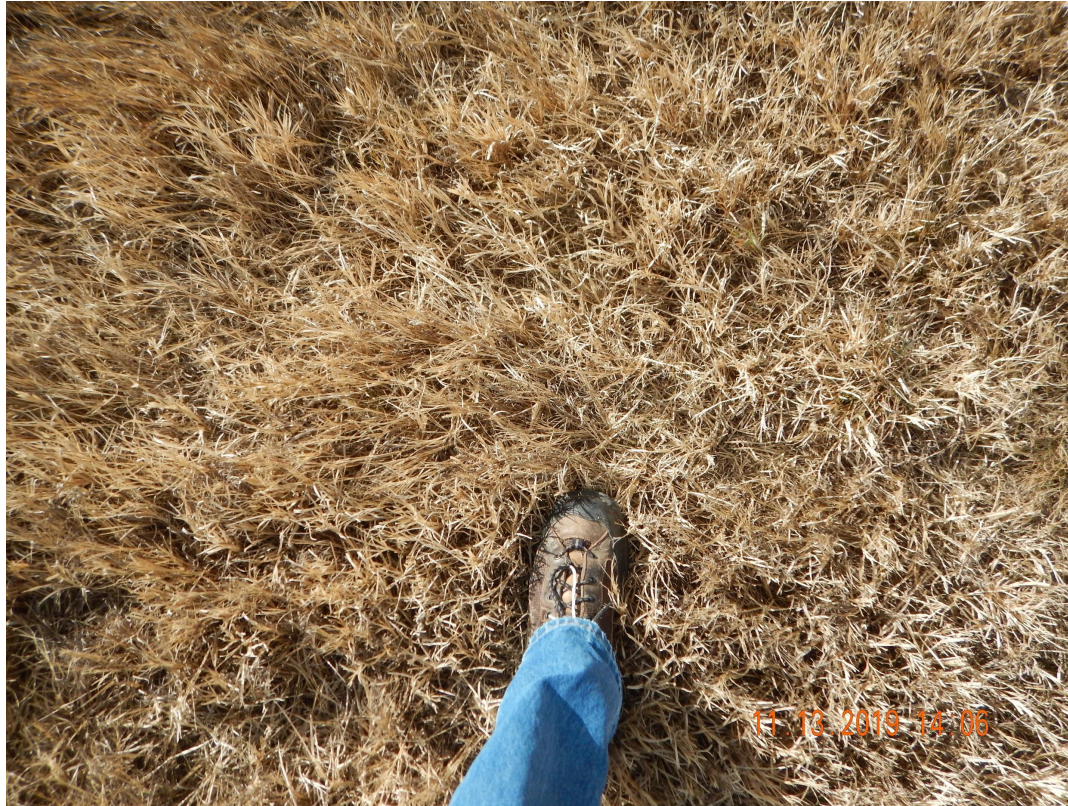
Photo 7. Close up reference photo illustrating the total cover of live perennial vegetation of a reference area which is not reflective within the location.

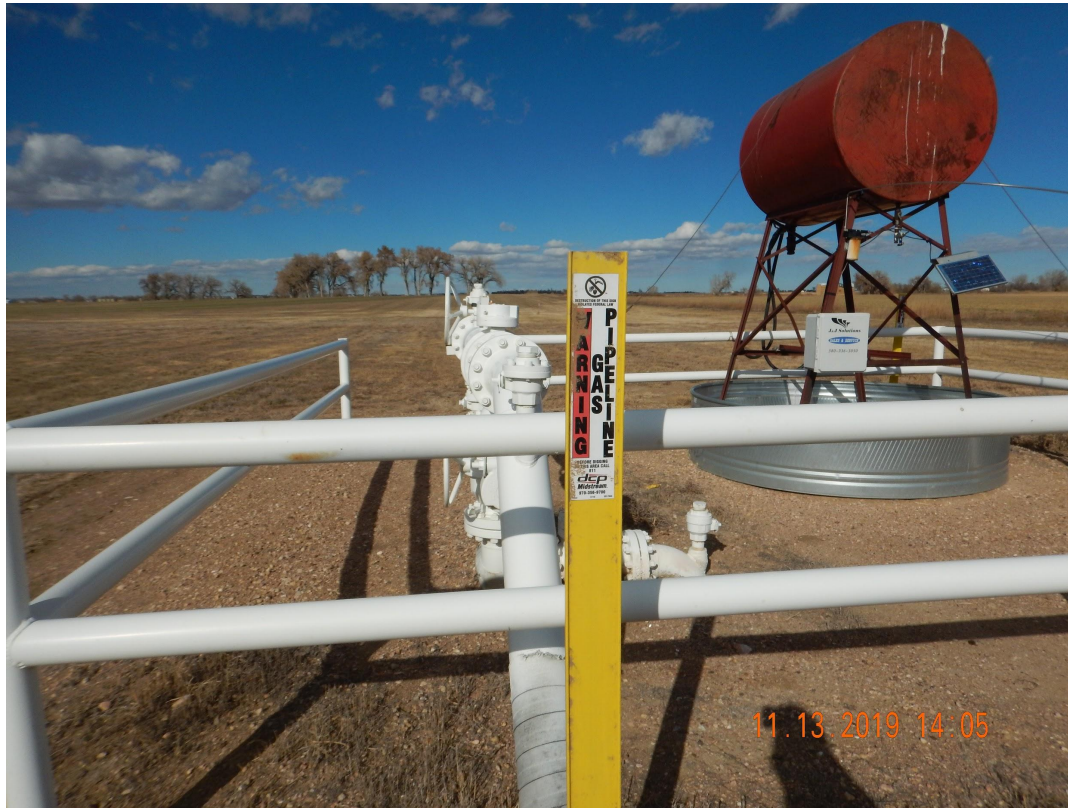
Photo 8. Photo taken from the southern location, facing North. Photo illustrates what appears to be an active DCP midstream gathering line.
