# Inspection Photos

API: 05-071-09512

Operator: PIONEER NATURAL RESOURCES USA INC

Inspection Date: 11/8/2019

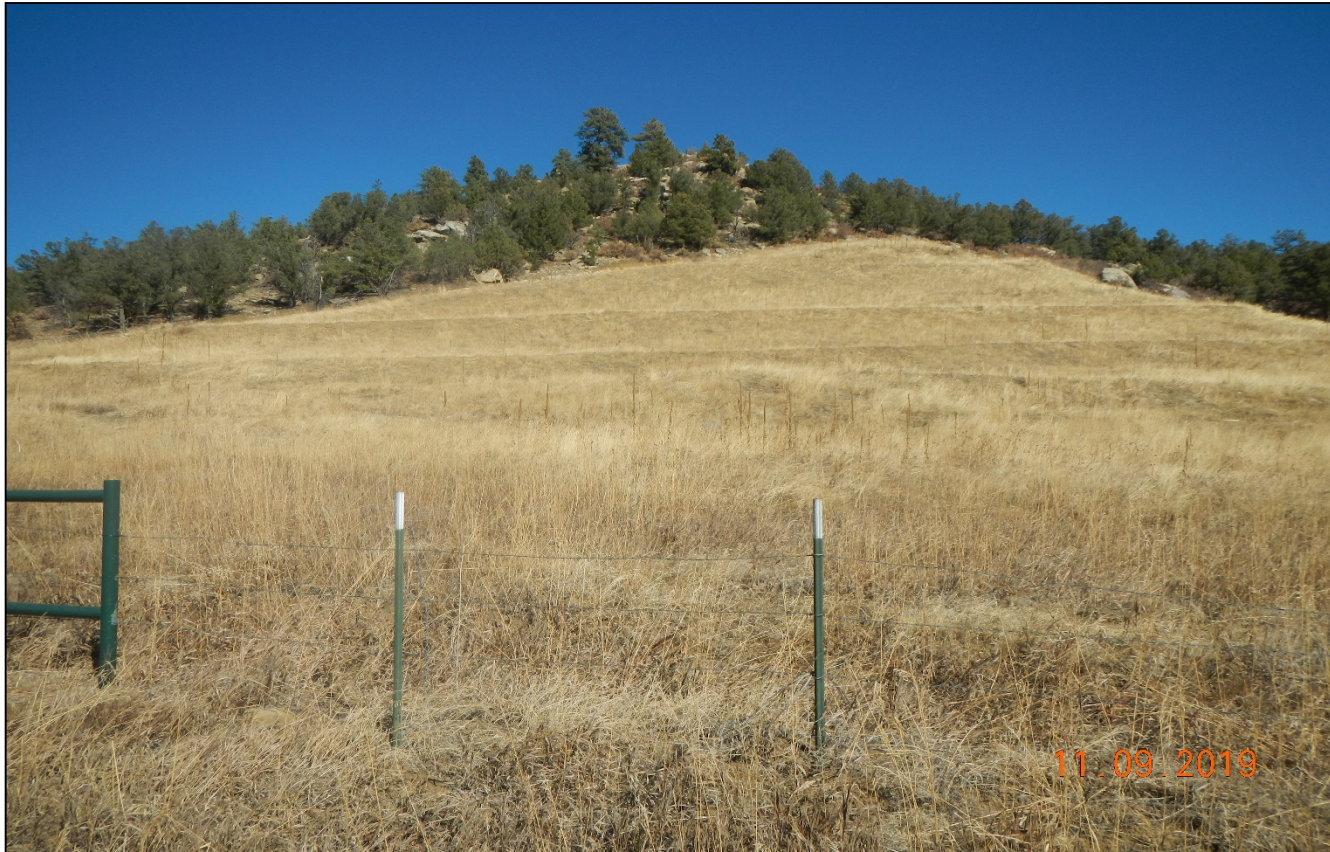
**Photo 1.** Facing north toward the location. There are large berms or terracing across the recontoured site that do not match the surrounding terrain.

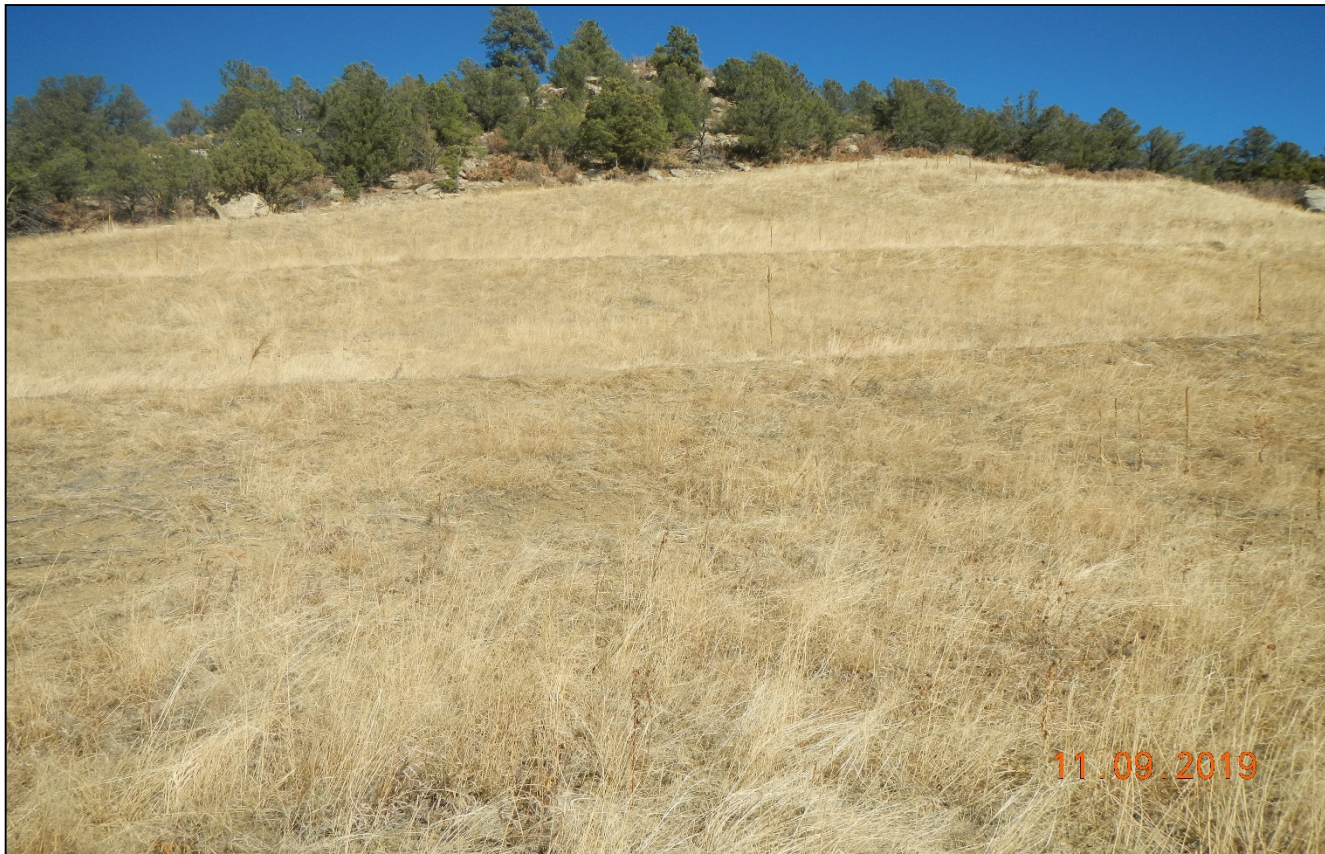
**Photo 2.** Facing north toward the location. There are large berms or terracing across the recontoured site that do not match the surrounding terrain.

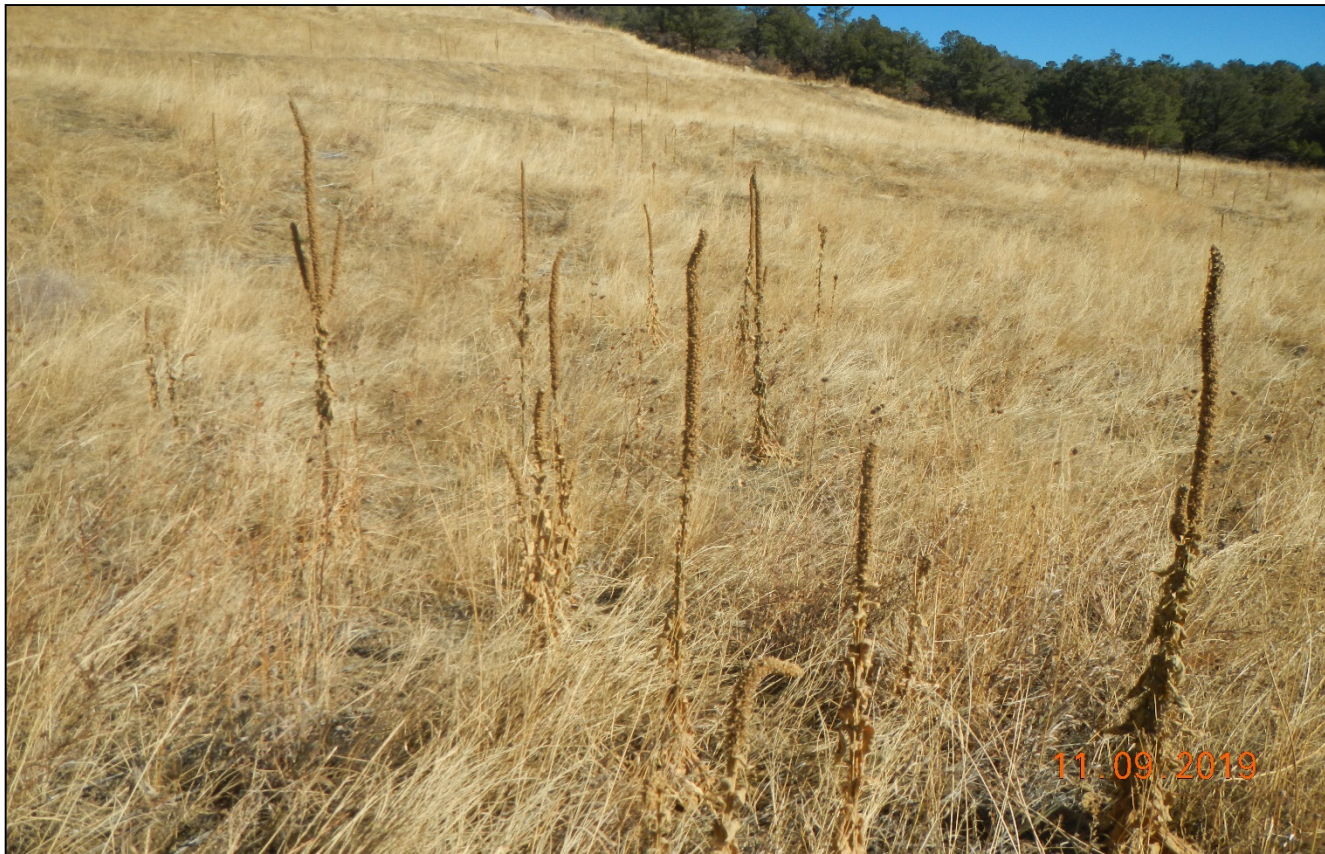
**Photo 3.** There are some noxious weeds present which include Musk thistle and Common mullein.
