# Inspection Photos

11/05/2019

Operator: WHITING OIL & GAS CORPORATION  
- 96155

Location ID: 315169  
Rio Blanco County, CO

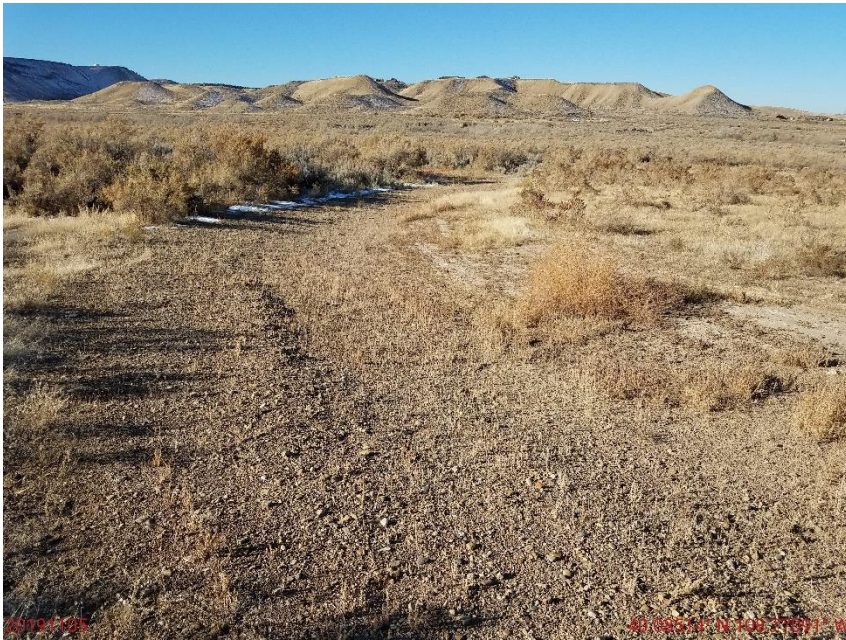
**Photo 1:** Photo taken from the CR 218, facing west. Photo shows access road leading to the location

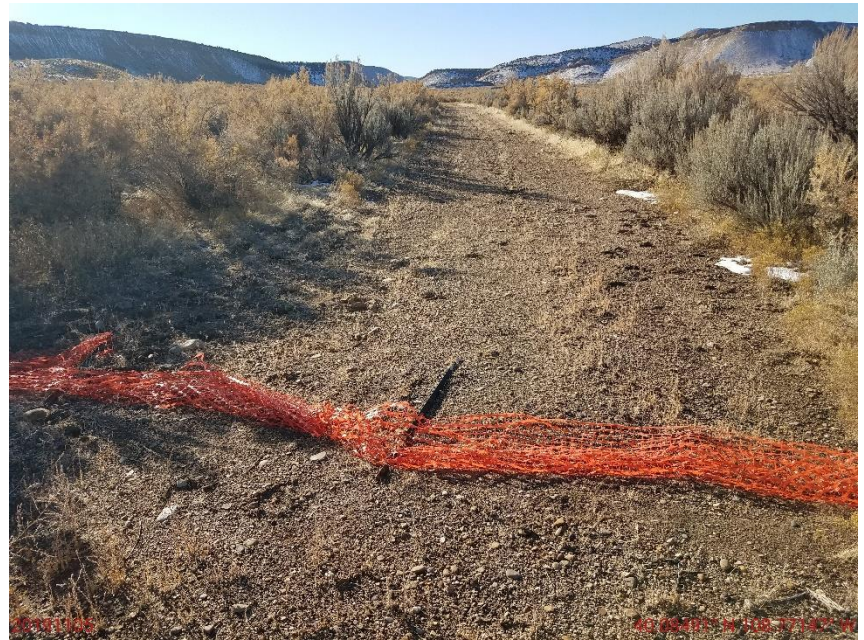
**Photo 2:** Photo taken from the access road, facing south. Photo shows orange fence used to restrict vehicle access over the reclamation areas. Fence in disrepair and vehicle traffic evident along access road.

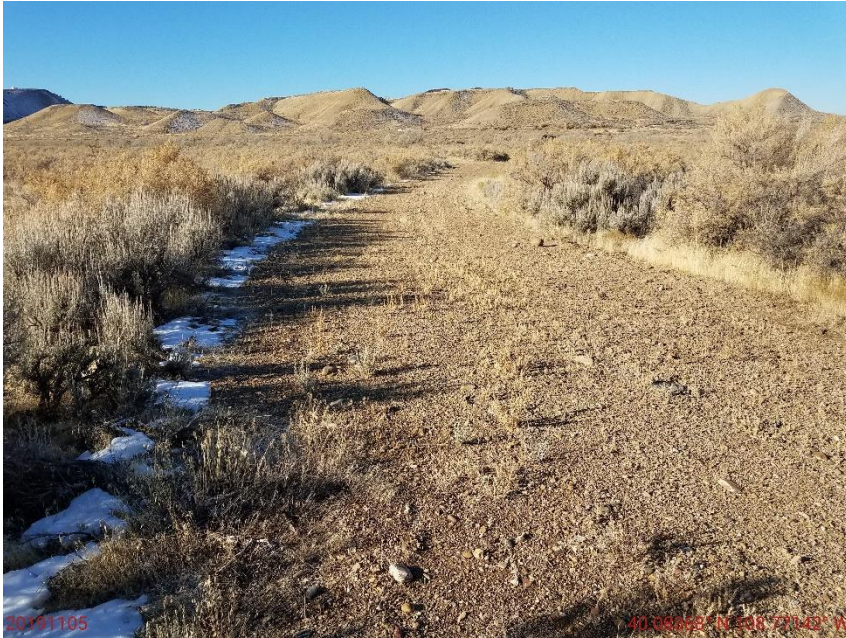
**Photo 3:** Photo taken from the access road, facing west. Photo shows reclamation over access road is not progressing towards COGCC 1000 series rules and requirements. Vegetation observed on access road predominantly undesirable weedy plant species such as *Salsola* sp. And *Kochia*. Desirable species reflective of the reference area were not observed to be establishing on access road.

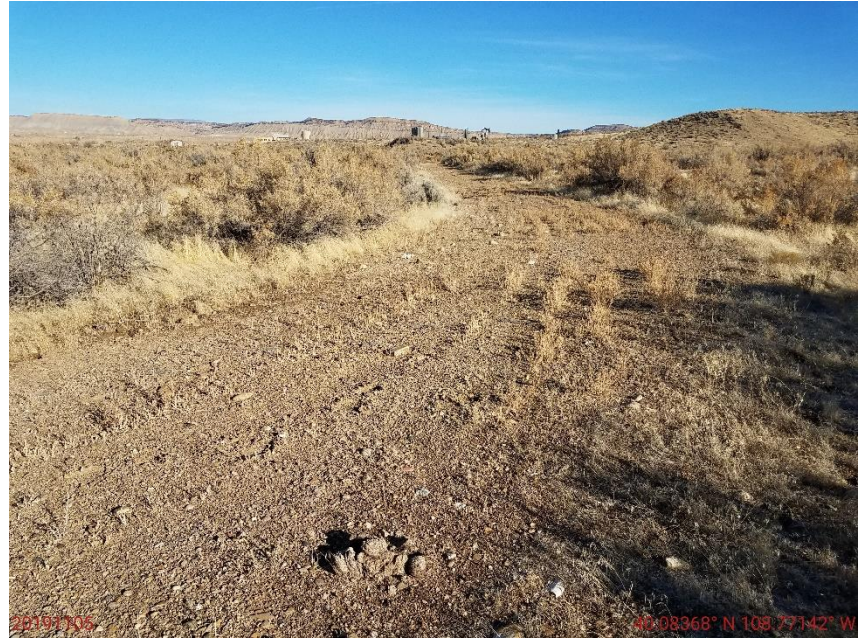
**Photo 4 :** Photo taken from the access road, facing north. See comments under photo 3.

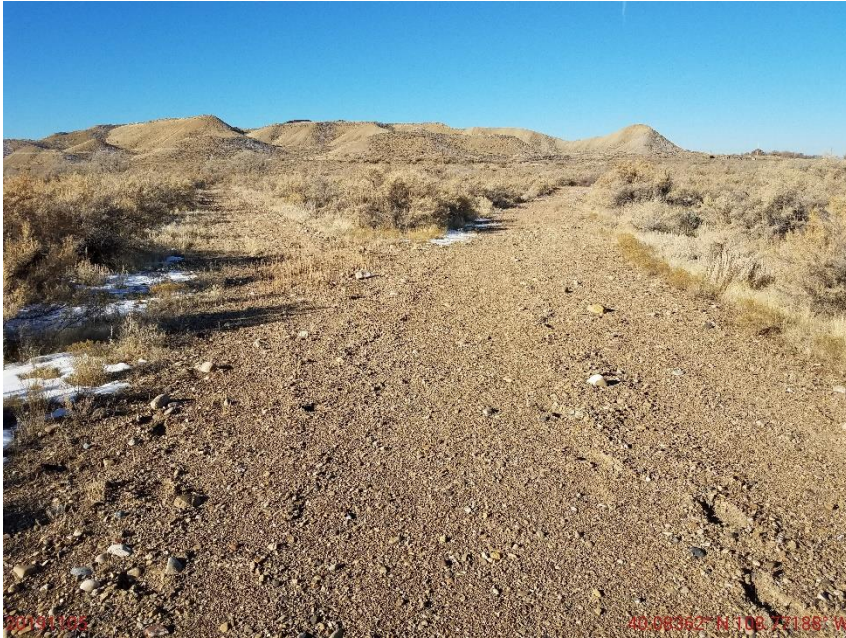
**Photo 5:** Photo taken from the access road, facing west. Photo shows area where access road splits and forms a loop leading to the well and battery locations. See comments under photo 3.

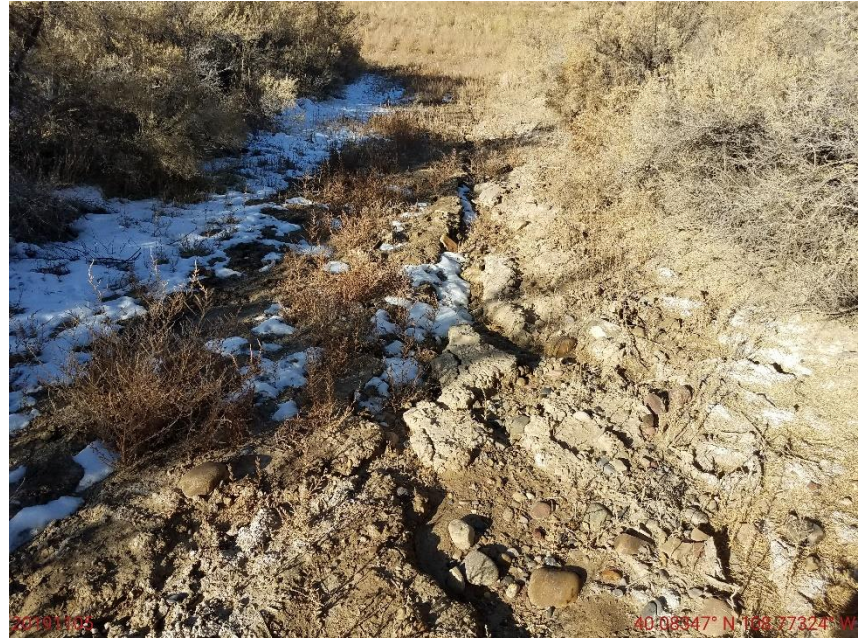
**Photo 6:** Photo taken from the access road, east of the location facing west. Photo shows stormwater erosion degradation along sloped access road.

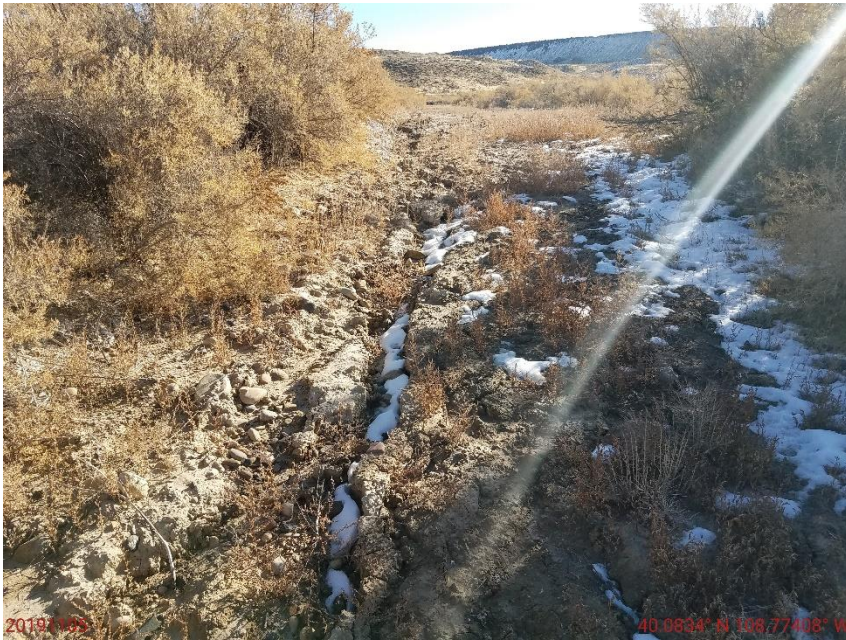
**Photo 7:** Photo taken from the east end of the location, facing east. Phot shows stormwater erosion degradation along sloped access road. Insufficient stormwater and erosion control BMPs on access road.

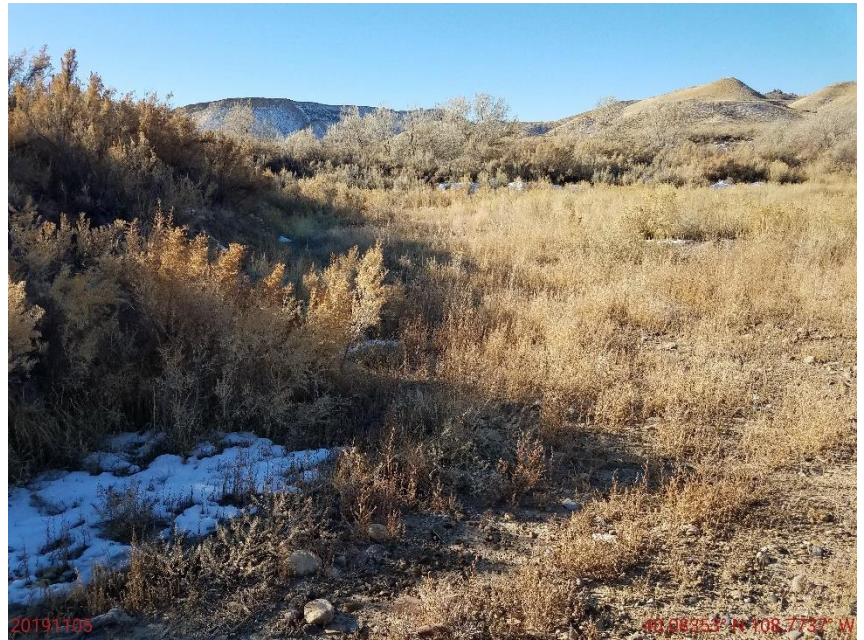
**Photo 8:** Photo taken from the east end of the location, facing southwest. Photos 8-10 provides and overview of the well location from southwest, west to northwest. Photo shows vegetation over the reclamation area; vegetation on the location is predominantly undesirable weedy plant species such as Salsola sp. and Kochia. Vegetation on the north and southern ends of the location appears to be progressing towards reclamation requirements. Additional seeding will likely be required for location to meet COGCC 1004 uniform desirable vegetative requirements.

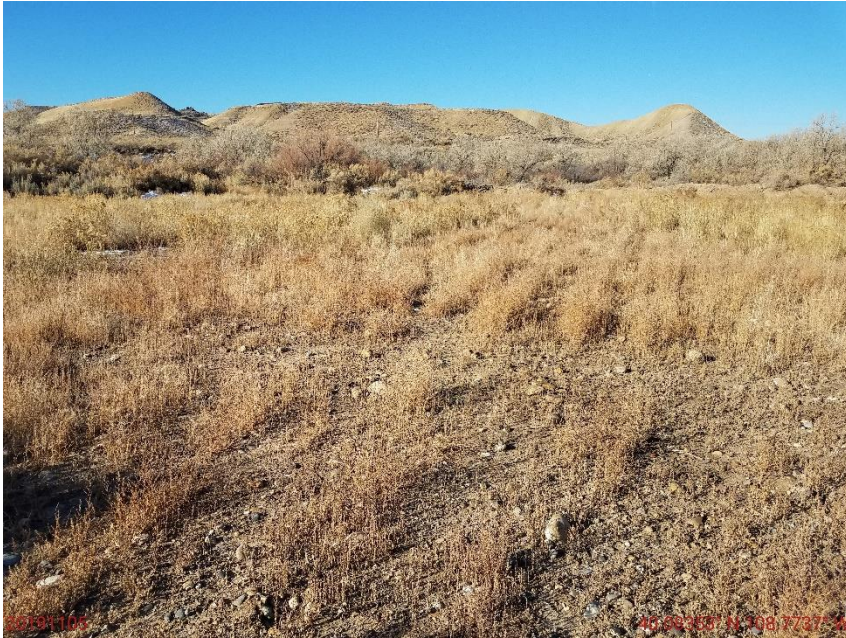
**Photo 9:** See comments under photo 8.

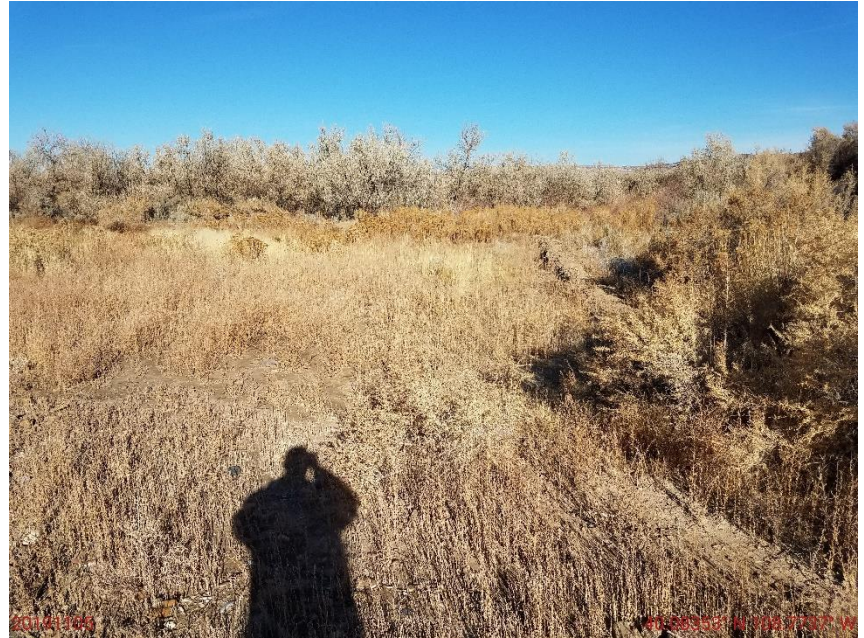
**Photo 10:** See comments under photo 8.

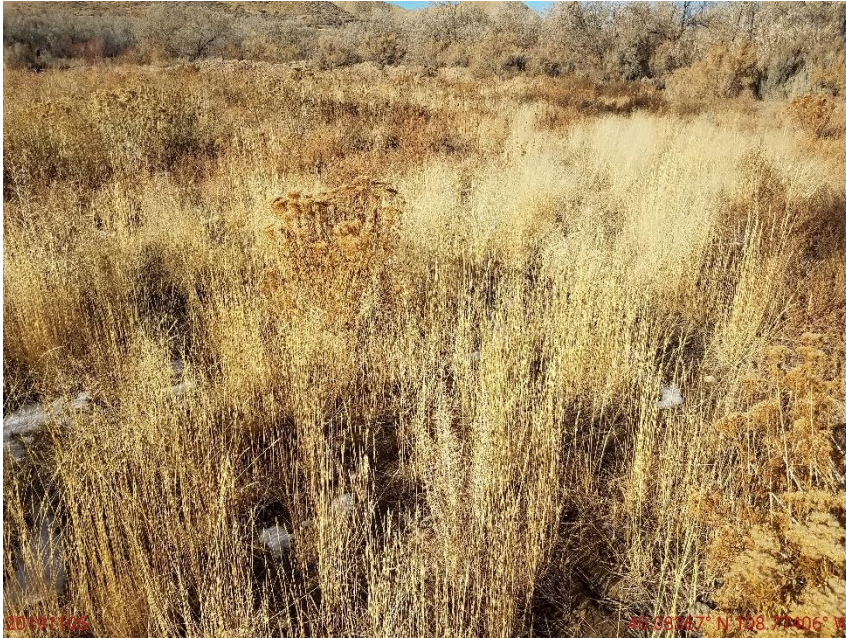
**Photo 11:** Photo taken from the north end of the location, facing west. Photo shows desirable vegetative establishment on the north end of the location. The northern and southern ends of the location appear to be progressing towards reclamation requirements.

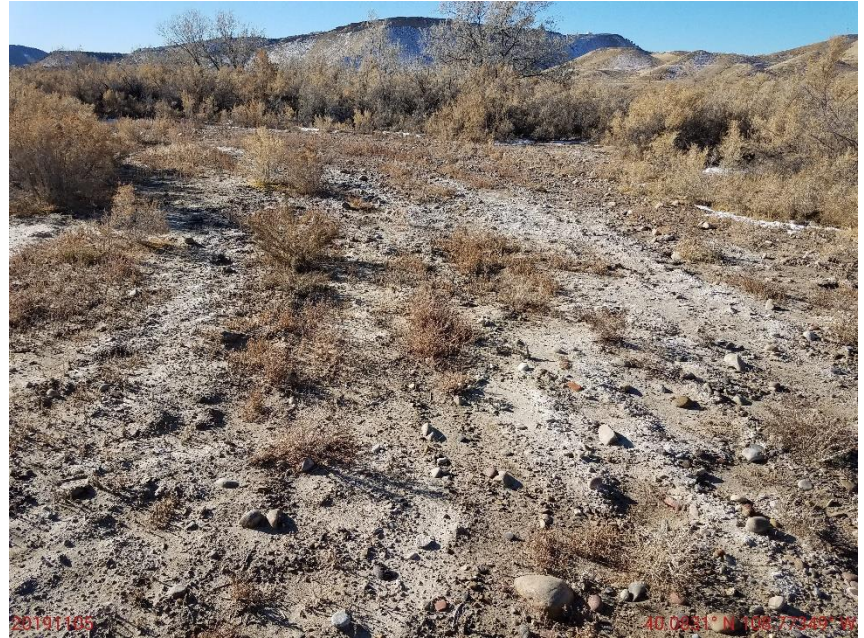
**Photo 12:** Photo taken from the southern end of the battery location. Photo shows reclamation of the access road and battery is not progressing towards reclamation requirements.

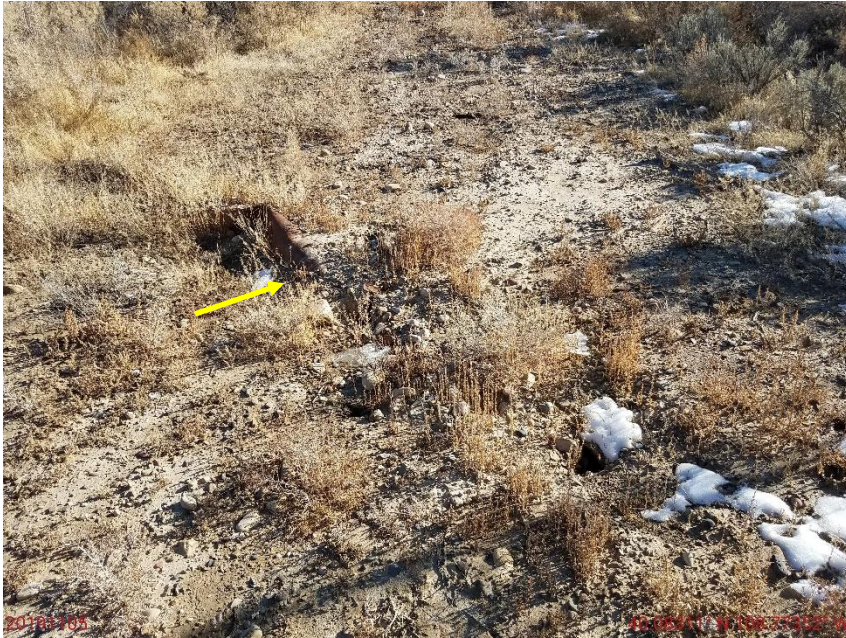
**Photo 13:** Photo taken from the south end of the battery location. Photo shows pipe, possibly a culvert, remaining at the battery.

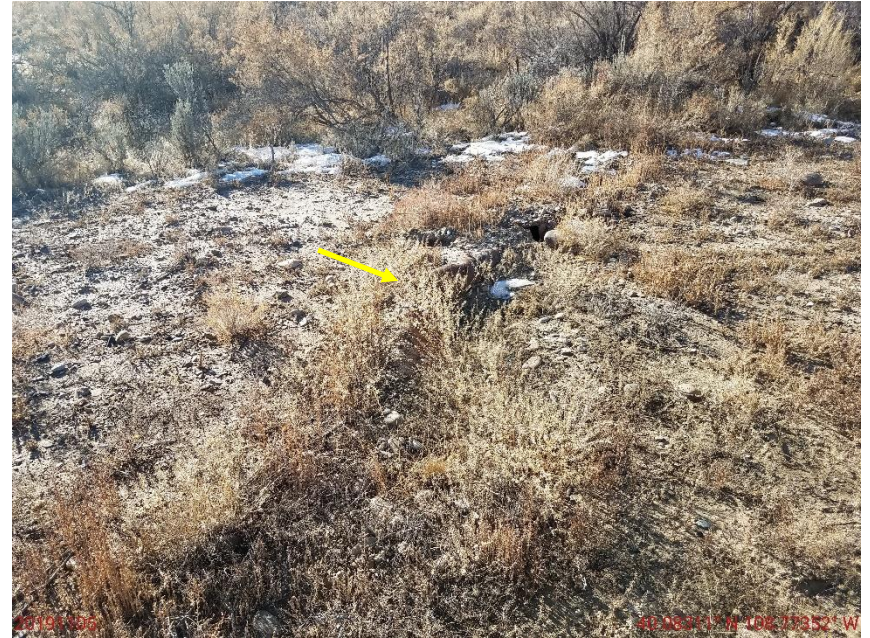
**Photo 14:** See comments under photo 13.

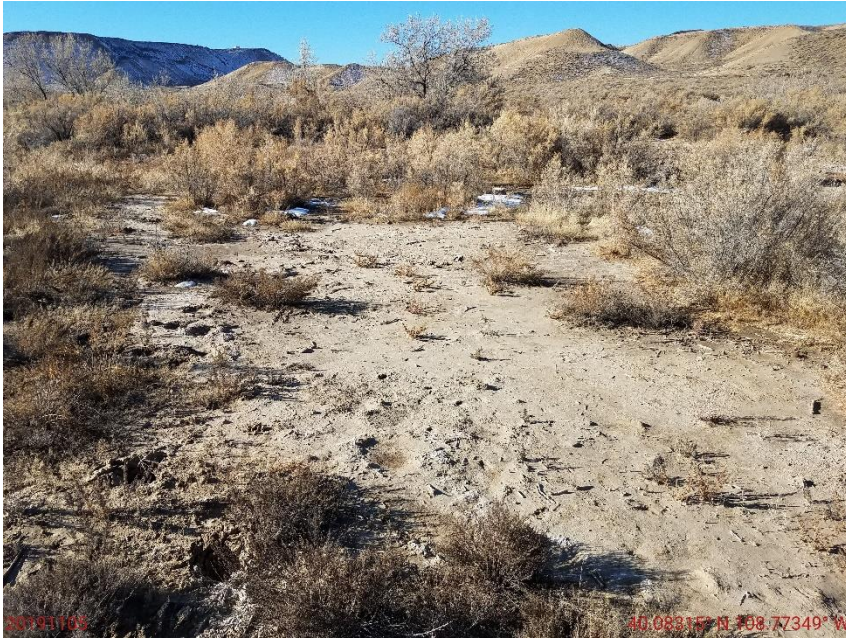
**Photo 15:** Photo taken from the battery location facing west. Photo shows battery location remains predominantly bare and exposed soil. Reclamation of the battery location is not progressing towards reclamation standards.

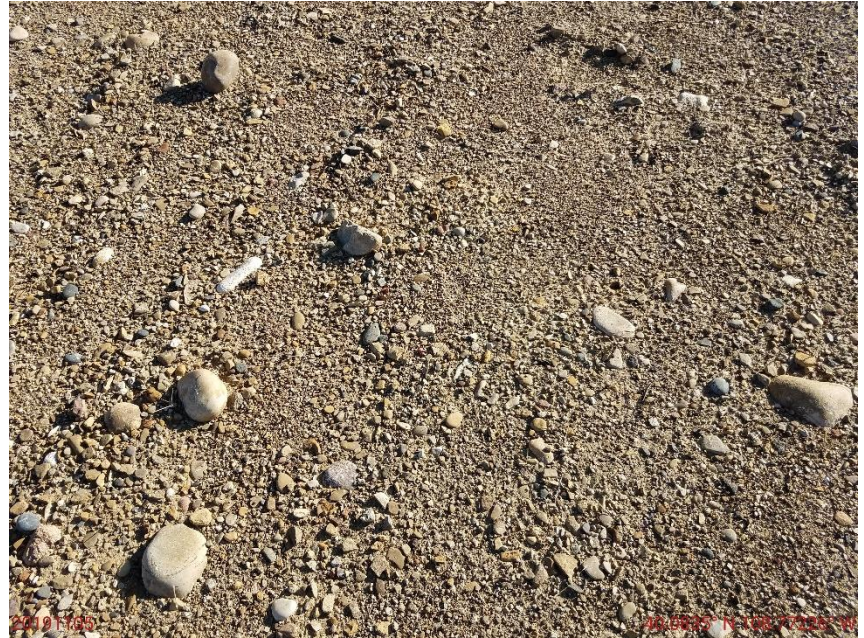
**Photo 16:** Photo taken from the access road. Photo shows what appears to be gravel remaining on the access road. Material was not observed on the soils of the adjacent reference areas. Aggregate likely hindering desirable vegetative establishment.

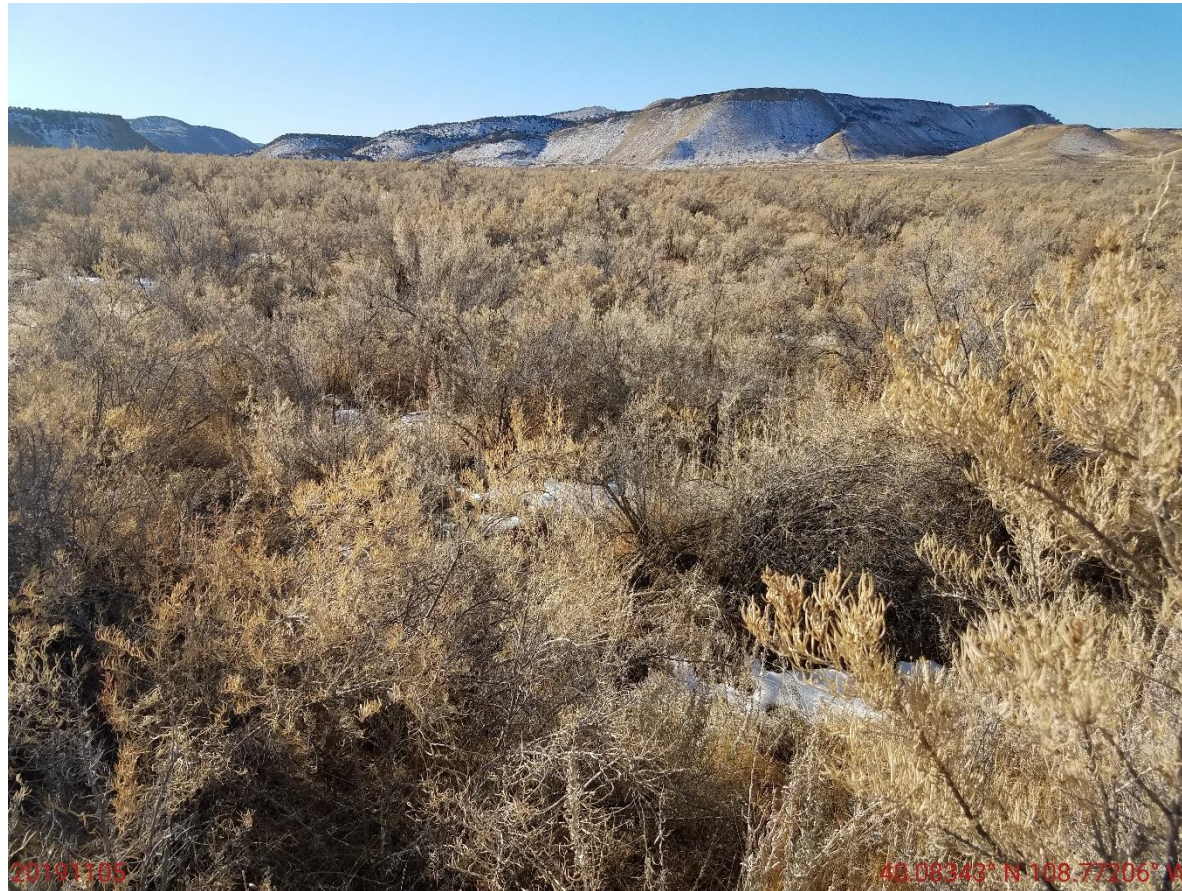
**Photo 17:** Photo shows vegetation over the adjacent reference area.

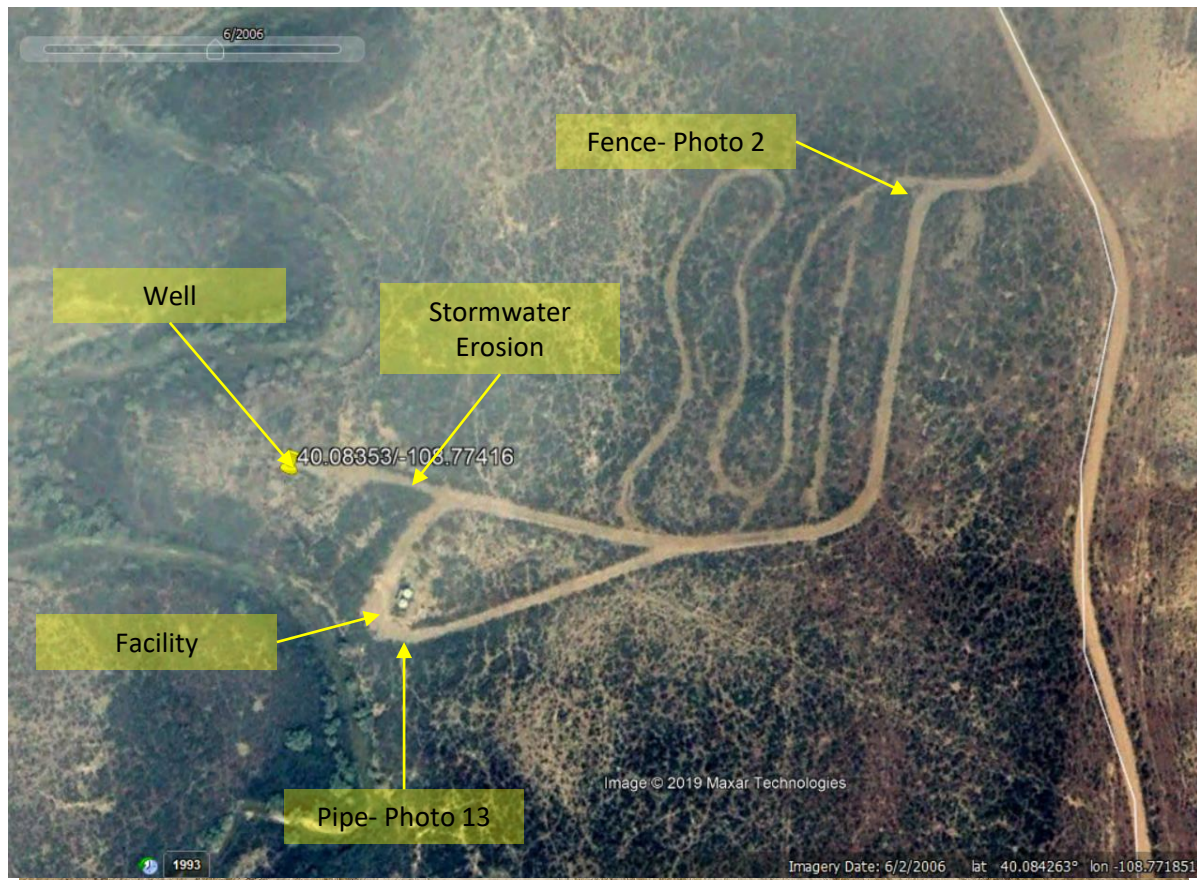
**Photo 18:** 2006 Google Earth Aerial imagery. Photo shows overview of the well and battery locations, and access road.
