Inspection Photos
Location Name: LAURA-65N63W /28SENE
Location #: 305671

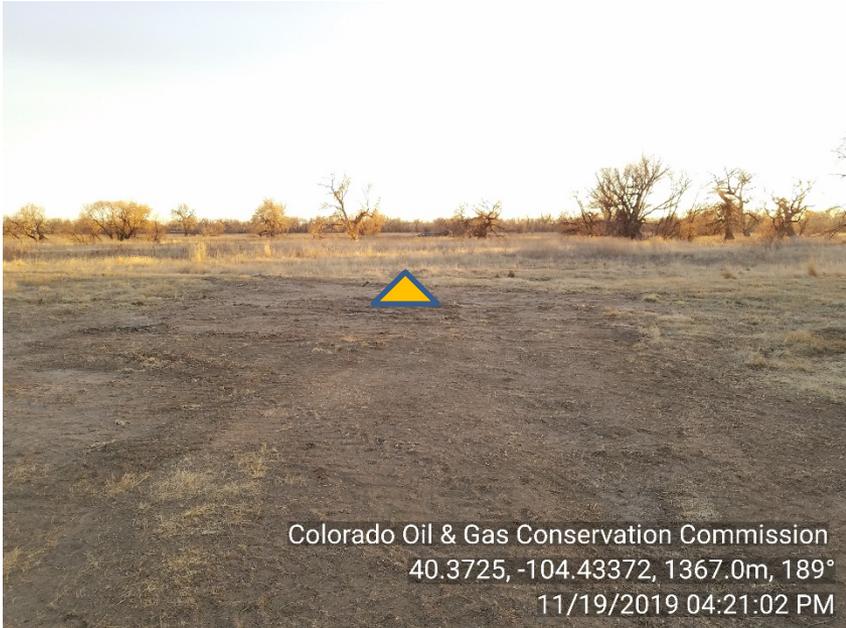
Colorado Oil & Gas Conservation Commission
40.3725, -104.43372, 1367.0m, 189°
11/19/2019 04:21:02 PM

Photo #1
Laura 8-28 (05-123-23332) Wellsite
Plugged & Abandoned | PA
~ 15 yds.
Appears to be cut & capped
Reclamation progressing

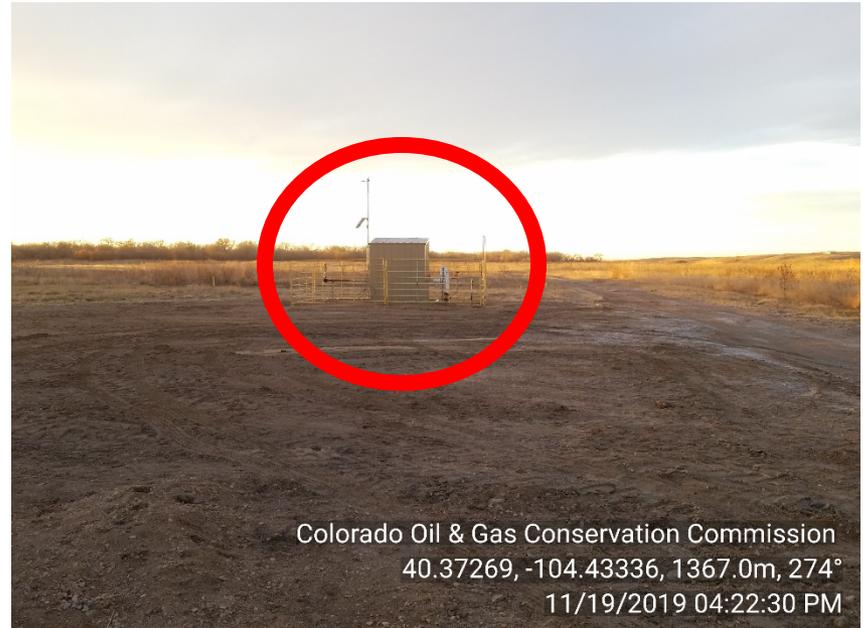
Colorado Oil & Gas Conservation Commission
40.37269, -104.43336, 1367.0m, 274°
11/19/2019 04:22:30 PM

Photo #2
Laura 8-28 Battery site
Abandoned | Most equipment removed
Reclamation progressing
Unused Gas meter run
