Inspection Photos
Location Name: CF&I 29 2
API#: 05-071-60013
INSP. #: 695101768

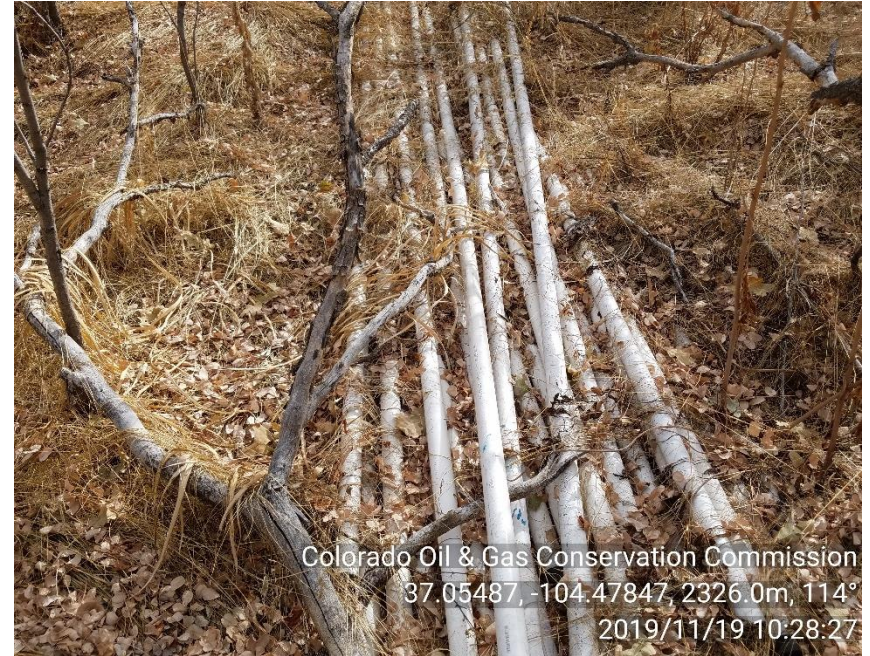
PHOTO 2: UNUSED EQUIPMENT LEFT ON LOCATION (SEVERAL JTS OF 1 ¾" PVC PIPE USED FOR P&A). REMOVE UNUSED EQUIPMENT FROM LOCATION AS PER RULE 603.f. CA DATE 12-20-19.
